TECHNICAL MEMORANDUM

| INVESTIGATION | Remedial Action Plan – Initial Concepts | PROJECT | Horncastle Arena Diesel Spill |
| CLIENT | Vbase | PROJECT NO | CJ747100 |
| DATE | 12 October 2018 | SIGNATURE | |

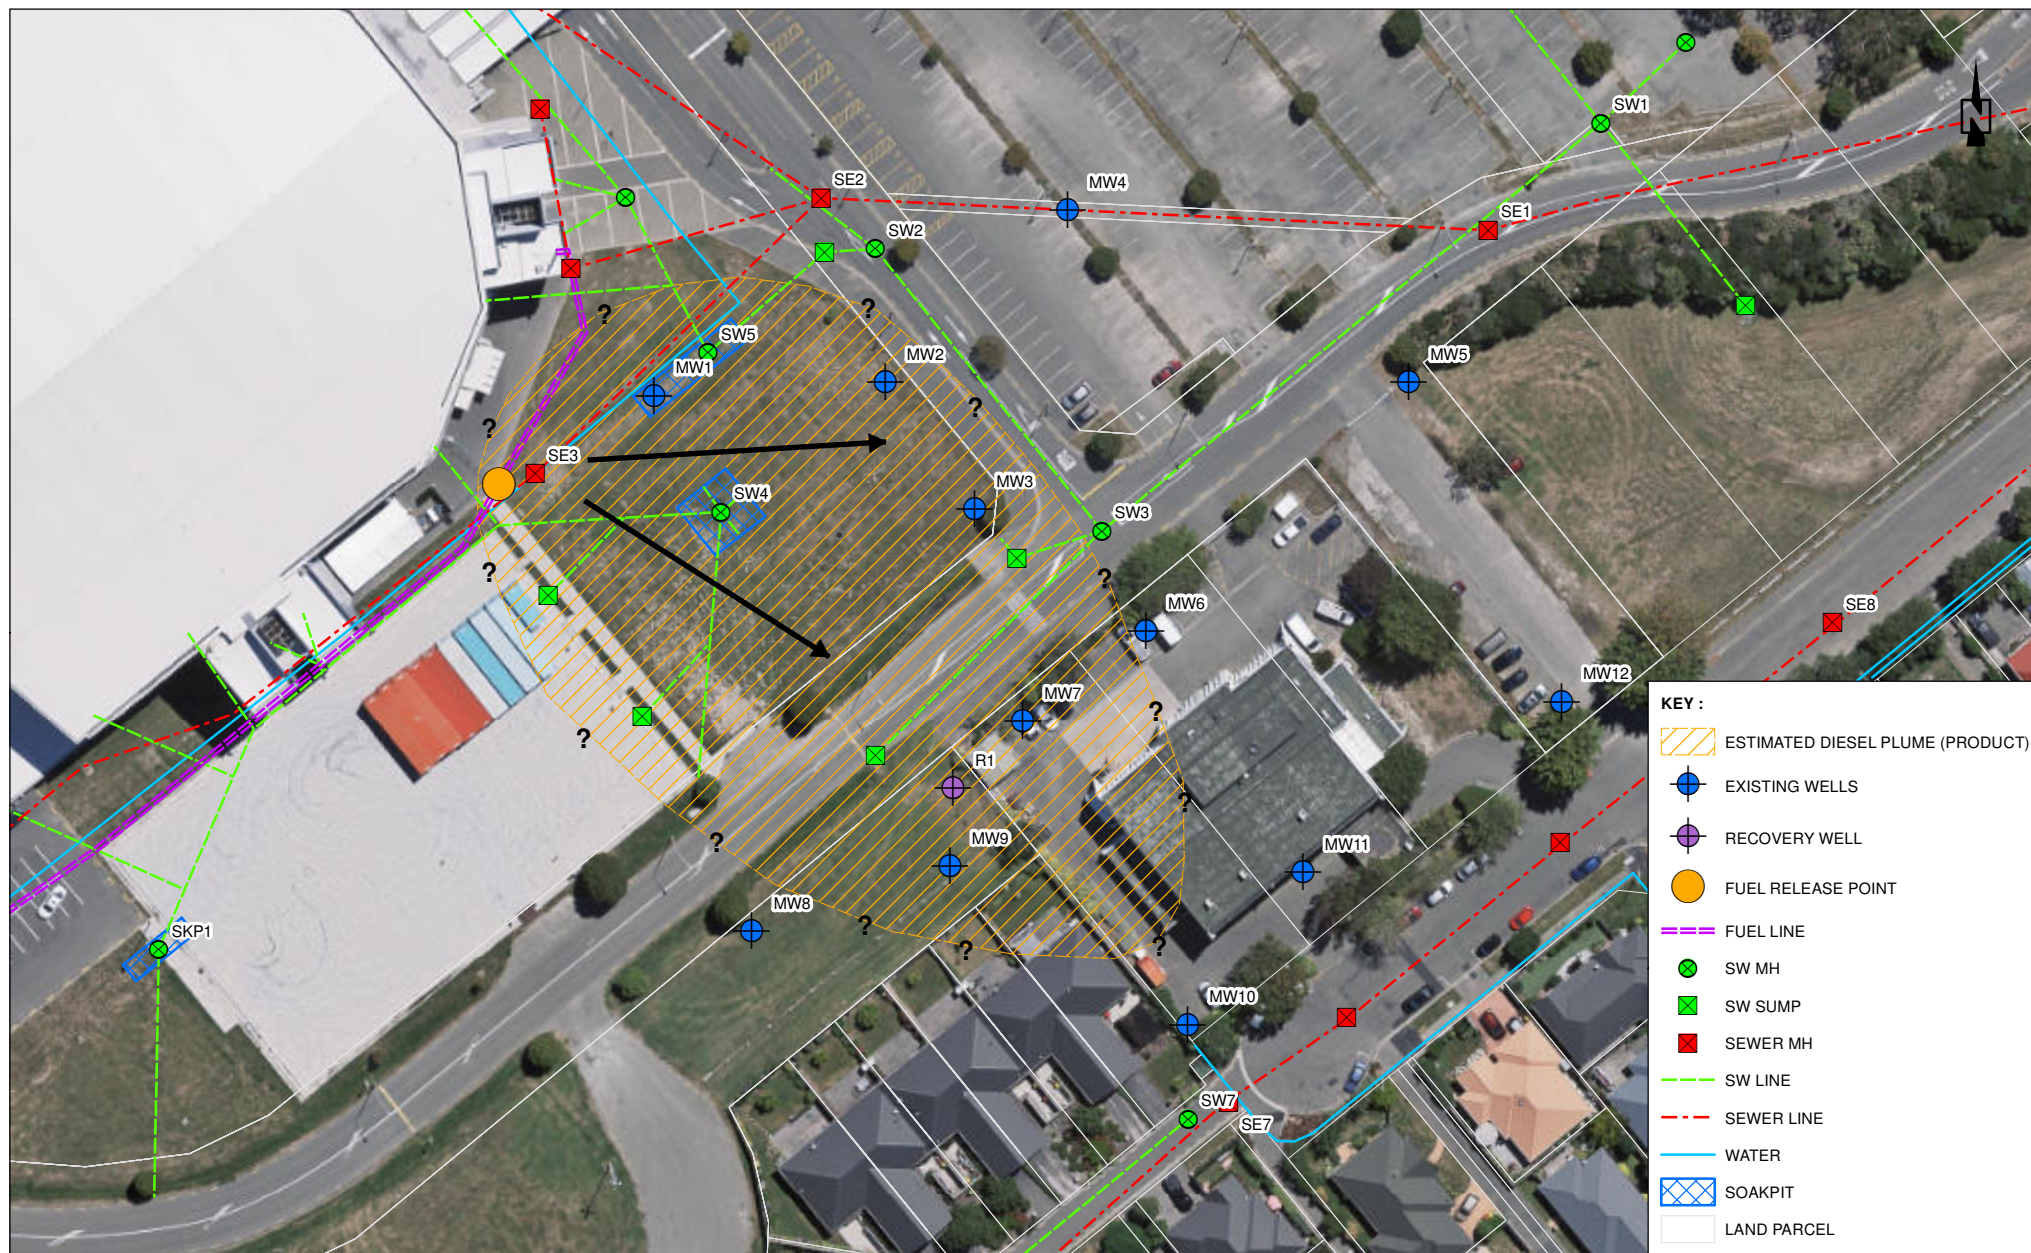
seepages into underground services (i.e. groundwater entering deeper service lines) as well as soak pits discharging roof water/hardstand runoff into the ground into the area (soak pits defined as SW5 and SW4 on the plan). Subsurface geological conditions may also be influencing the flow direction (i.e. former river channels). This is still being investigated.

- ✧ The extent of the separate phase plume is shown on the attached plan (based on wells showing separate phase diesel on the water surface). The extent of the dissolved phase plume is yet to be determined, but will be larger than the separate phase plume.

- ✧ The most plausible entry point of diesel into the stormwater system is via the stormwater manhole on Jack Hinton Drive (shown as SW3 on the plan). The invert level to the base of this manhole is 1.5 m bgl and the location of this manhole is around the approximate edge of the separate phase diesel plume. The triggering point could either be the separate phase plume reached this point as the plume was advancing or that the water table has risen allowing the floating diesel to touch the base of the manhole and entering through cracks in the base (the integrity of the base has not been assessed, but this is a typical assumption that some cracks may exist).

APPROXIMATE EXTENT OF DIESEL PLUME (PRODUCT)

6. A deep recovery well is proposed to be installed (7 m deep and 150 mm dia – refer attached plan) to continue to recover the mobile fraction of diesel in the ground. A trial pump test will be undertaken once installed to determine the drawdown required to create a suitable radius of influence to draw the mobile fraction of diesel towards the well for removal (water abstracted discharged to sewer and vacuum truck to skim any accumulating diesel on the surface). The drawdown created will also ensure that the water table/product levels are maintained below the suspected release point into the stormwater manhole and lift shaft. Once the trial has been completed a semi-permanent system is proposed to be installed. The details of this system will be finalised once the trial has been completed, but will look to achieve the same objective of maintaining a water table depression and skimming of any accumulating diesel on the surface. **DRILLING AND TRIAL TO COMMENCE NEXT WEEK**
