Farm Environmental Management

Plan: Maryburn Station (Classic Properties Ltd)

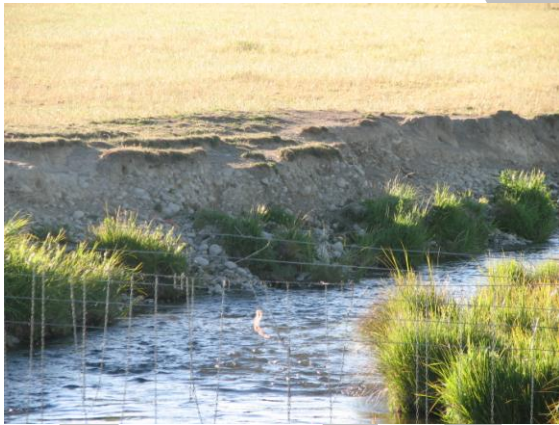
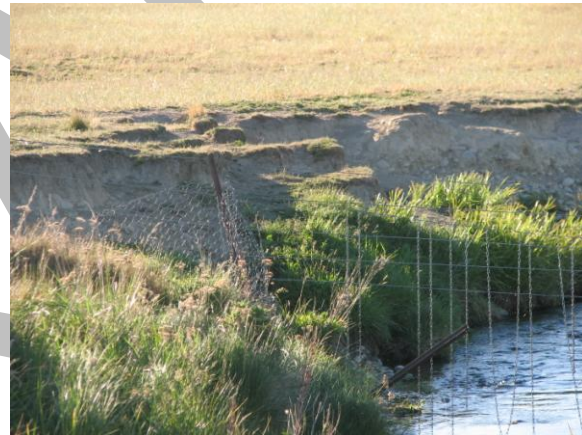
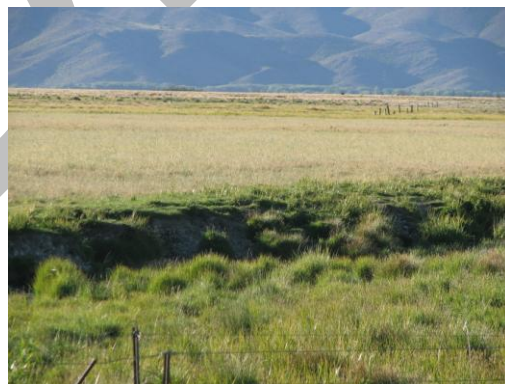
- 4.3.13** Along the Maryburn stream there are areas of relatively bad stock induced erosion (approximately 50 meters, see photos); this according to the applicant is from sheep. There were at the time of the visit around 50 cattle in this vicinity as well.

Photos showing the worst area of erosion that is stock induced, this area extends for approximately 100 metres

Development of a Riparian margin of a minimum of 5m width along the most affected areas of the Maryburn Stream (the 100 metres that will be fenced)
