Farm Environmental Management Plan

Godley Peaks Station

Prepared for Lone Star Farms Ltd

Ryder Consulting

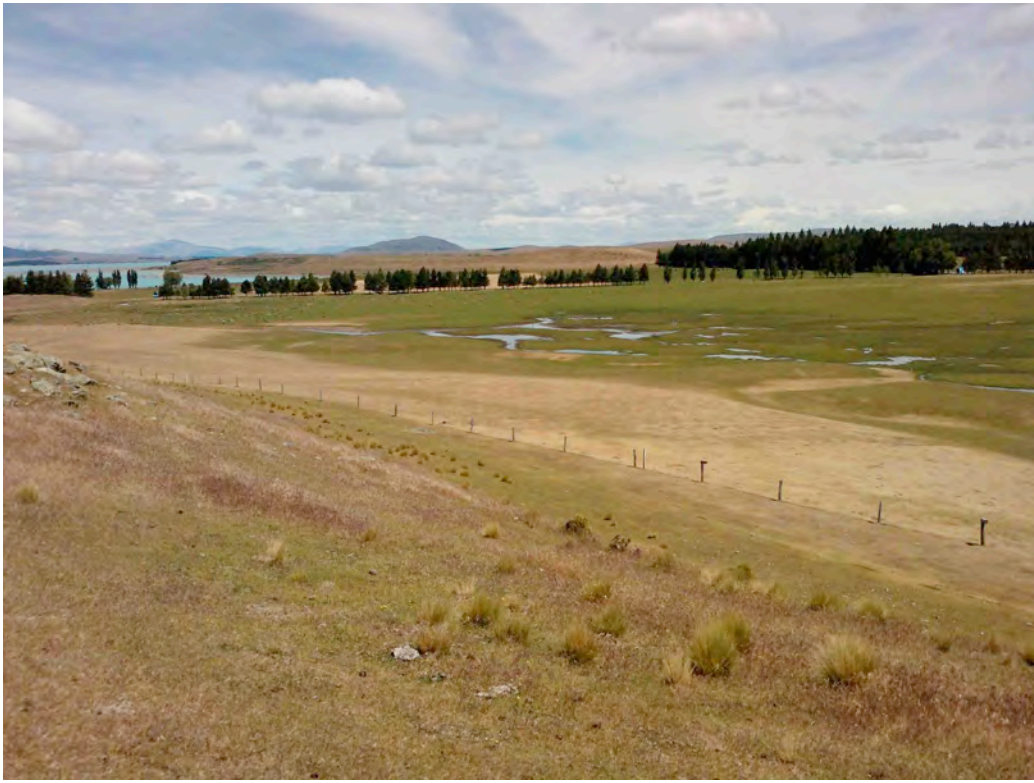
Figure 4 Ephemeral surface water runoff to Rapuwai Lagoon

- The installation of a buffer strip and subsoiled strip on foot of eastern slopes approaching Micks Lagoon;
- Ephemeral channel carrying flows to Rapuwai Lagoon to be grassed and remain under grass;
- Where conditions are such that there is surface water ponding flowing (ephemeral channels flowing to Rapuwai Lagoon and Lake Tekapo), stock to be restricted from the immediate area by temporary fencing;
- No cultivation of lower terrace North of Mistake River adjacent to the lake margin; and,

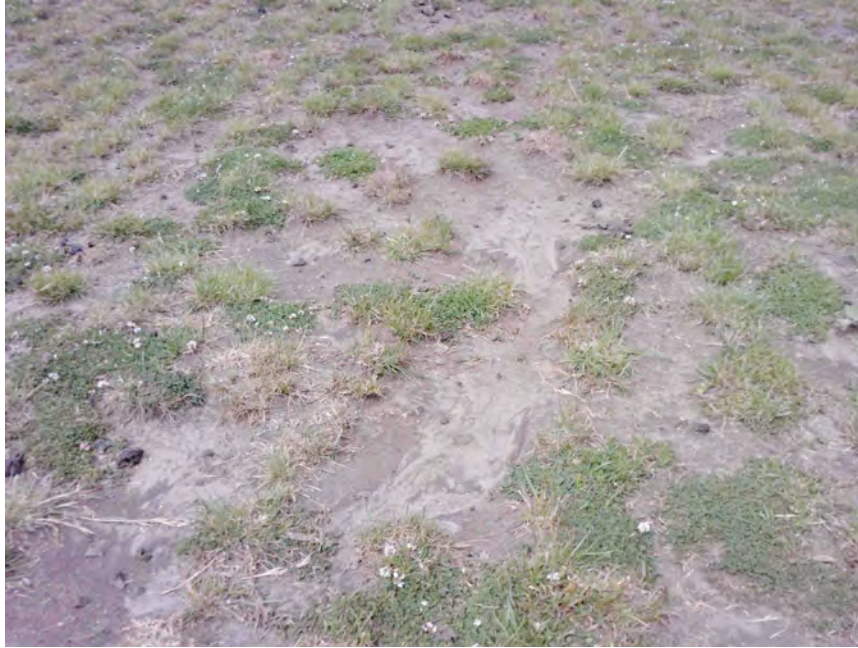
Figure 6 Marginal surface runoff on slopes to Micks Lagoon

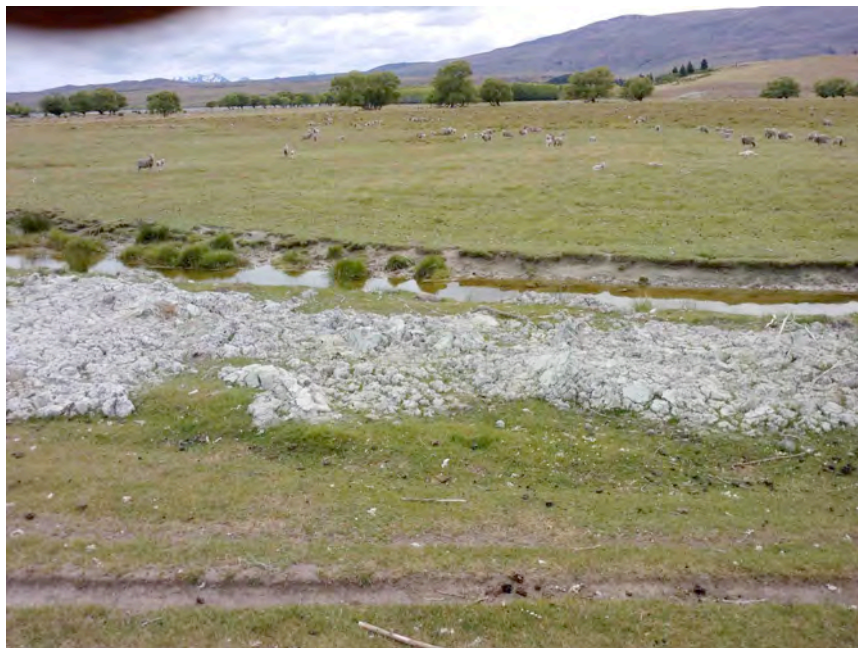
Describe Local receiving environments		Mistake River	Homestead Pond	Micks Lagoon	Rapuwai Lagoon	Lake Tekapo	Cass River
Type		Watercourse	Pond	Lagoon	Lagoon	Shoreline of Lake Tekapo	River
Source		Highland, contained on farm	Spring fed pond augmented by 2 water races. Would be smaller without this augmentation	Irrigation water from Mistake River via water races	Spring/GWR level is thought to reflect Lake Tekapo level	NA	Highland
Destination		Lake Tekapo	-	-	No outlet	Water leave UW via canal system and Lake Benmore	Lake Tekapo
Germorphology		-	-	-	-	-	-
Condition		-	Degraded	Lagoon is good	-	Good	ND
Value		Habitat and unmodified status (IO)	Wetland of Representative and Ecological importance (WERI)	Biodiversity/ Black stilt	-	amenity/ visual	Habitat
Protection		-	-	DoC sanctuary	-	-	-
Regulation/required quality		-	-	-	NS	-	-
Current threats							
	Stock	No stock access	Stock access to lagoon although normally only sheep in this paddock. Stock on sloping field draining to lagoon	Protected from Stock	Stock have access to part of lagoon	Although stock are not restricted completely from the Lake there was no evidence of damage by stock. There is extensive (although variable) gravel foreshore	Stock are not restricted from Micks Lagoon outfall channel (Figure 7)

Figure 7 Outflow from Micks Lagoon including stock encroachment

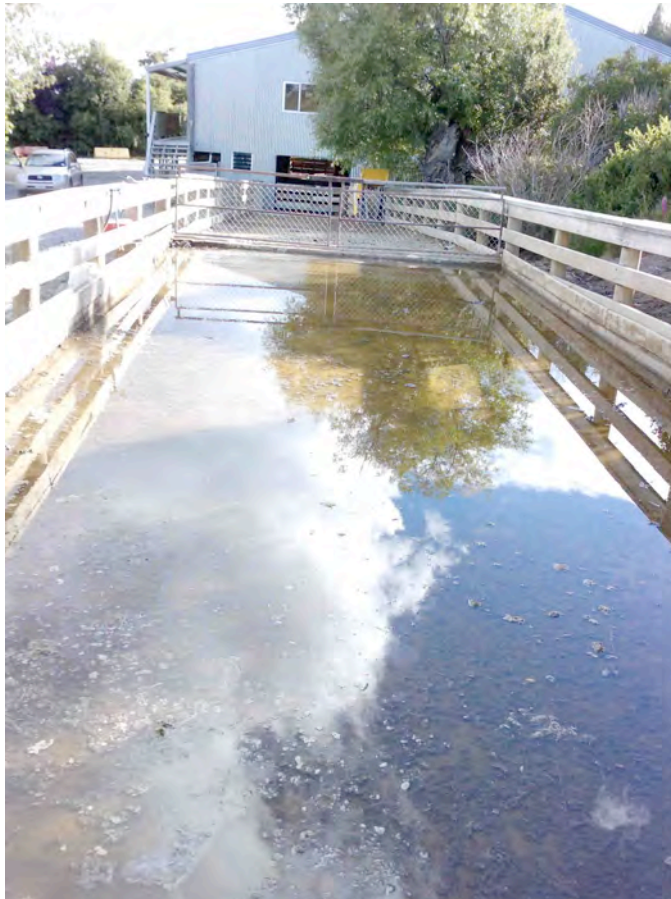
Figure 8 Yard where sheep jetting occurs with drainage at far end

- Contaminated yard runoff to pass through a biobed for treatment prior to being discharged onto Killer Paddock. A biobed is essentially an organic filter system consisting of a lined structure that contains a biomix - a mixture of topsoil, compost and straw. The biomix removes the pesticides from the contaminated water, the retained pesticides are then degraded and the treated water can be reused (Fogg, 2007). Further details on biobed construction and use are given in Annexure 2;
- No spray areas for chemicals to be mapped and clearly displayed in sprayer cabs; and,
- Back siphoning prevention measures to be implemented on the farm when filling sprayers from an un-isolated water supply.

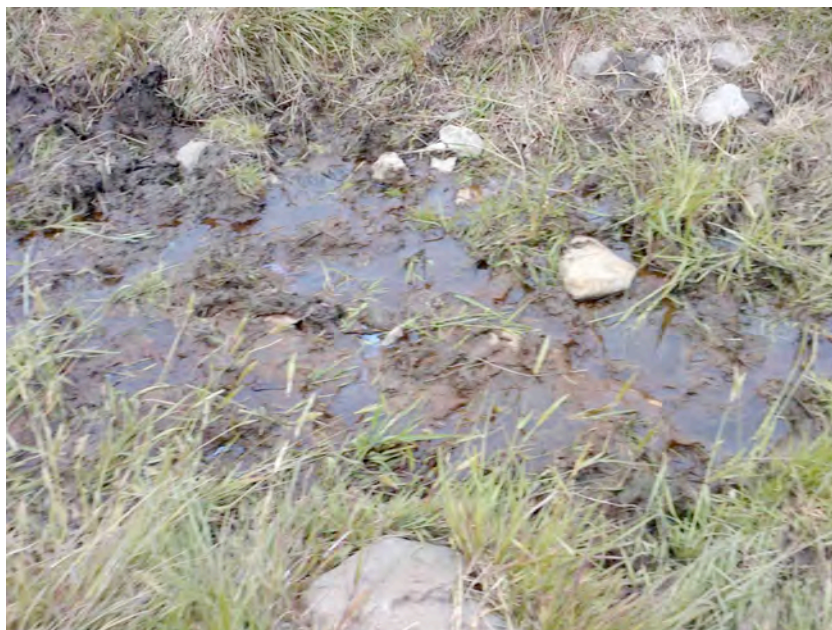
Runoff	In vicinity of irrigation the very shallow gradient to the river would reduce the vulnerability to runoff	Roofwater is piped via downpipe and drain under track to outlet across the paddock and meanders in a runoff channel to Lagoon. Cross drain at lowest point of yard also drains into this drain. Yard is used to treat and jet sheep and therefore runoff is contaminated with excreta and chemicals (Figure 8)	Runoff potential into Micks Lagoon - capped soils with some consolidation sloping down to lagoon (Figure 6)	The surrounding slopes may runoff, but this is a natural phenomenon	Ephemeral channel in proposed hardnose area east of eastern pivot. Runoff to lake.	-
	Effluent	NA	NA	NA	NA	NA	NA
	Fertiliser	-	NA	-	Absence of buffer	Fert applied within 20 m of the shoreline	-
	Chemicals	-	In runoff channel in Killer paddock a white/opalescent sheen was seen on the surface of the runoff water (figure 9).	-	Absence of buffer	Absence of buffer	-

Figure 9 Contaminate drainage from yard in Killer paddock discharging to Homestead Pond. Note Opalescent film on water.

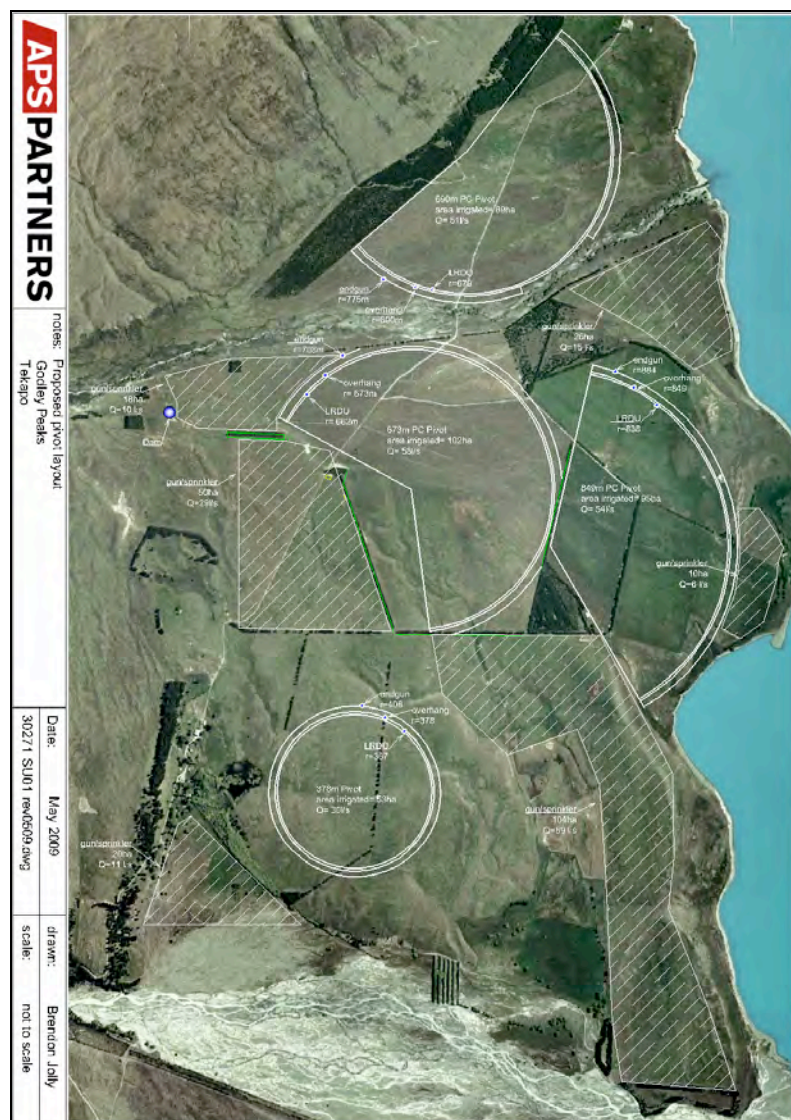
The proposed farm system is an extension of the current system. The proposed irrigation, shown in Figure 10, is largely being sought as a risk management strategy in this dry environment. It would provide increased reliability of feed supply throughout the summer, and provide increased areas where winter feed area crops could be grown. The base stock numbers will increase but it is not envisaged that capital numbers would be increased significantly above the levels the property has historically run (up to 14,500 SU) and the stock numbers over the winter period would not alter significantly. The additional feed provided by the irrigation over the summer and autumn would go towards increasing per head performance of capital stock, and the balance would see an increase in summer trading stock (November to April).

Figure 10 Map of proposed irrigation areas on Godley Peaks Station
