# **Farm Environmental Management Plan: West Edge Ltd – Birchwood Run**

# 1. Introduction

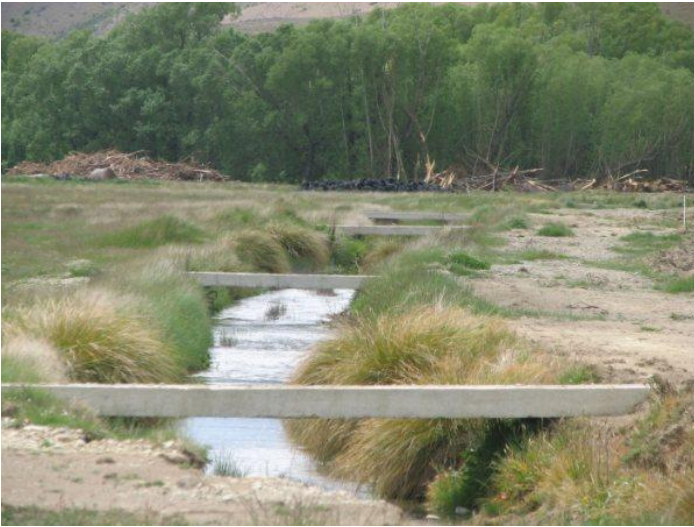
Photo A: Bridges where the pivot crosses the creek

1. Bridges have been installed where the existing pivot crosses Wairepo/Spring Creek and also where stock and vehicles cross the creek. The west side of the creek has been fenced within the irrigation area and the east side fencing is yet to be completed. It must be noted that the water consented for irrigating this area is through the Benmore Irrigation Company.

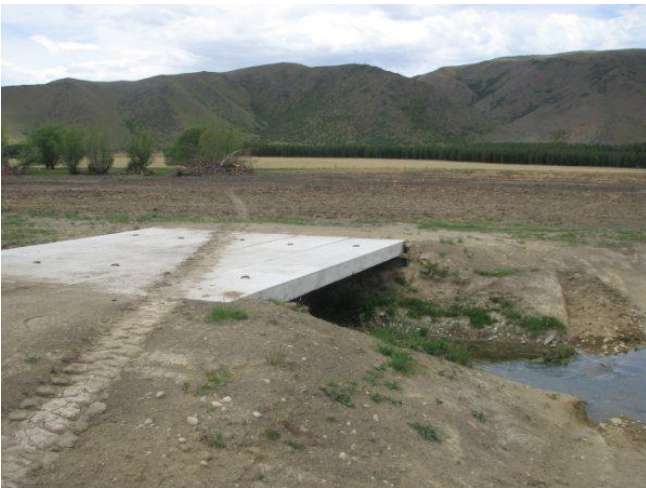
The risks associated with water are that although no bank erosion was evident on Wairepo/Spring Creek, the banks are dirt and have a steep gradient in some areas and will need to be monitored for erosion (see Photo B).

Photo B: Vehicle/Stock Bridge where the pivot crosses Wairepo/Spring Creek. Once finished the bridge will have a gate installed and a fence either side.
