**Farm Environmental Management
Plan: Riverside (Greenfield Rural
Opportunities Ltd)**

1. Introduction

2. General farm description

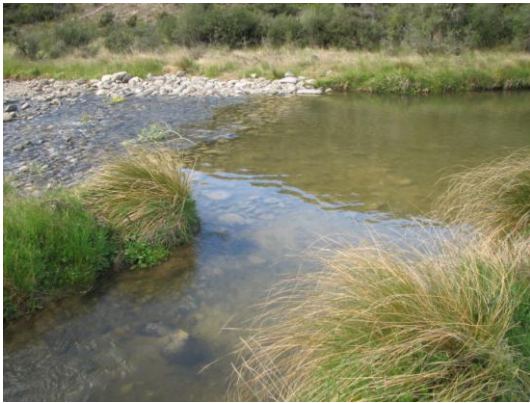
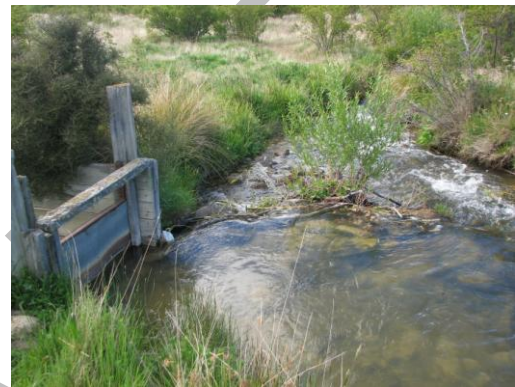
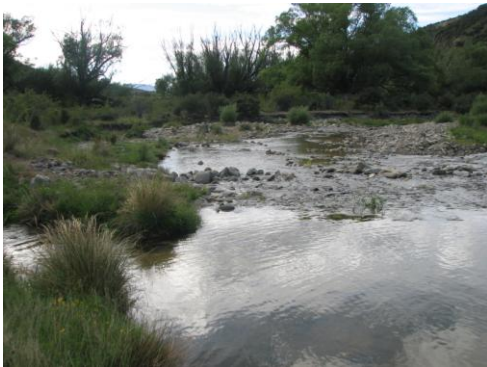
The intake from the Quailburn that will be upgraded

FEMP stage	Measure	Monitoring	Auditing
3	Maintain a 20 metre buffer zone from permanent waterways with the irrigation area	Photos	Annual audit visit
3	Upgrade the take point out of the Quailburn River in conjunction with Ellis Lea Farms and Willowburn Station	Photos and location map	Annual audit visit
