Farm Environmental Management Plan: Lilybank Station

1. Introduction

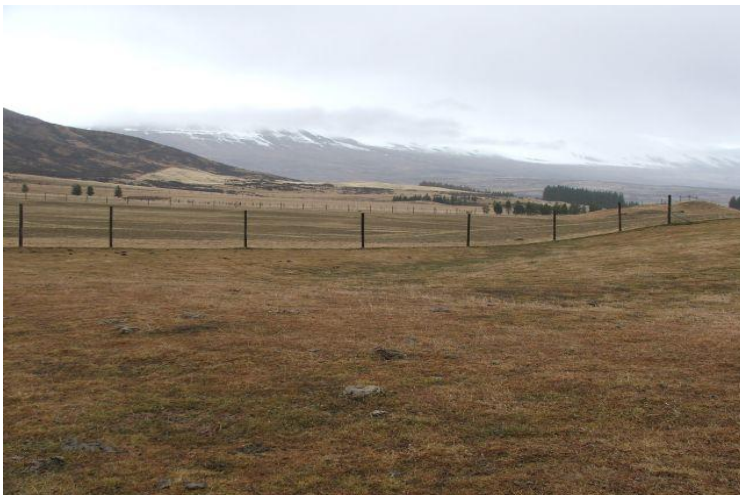
Photo A: Existing landcover of proposed irrigation development area

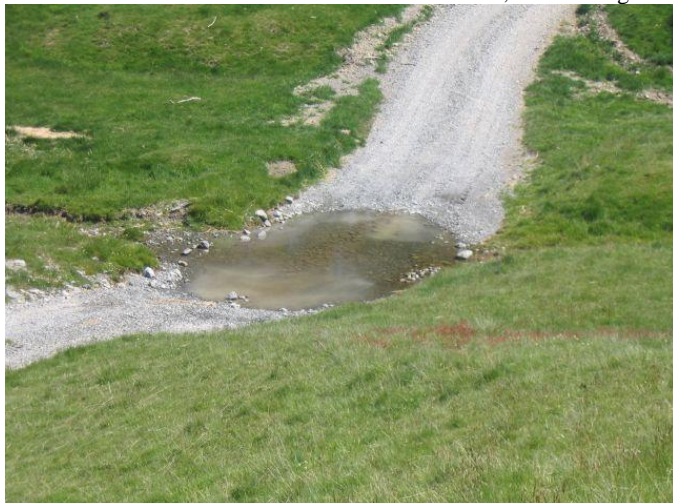
Photo B: Wool wash Creek where the track crosses, additional gravel and planting on the south side is to be completed

The risks associated with tracks are that the main vehicle track at Lilybank runs through Wool wash creek.

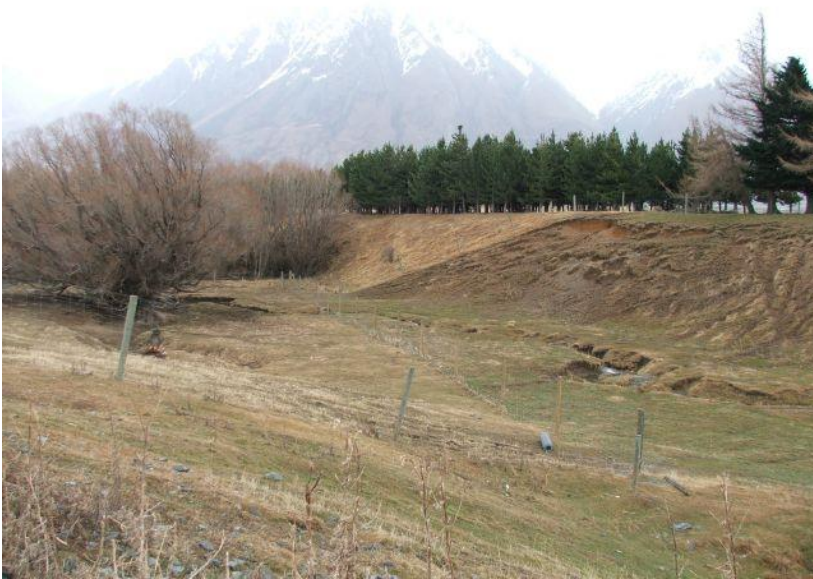
Photo C: shows the fencing that has been undertaken to reduce erosion around the waterways. The land below the pine trees shows an area that has been fenced for some time, hence the ground cover. In the foreground is an area of land that has been recently fenced note the erosion due to stock access, it is anticipated that the ground cover will increase via natural regeneration as is evident on the other side of the fence (Taken September 2009)

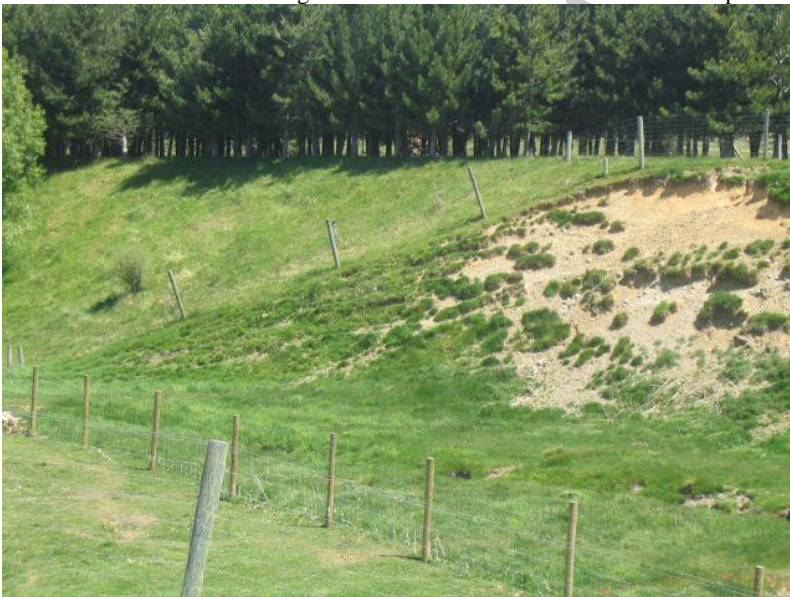
Photo D: Shows the natural regeneration that has occurred over a 3 month period in 2009, of the same areas as Photo C.

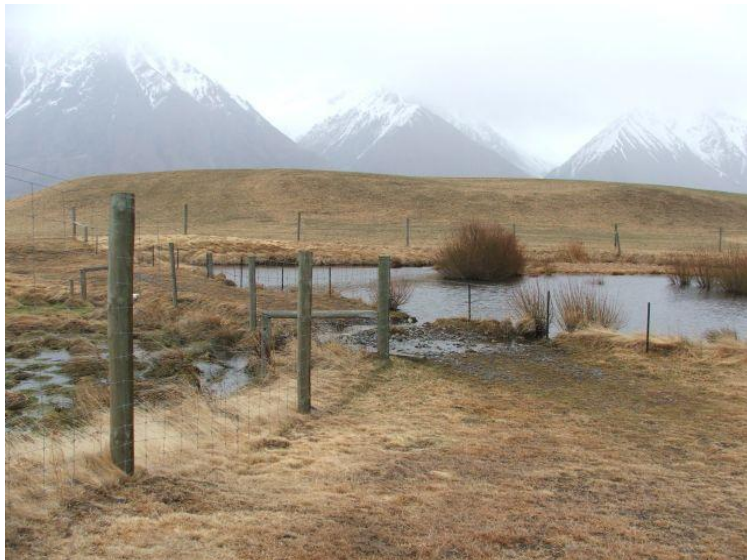
Photo E: Shows the small ponded area on the right and the DOC swamp area on the left of the photo. The ponded area is one area where strategic planting will be undertaken.
