# **Farm Environmental Management Plan: Willowburn Station**

# 1. Introduction

## 2. Farm Description

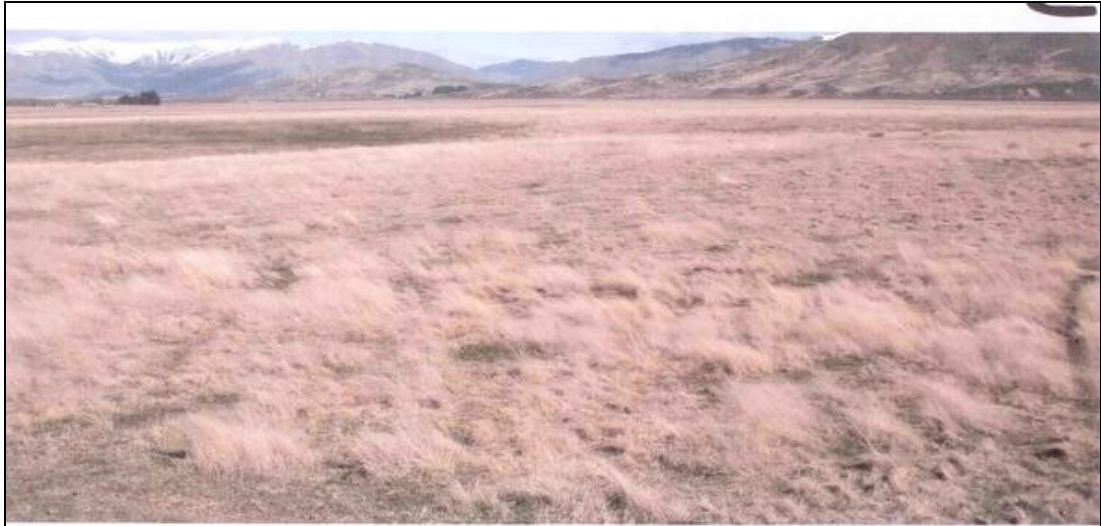
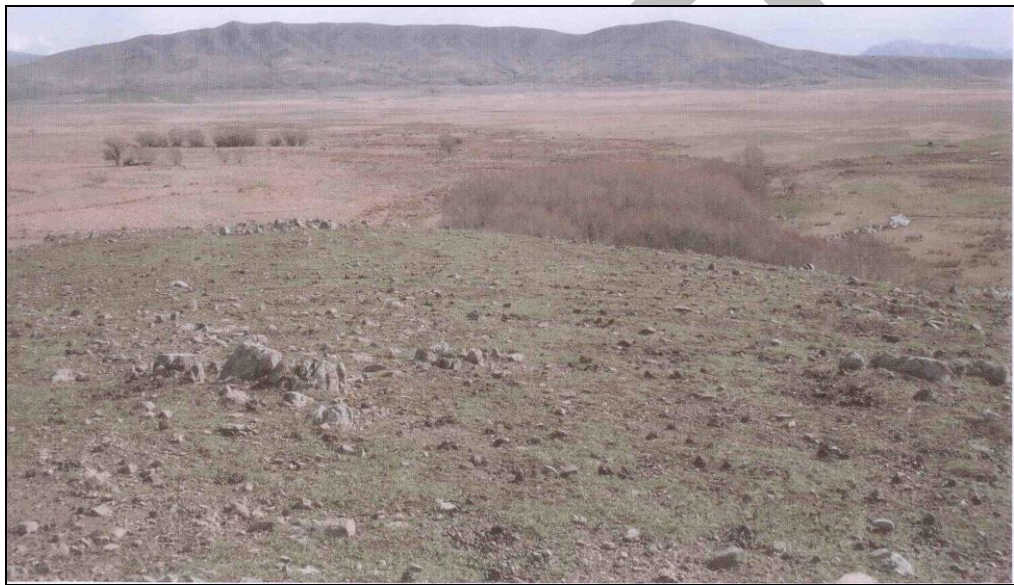
**Topography of Willowburn Station**

Willowburn Station is 80% rolling flats to very steep, with the Willowburn Swamp in the SE corner.

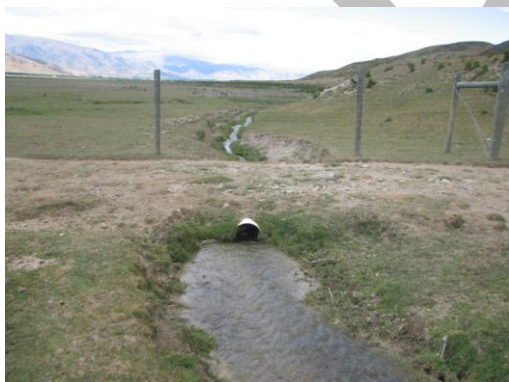
- 4.3.5** On the dear block the streams are unfenced allowing access to the waterway. There are around 170 hinds, 89 stags, and 40 yearlings in this block of 150 hectares, there are also a handful (50) steers on this block.

Part of stream within the deer block that needs to be fenced off, note the culvert and also the evident erosion

3	Either plant a riparian margin, a filtration zone, or look at putting in a stilling basin in location described in below map	Water quality monitoring continued quarterly, and photos in the audit report	Annual audit report and visit
3	Fence off the streams that run through the deer block, but keep drinking bays	Monitor the quality of the water, photos	Annual auditing visit
3	Maintain a 20 metre buffer zone from waterways while irrigating	Photos	Annual auditing visit

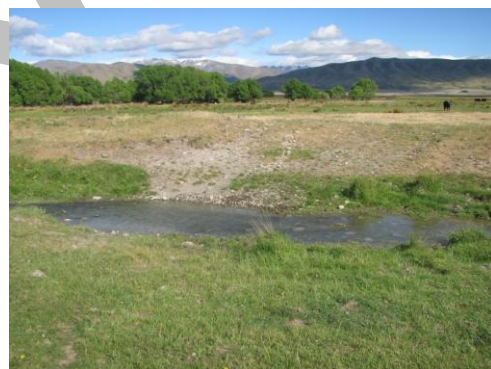
- 4.3.4** Throughout the 'heavier' land near the Willowburn swamp (on the Homestead block) the stock have access to the Willowburn stream/river. This is not fenced off and in areas there are stock crossings where the stock tend to be concentrated, these crossings are not culverted and in certain areas there is relatively bad stock induced erosion. The applicant realises the possibility of having to culvert these crossings (see photos below section 5 of eroded areas due to stock).

Evidence of erosion, this area should be fenced and culverted to restrict stock access as much as possible

FEMP stage	Measure	Monitoring	Auditing
3	Fence off the wettest area of the Willowburn swamp to stop stock access; this could be done with a two or three wire waratah fence. The area is approximately 40 hectares.	Surface water testing of Willowburn as it enters and exits the property	Annual auditing visit.
3	Restrict stock access to the Willowburn during the winter months of June, July and August	Annual compaction and erosion survey	Annual auditing visit and report
3	Place culverts at selected areas along the Willowburn Stream for stock movement	Photos	Annual auditing visit
3	Fence off the areas that have already been pugged up and eroded badly (as seen in the photo) along the Willowburn	Photos	Annual auditing visit
3	20 metre layback from any water way when applying fertiliser by land based application e.g. bulk spreader	Field records	Annual auditing visit and report
3	Create a sufficient track in the areas around the Willowburn Stream to allow for the shifting of stock with out them accessing the stream readily.	Photos	Annual auditing visit
