Farm Environmental Management Plan: Otamatapaio Station, Omarama.

1. Introduction

The Water Quality Study ('WQS') funded by Mackenzie Water Research Limited ('MWRL'), found that the additional irrigation proposed in the catchment could take place without significant adverse effects on the environment providing that nutrient reduction occurred on the farms.

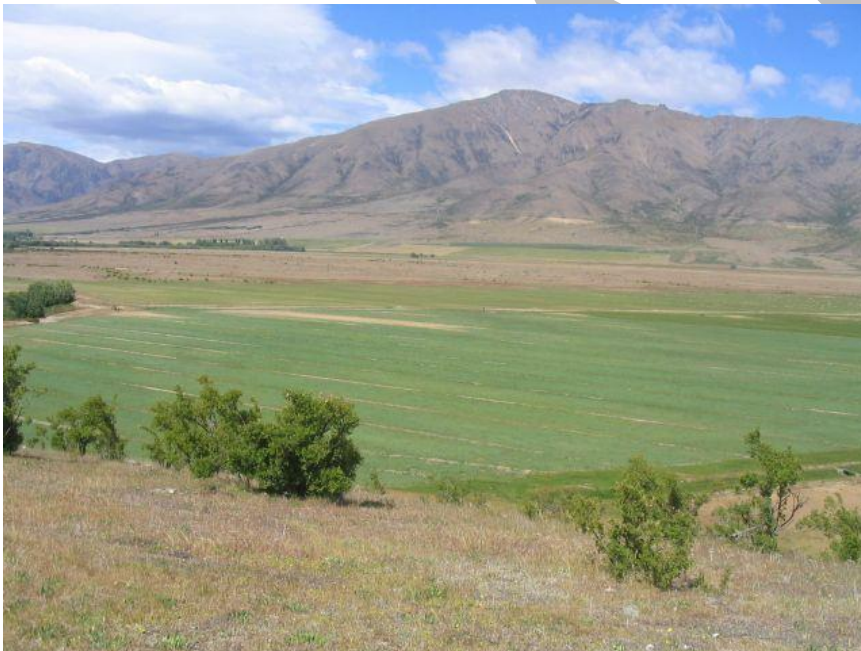
Photo B: Existing border dyke irrigation at Glenburn

There are currently 280 hectares of border dyke irrigation at Glenburn; with the conversion to spray this would increase to approximately 420 hectares.

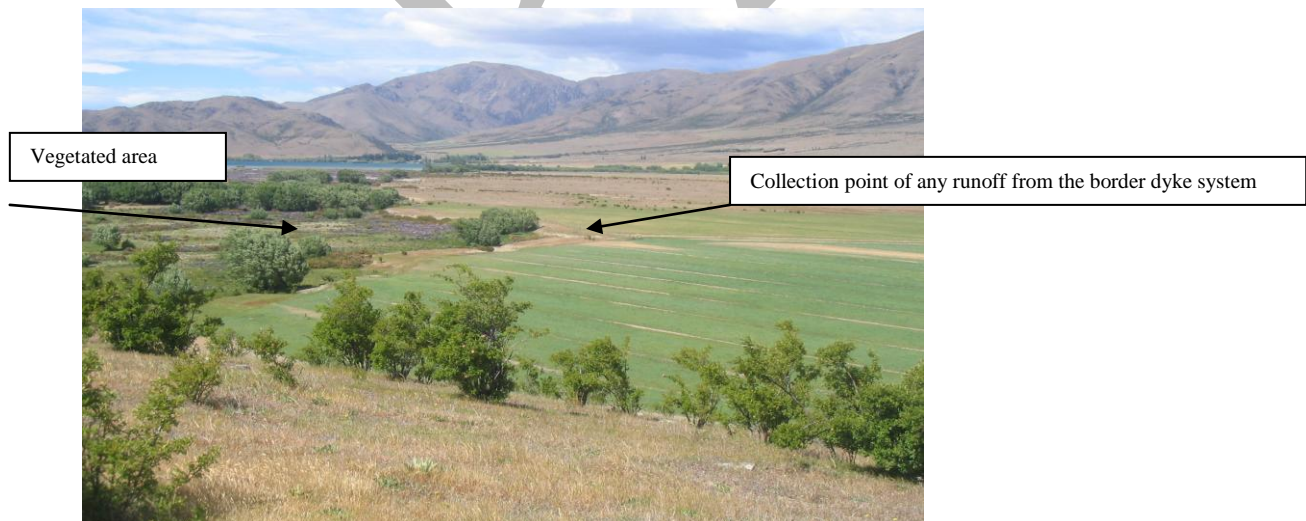
Photo F: Showing the vegetated area that acts as a filter system for any run off

1. At Glenburn any runoff from the border dykes is filtered through a large vegetated area prior to being discharged into the Ahuriri River (also see Map E)

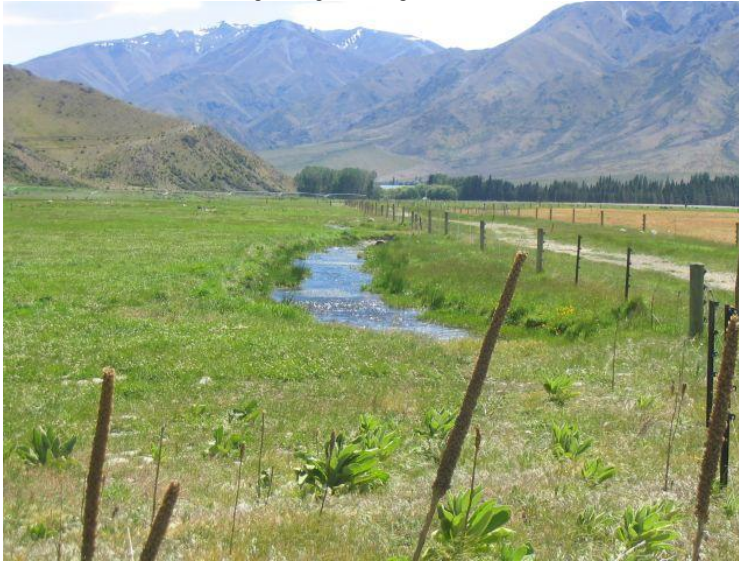
Photo C: Clark Creek running through the irrigation area to be fenced to restrict stock access

The risks associated with stock are that at present stock are not excluded from watercourse within the irrigation area.

See Photos B and C for location of riparian margins, See Map B for the location of the existing irrigation area and Maps E and F for the approximate locations of mitigation measures.

Fencing stock out of permanently flowing waterways namely Clark Creek through riparian fencing within the irrigated area at Otamatapaio	Check fenced areas are present. Photos	Areas of fencing damage should be repaired.
If redevelopment of the irrigation system at Otamatapaio is to occur alongside the banks of the Otamatapaio River then stock should be fenced out of the river and a 25m setback established	Check fenced areas are present and where they have indicated they will be. Photos	Areas of fencing damage should be repaired. Areas of less than 25m setback should be extended to ensure the minimum is 25m
Minimum of 15m setback from new irrigation development at Glenburn and the Glenburn Swamp.	Check setback area is present. Photos	Areas of less than 15m setback should be extended to ensure the minimum is 15m.
Fencing 50 metres from Lake Benmore if the proposed new irrigation development occurs at Glenburn and Otamatapaio	Check fenced area is present. Photos	Areas of fencing damage should be repaired.
