# **Farm Environmental Management Plan: Rostriever Station**

# 1. Introduction

The Water Quality Study ('WQS') funded by Mackenzie Water Research Limited ('MWRL'), found that the additional irrigation proposed in the catchment could take place without significant adverse effects on the environment providing that nutrient reduction occurred on the farms.

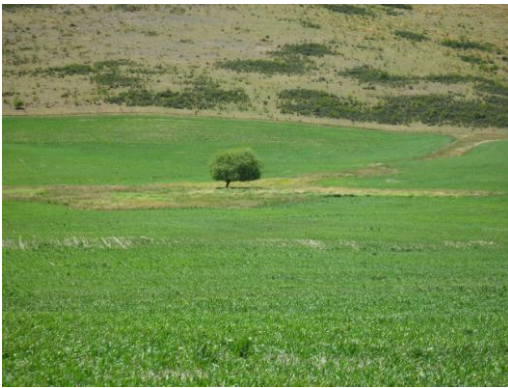
Photo showing the small swamp/heavy ground area located within the paddock. This area is approximately 50 metres by 50 metres

1	Good design of irrigation systems	Design of irrigation system by a certified professional	Irrigation system audited by a certified auditor every 5 years
1	Robust irrigation scheduling	Calculation of annual % effective water use	Submission of annual % effective water use
2	No winter application of fertiliser	Field records	Signed field records
2	N fertiliser applications split to under 50 kg N/application	Field records	Signed field records
2	No P fertiliser within three weeks of irrigation	Field records	Signed field records
2	Olsen P of below 30 maintained	Regular soil testing (every 3 years)	Submission of soil tests
3	Fence along the stream that flows at the base of the paddocks where the irrigation is proposed, allow for drinking bays for stock water	Photos	Annual auditing visit.
3	Temporarily fence off the small area of swamp in the middle of the paddock as seen in the photo	Photos, visits to test quality of the swamp	Annual auditing visit

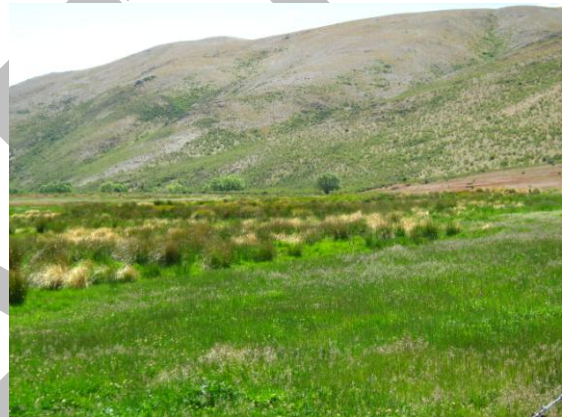
**4.3.6** There are no real areas of interest on the property that I was made aware of. There was one species of fish (Galaxiids?) that was noted in a study that inhabited the swampy area at GPS position E2279732 N5618315. This location was taken on the boundary of this area.

- 4.3.7** At the above GPS position there is a small wet area/swamp found; this is fenced off into its own block, with stock not accessing it often, but during certain periods of the year stock have access to this area for stock water. The only stock that will have access to this are sheep (Approximately 500).

Swampy area  
Swampy area located at point E2279732 N5618315 that is fenced and will have stock access restricted during the winter

Water	Surface water quality	Swamp located at GPS point E2279732 N5618315	Quarterly to be consistent with ECAN for the first 5 years and then reviewed	Total Nitrogen, nitrate, ammonia, total Kjeldahl nitrogen, total phosphorus, dissolved reactive phosphorus, suspended solids.	No significant decrease in water quality	If comparative surface water analysis indicates a decrease in surface water quality then the particular contaminant should be identified while a full root cause analysis is undertaken
Water	Irrigation application	Irrigation area	Annually in house and 1 in 5 years by an independent	Application uniformity	>80 %	Optimisation of the irrigator performance will be performed at the time of testing
Tracks that cross waterways	Visual assessment of bank/track erosion	All tracks that cross creek/stream within extensively farmed areas	Annually	Visual assessment of bank/stream erosion caused by vehicle crossing or stock	Any sign of extensive visual erosion	Restrict vehicle and stock access until an assessment of the damage and cause can be made
