Farm Environmental Management Plan: Bog Roy Station

1. Introduction

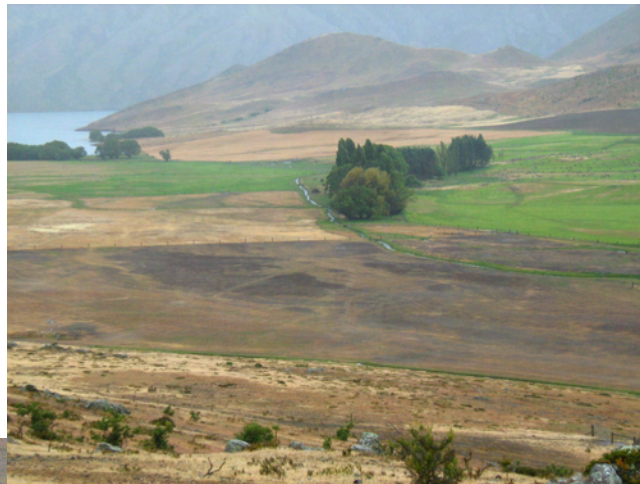
Photo 1 shows the current flood irrigation land, the dark area (sprayed off) is going to likely be converted to spray irrigation with the rest of the flood irrigation land becoming improved dry land.

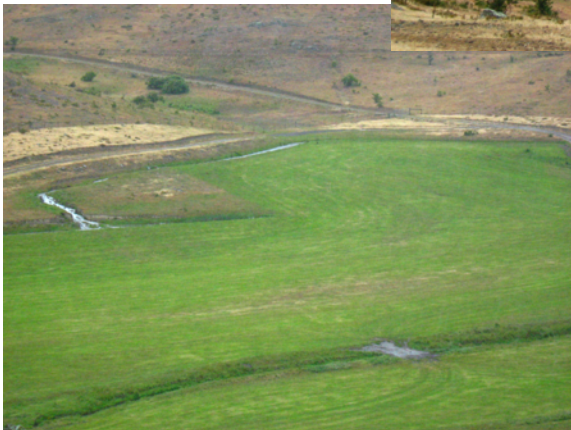
Photo 2 shows the flood irrigation at work and the runoff race located in the middle of the paddock. This race is allowed to enter the lake. It is proposed that within 5 years all irrigation will be converted to spray
