Farm Environmental Management Plan: Ribbonwood Station (Maree Horo)

1. Introduction

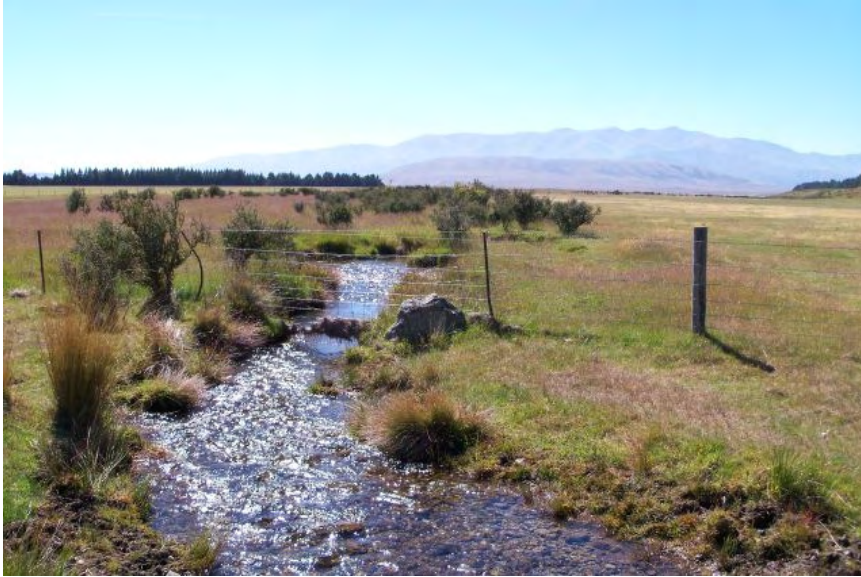
Photo A: North Branch Serpentine Creek within one of the proposed irrigation areas

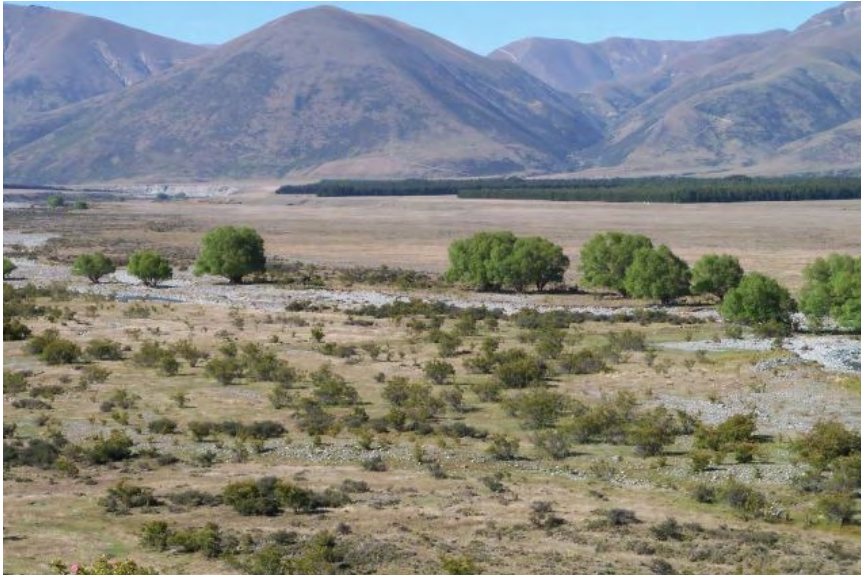
Photo B: Proposed irrigation area at East Ahuriri in the background amongst the shelter trees

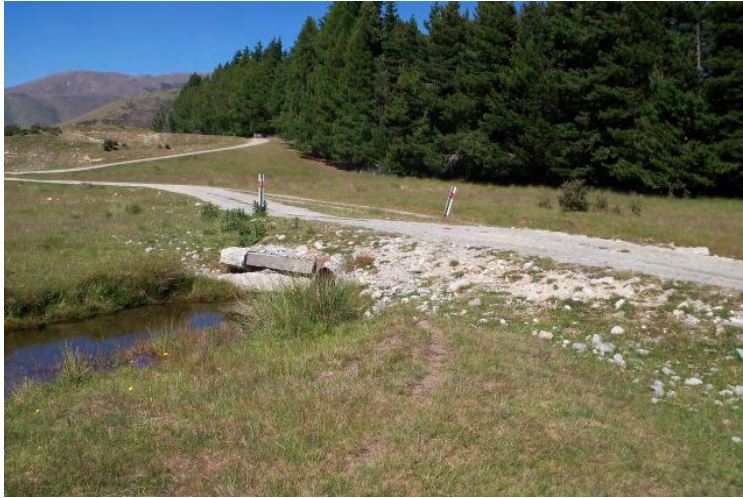
1. All of the crossings over creeks within the proposed irrigation area have culverts or bridges for stock and vehicle access.

Photo C: Bridge across the Serpentine Creek within the proposed irrigation area, one of many bridges over creeks

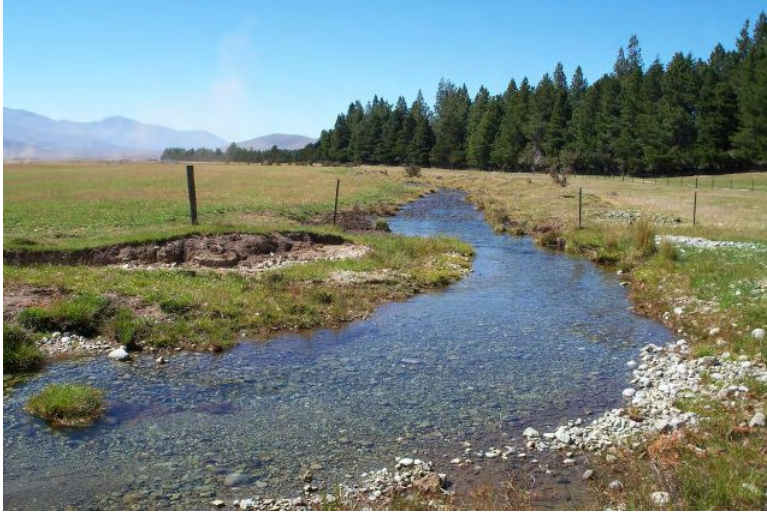
Photo D: Wairepo Creek flowing through some of the proposed irrigation area, this si to be fenced to restrict stock access

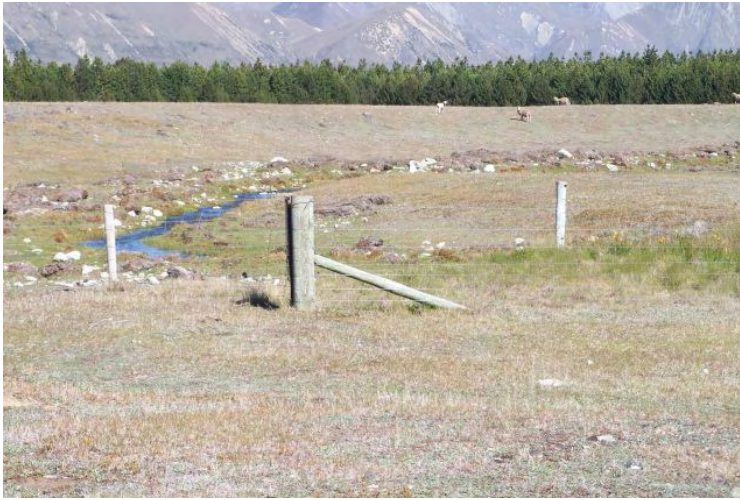
Photo E: One of the water races that flow within the proposed irrigation area at the East Ahuriri
