**Farm Environmental Management
Plan: Riverside (Greenfield Rural
Opportunities Ltd)**

1. Introduction

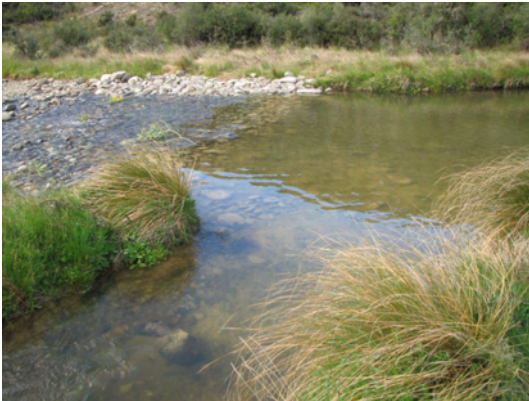
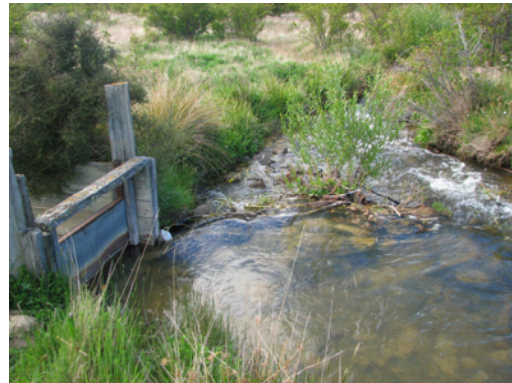
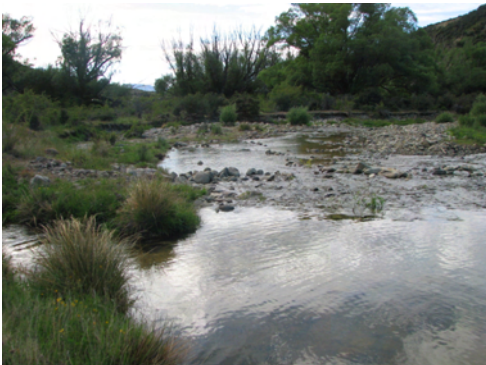
The intake from the Quailburn that will be upgraded

FEMP stage	Measure	Monitoring	Auditing
3	Maintain a 20 metre buffer zone from permanent waterways with the irrigation area	Photos	Annual audit visit
3	Upgrade the take point out of the Quailburn River in conjunction with Ellis Lea Farms and Willowburn Station	Photos and location map	Annual audit visit
