Water quality and ecosystem health monitoring programme of Ihutai

**The sediments and biota of the Avon-
Heathcote Estuary/Ihutai and tidal
reaches of the Avon and Heathcote rivers**

Summary report on data collected in 2008

Report No: R09/85

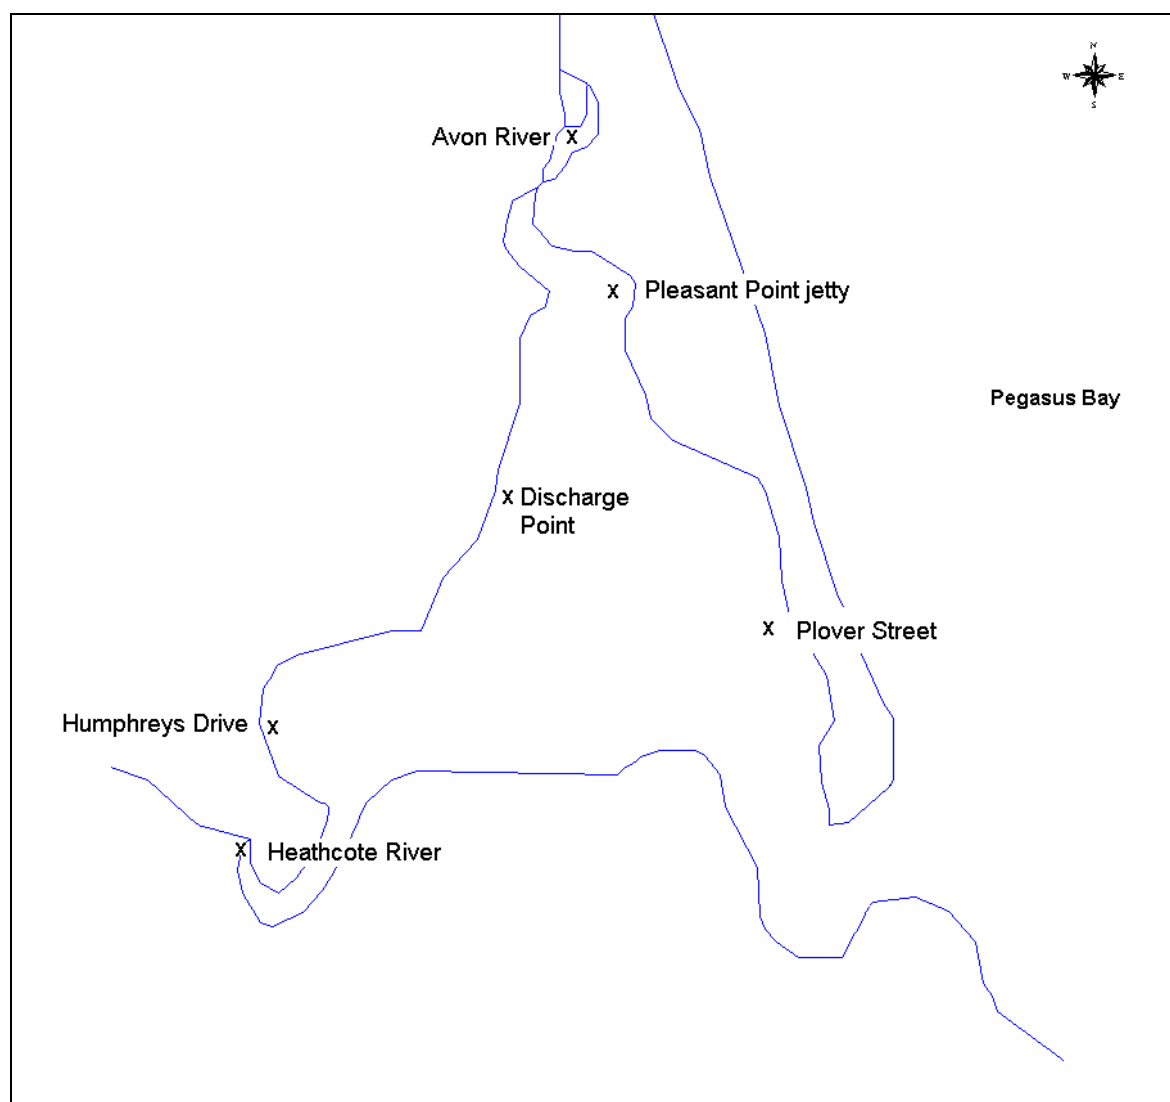
Figure 1 The sampling sites within the Avon-Heathcote estuary/Ihutai and in the tidal reaches of the Avon and Heathcote rivers

The sites sampled are shown in Figure 1. Note: in the 2007 summary report results from Sandy Point (between Discharge Point and Humphreys Drive) were included.

Sandy Point is not a routine site for the Healthy Estuary and Rivers of the City programme but is currently sampled every two years as a condition requirement of the resource consent for the discharge of wastewater into the estuary.

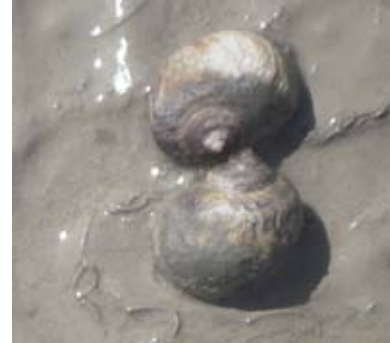
Mudflat snails feed on the micro-organisms and organic matter in the sediment. As they feed they leave a string-like trail of waste on the surface of the mud. They lay their eggs into a tyre-like rim of mud. These egg cases can be seen on the mud surface from late November to March. Mudflat snails can tolerate a wide range of salinities and temperatures and exposure to air for considerable periods of time.

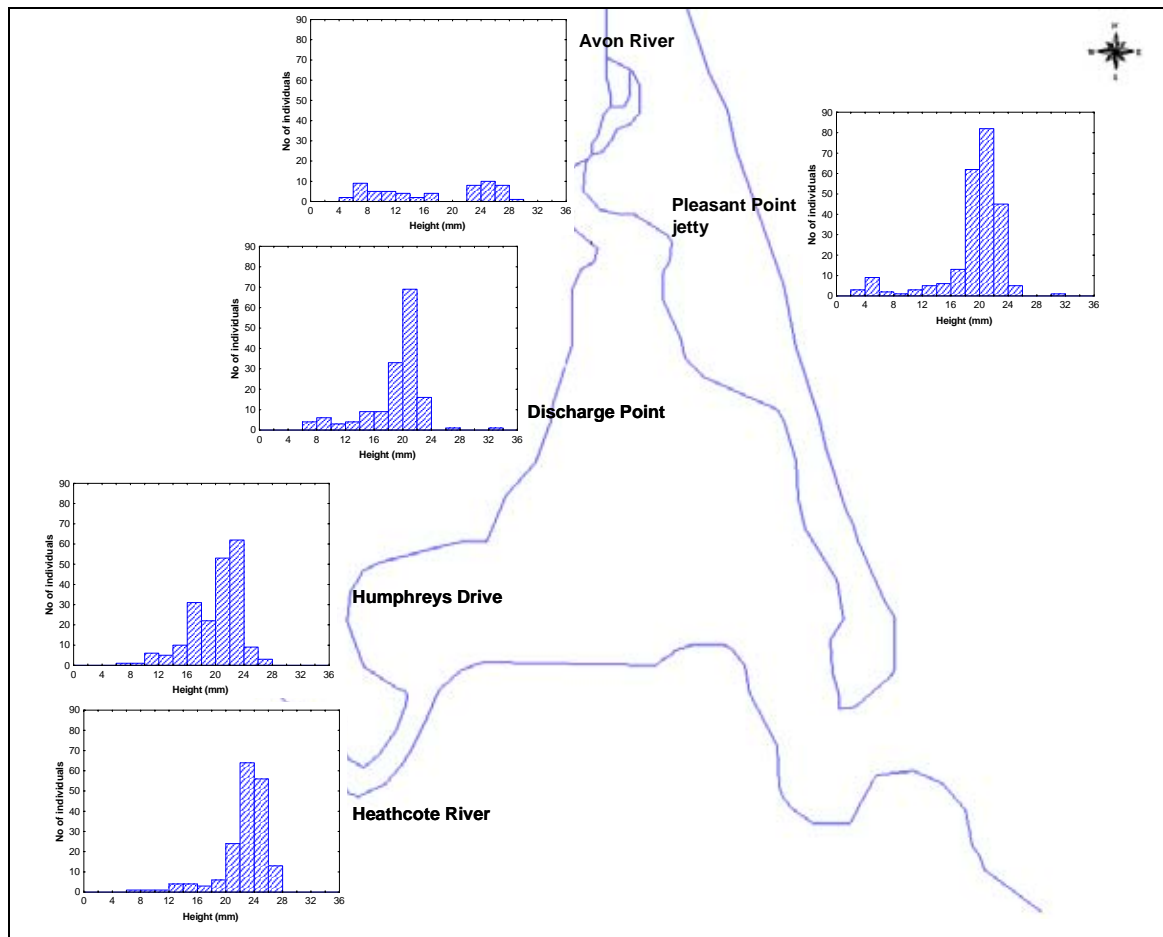
Figure 5 Height (mm) distribution of the mud flat snails at each site

The snails sampled ranged in height from 3 - 32.5 mm. Of the individuals measured, 40% at the Avon River site, 9% at both Pleasant Point jetty and Discharge Point, 5% at Humphreys Drive and 3% at the Heathcote River site, were smaller than 14 mm.

That is, at most sites there were few juvenile snails with almost all snails being adults. At Pleasant Point jetty and Discharge Point 61% and 66% respectively of individuals, had a height of 18-22 mm. At Humphreys Drive 57% of individuals had a height of 20-24 mm and at the Heathcote River site 68% of individuals had a height of 22-26 mm.

The height distribution of all mud flat snails present in the fifteen quadrats sampled at each site are shown in Figure 5.

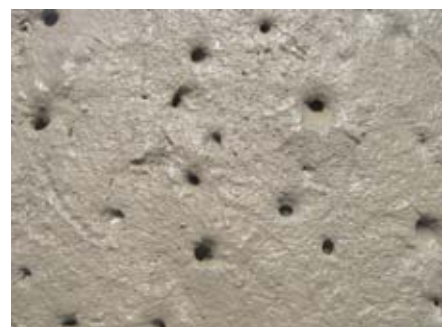
Crab burrows are a common sight in the estuary. Burrows are easily counted but whether a crab lives in the burrow is not known nor is the type of crab in the burrow known. The two common crabs that burrow in the estuary are the stalk-eyed mud crab (*Macrophthalmus hirtipes*) and the short-eyed mud crab (*Helice crassa*).

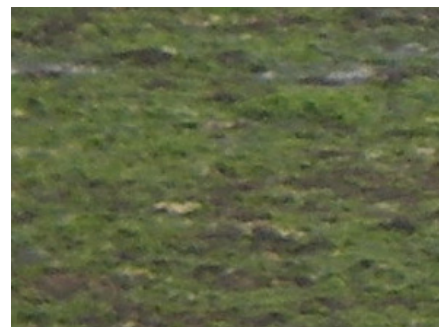
The most abundant seaweed within the estuary is the green sea lettuce (*Ulva* sp.) with the red seaweed *Gracilaria chilensis* also common. Where these seaweeds occur they cover the mudflat, so in a quadrat it is the percentage of the mudflat covered by seaweed that is used as a measure of seaweed abundance.

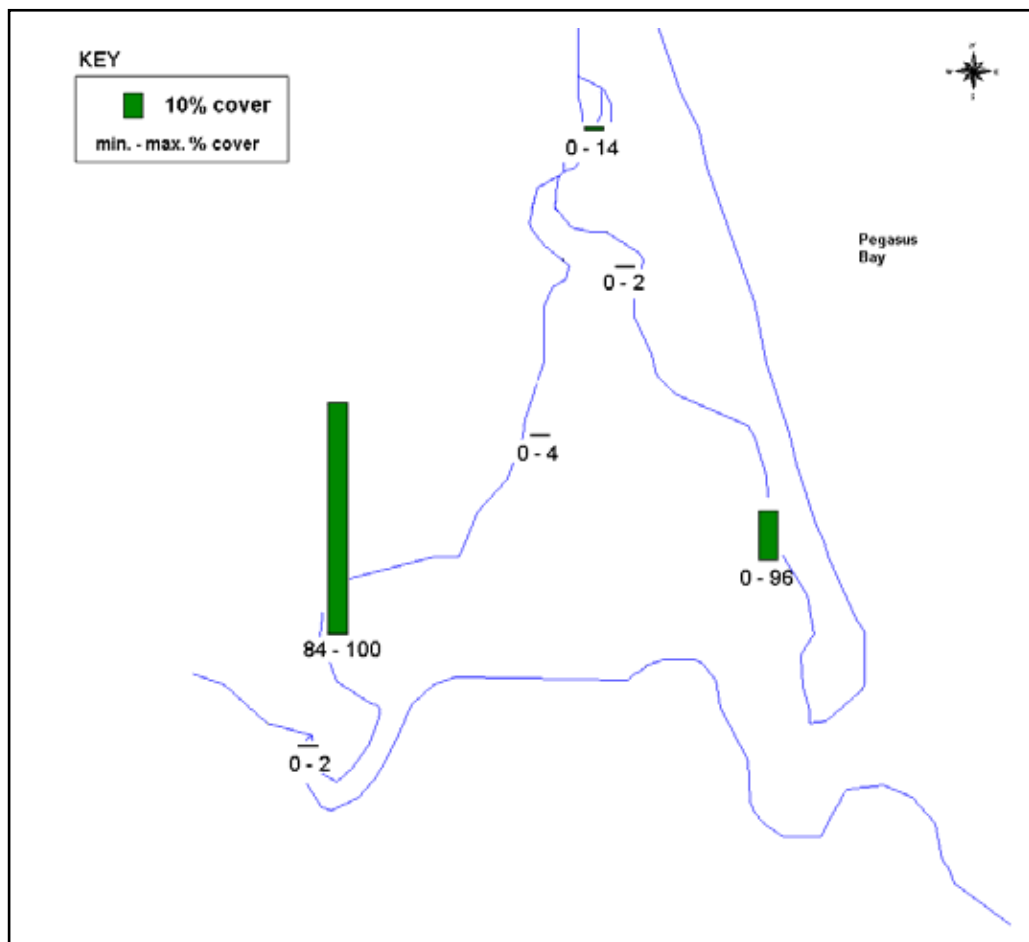
Figure 7 Average percent seaweed cover at each site

Seaweed was present at all sites. Of the 15 quadrats sampled two at the Avon and Heathcote river sites, three at Discharge Point and four at Pleasant Point jetty, contained seaweed. At Plover Street seaweed cover was patchy with no seaweed in five quadrats, and up to 96% cover in the other ten quadrats. At Humphreys Drive the mudflat was generally extensively covered with seaweed.

The average percent seaweed cover at each of the sites is shown in Figure 7.

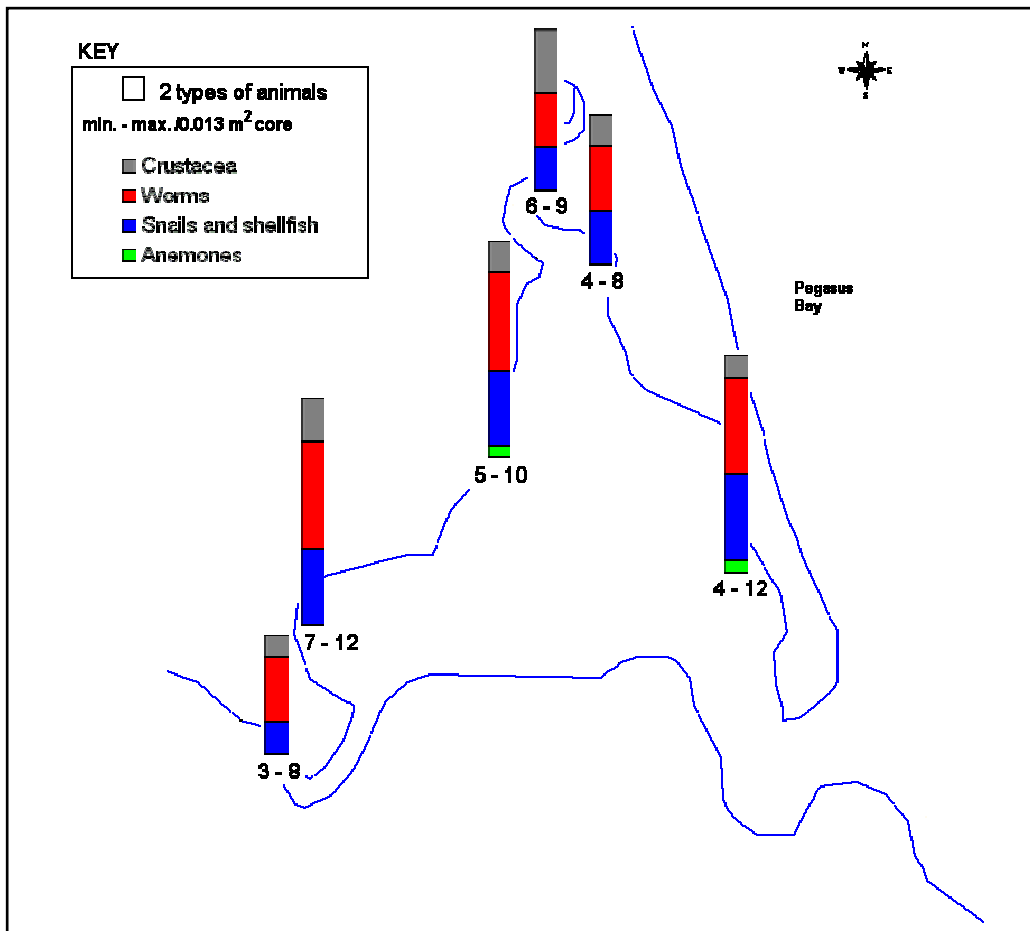
Figure 8 Number of different types of animals living in the sediment at each site

Worms, snails and shellfish and crustacea were present at every site while anemones were only present at Discharge Point and Plover Street.

At all sites in the estuary and at the Heathcote River site there were more types of worms than types of crustacea or snails and shellfish. At the Avon River site there was one more type of crustacea than type of worm. More types of worms occurred at Humphreys Drive, more types of snails and shellfish occurred at Plover Street and more types of crustacea occurred at the Avon River site, than at any of the other sites sampled.

There were more generally more types of animals at the sites in the estuary than in the rivers. However, there was one more type of animal at the Avon River site than at Pleasant Point jetty. Within the estuary there was one more type of animal at Humphreys Drive than at both Plover Street and Discharge Point.

The number of each type of animal living in the sediment at each site is shown in Figure 8.

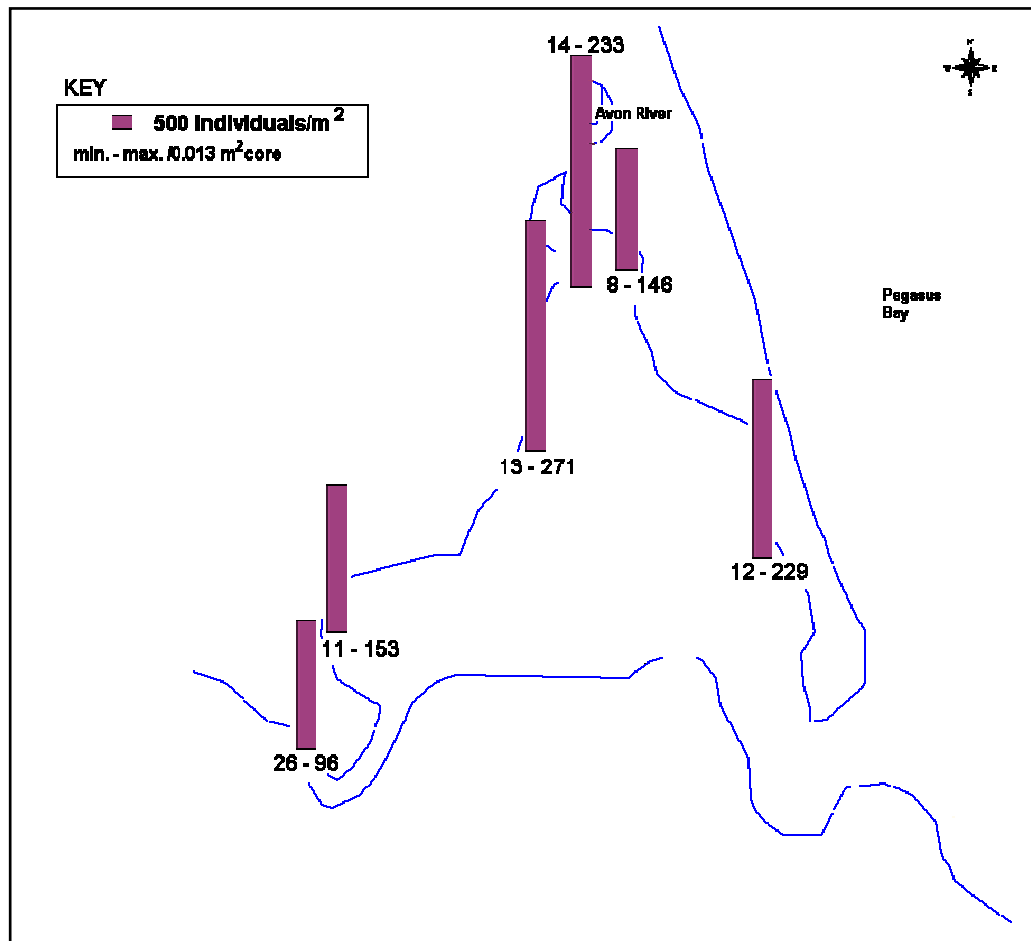
Figure 9 Average number of animal individuals per square metre living in the sediment at each site

In the estuary there were more individuals at Discharge Point than at any other site. However, the number of individuals at Discharge Point was similar to the number at the Avon River site. The average number of individuals at Plover Street was about 75%, at Humphreys Drive 65% and at Pleasant Point jetty 50%, of that at Discharge Point. The average number of individuals at the Heathcote River site was 55% of that at the Avon River site.

The average number of animals per square metre is shown in Figure 9.
