**Water quality of the Avon-Heathcote
Estuary/Ihutai**

Summary report on data collected in 2010

Report No. R11/70

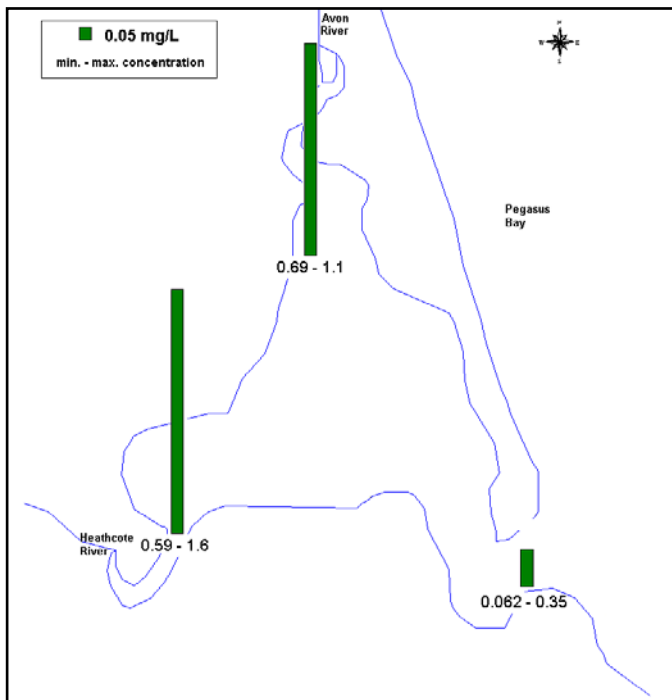
Figure 9: Low tide nitrite-nitrate nitrogen concentrations (mg/L)

Around low tide NNN concentrations were higher in the Avon and Heathcote rivers than at the mouth of the estuary.

These results indicate that the rivers are the major source of NNN to the estuary. The springs that feed the Avon and Heathcote rivers contain high NNN concentrations.

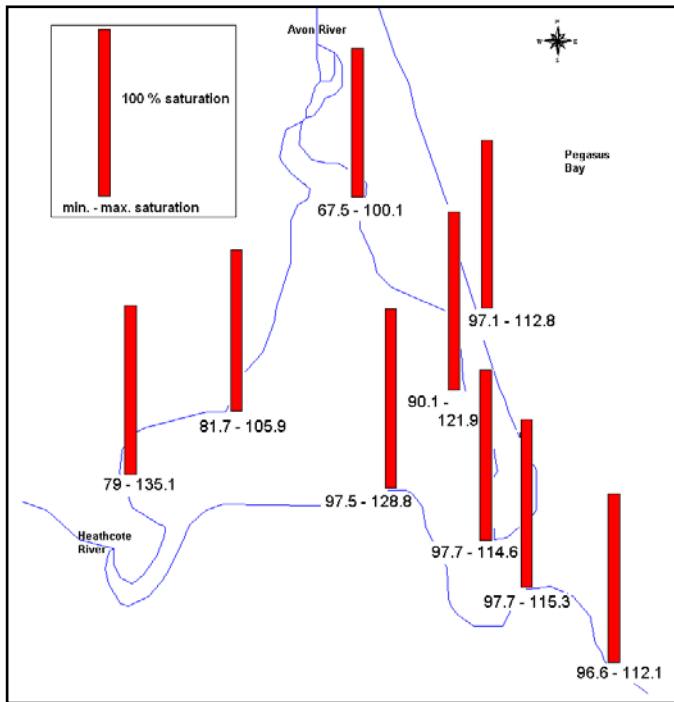
Figure 14: High tide dissolved oxygen saturation (%)

Around high tide the median dissolved oxygen saturation was lowest at Pleasant Point jetty and highest at Beachville Road.

There were differences in the minimum and maximum values between sites. Minimum concentrations were lower at sites close to the river mouths and at Sandy Point than at sites closer to the mouth.

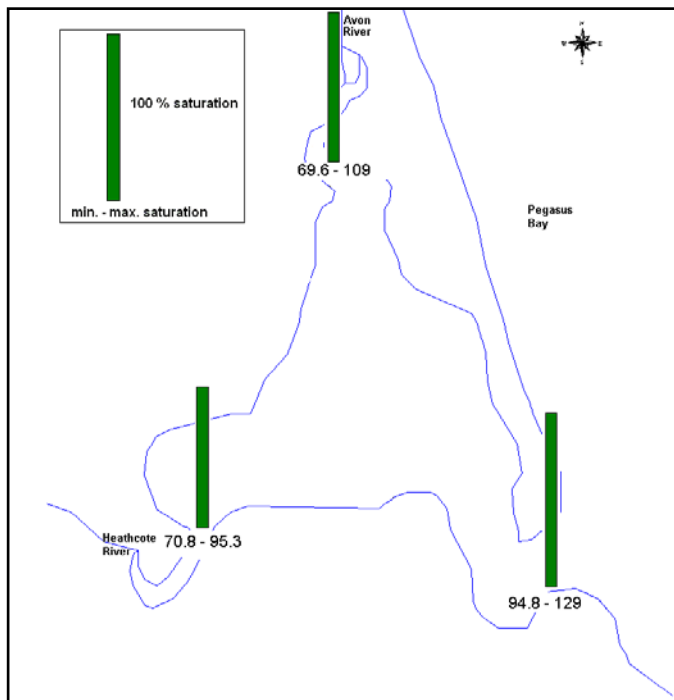
Figure 15: Low tide dissolved oxygen saturation (%)

Around low tide the median dissolved oxygen saturation at the mouth of the estuary was higher than in the Avon and Heathcote rivers.

The median and maximum dissolved oxygen saturations in Heathcote River water were lower than in Avon River water.

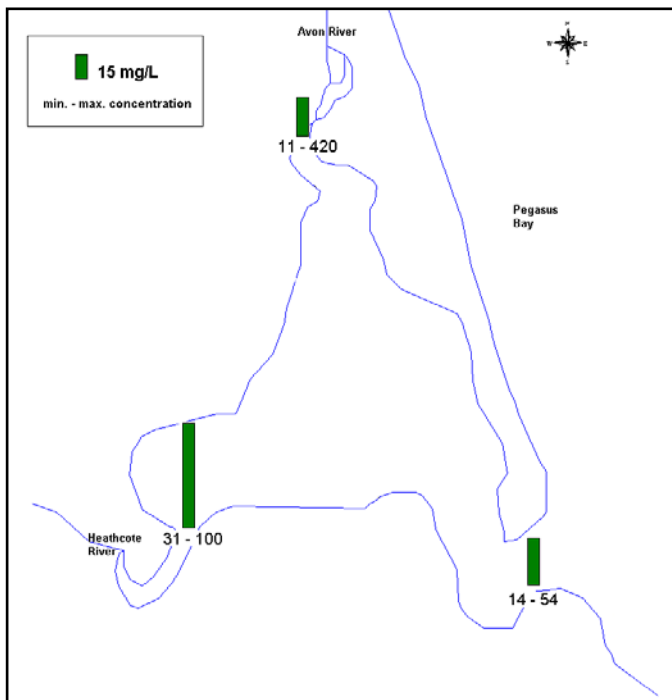
Figure 17: Low tide total suspended solids concentrations (mg/L)

Around low tide there were more total suspended solids in the water flowing out of the Heathcote River than the Avon River. Of note is the maximum concentration in the Avon River was higher than that in the Heathcote River.
