Healthy Estuary and Rivers of the City

Water quality of the Avon and Heathcote rivers

Summary report on data collected in 2010

Report No. R11/69

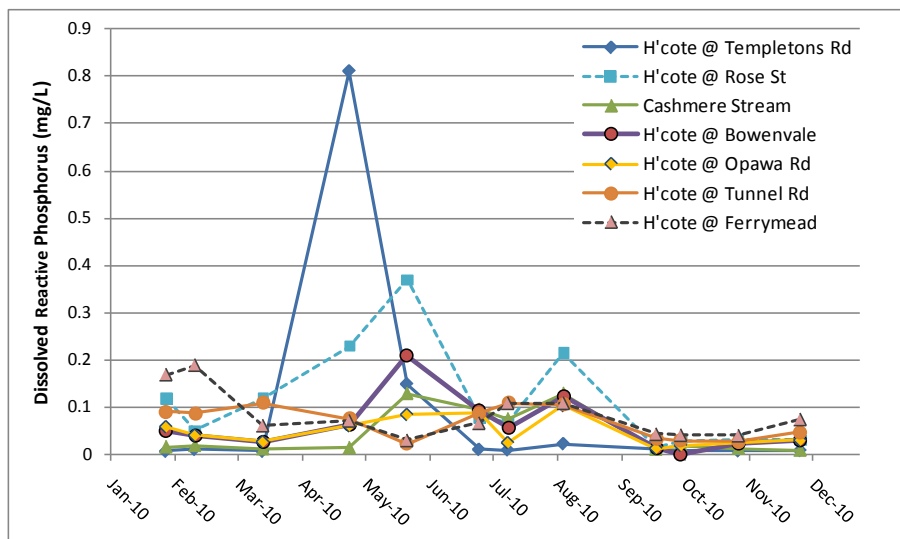
Figure 3-4: Monthly DRP concentrations at the Heathcote catchment sites (note the difference in scale on the y-axis compared to Figure 3-3)

difference to the upstream sites on a monthly basis (Figure 3-4) and this is due to the other sources of DRP in the catchment, namely industrial inputs and loess soils.
