CRC011361-A

Farm Environmental Management Plan: Dunstan Peaks, Clifton Downs and Twinburn Stations

Updated: November 2010, reviewed January 2012

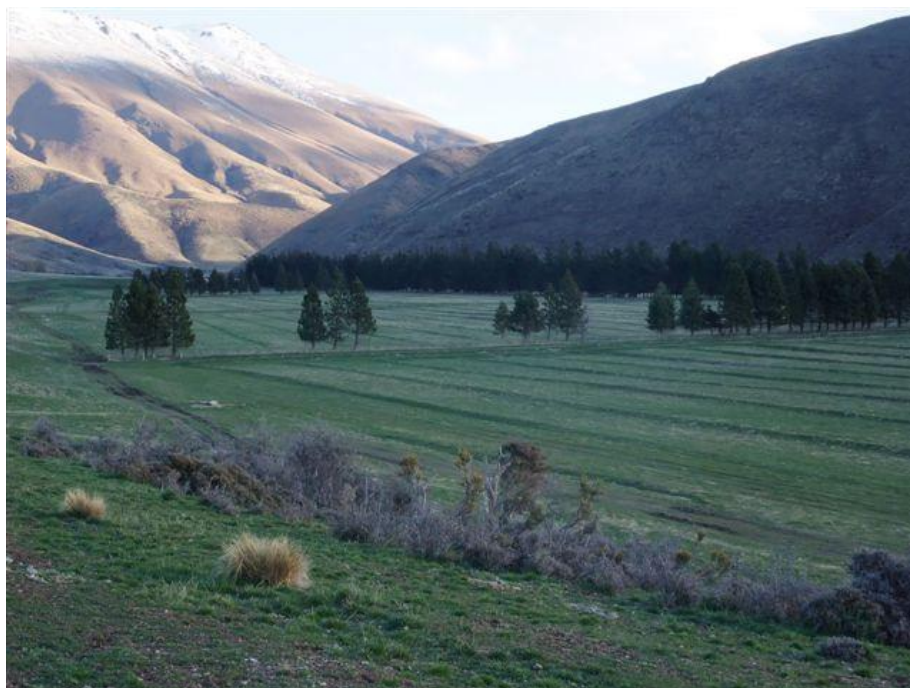
Photo A: Existing Border dyke system

There have been a number of changes to the consents lodged for Dunstan Peak, and this FEMP reflects those changes. The irrigation system at present is a mixture of wild flood and border dyke irrigation. There is a proposal to convert the current systems into a variety of spray irrigation systems with a relocation of some of the water from upstream sites to downstream sites within the next 5-10 years. This FEMP has been written to ensure that mitigation measures for both of the existing and proposed irrigation systems have been included.

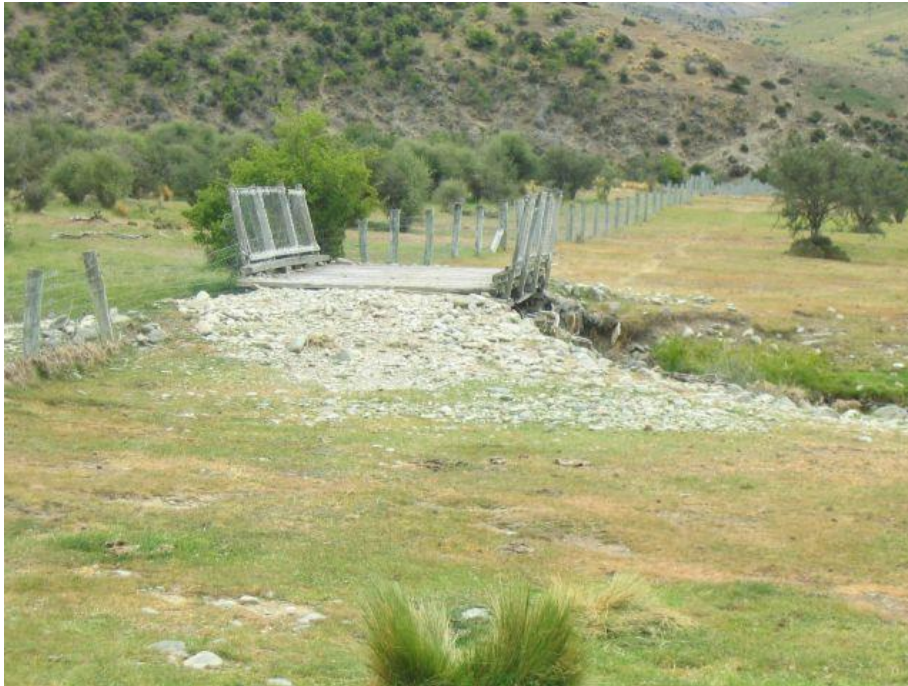
Photo H: Stock and Vehicle Bridge crossing the upper reaches of the Omarama Stream

1. Culverts are evident on streams within the irrigated area as are stock bridges.

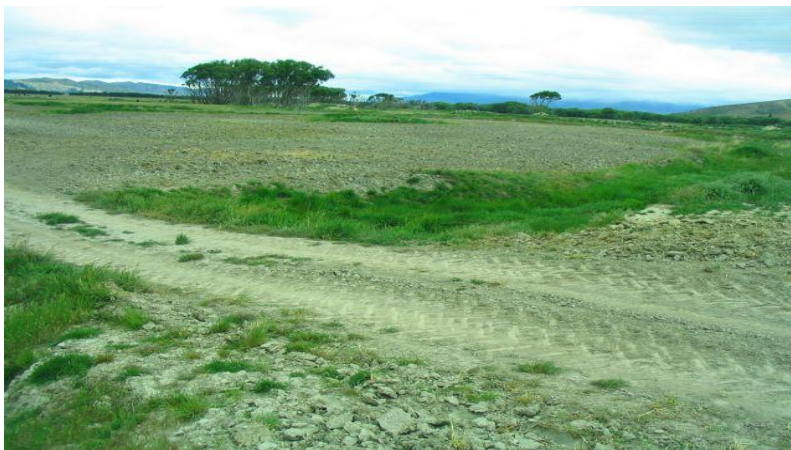
Photo I: Clifton Downs swamp cultivated land for cropping. This practice has been ongoing for at least the past 15 years.

3. Swamps/heavy grounds are an integral area in a high country farming system; they provide a water source and good grazing for stock in dry years. In undertaking the FERA it has been identified that all swamps/heavy ground need to be monitored to ensure that bank erosion, compaction and pugging does not occur.
