# **Farm Environmental Management Plan: Te Akatarawa Station**

# 1. Introduction

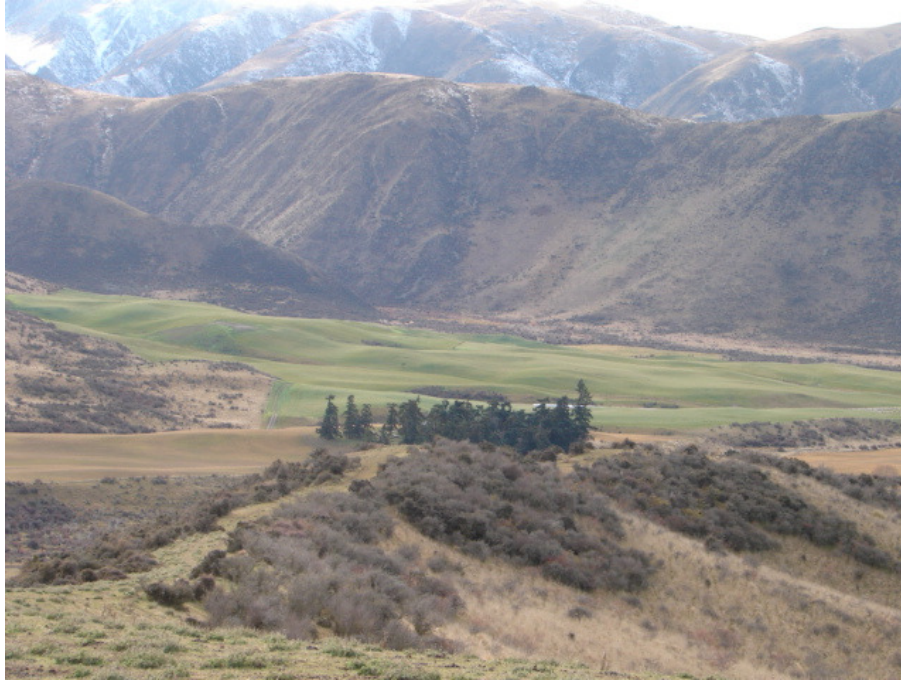
Photo A: Showing the topography of Te Akatarawa Station

The farm consists of 407 ha of easy freehold land. 616 ha of low altitude easy county, 5,427 ha of steep hill, 4,811 ha of Class VII (very steep hill) and 336 h of Class VII which is not allowed to be grazed

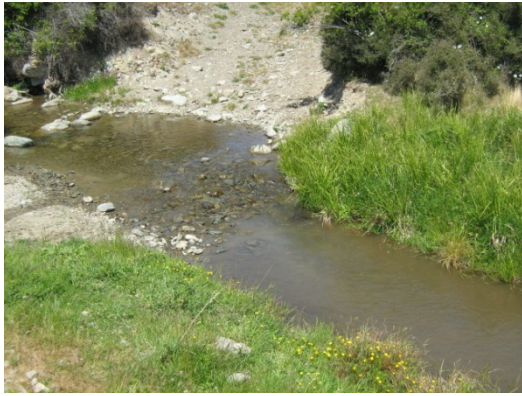
**4.3.1** The tracks that lead out to the irrigation area all cross through the Black Jack stream, these tracks all show a small degree of vehicle and stock induced erosion and will be culverted in the future.

**Evidence of a crossing through the Black Jack stream that needs to be culverted**

3	Maintain a 5-11 metre irrigation buffer from any waterways (such as the springs), these areas should also be planted to allow for filtration of nutrients before they enter the waterway	Photos in the report	Annual auditing report until the planting is complete, then annual auditing visits to monitor the progress
3	Fence off the streams (Black Jack) to restrict stock access, drinking bays may be used. These fences only need to be a temporary fence while stock are in the area	Photos	Annual auditing visit
3	Culverts will be placed in the various positions where vehicles cross the Black Jack stream	Photos in the audit report	Annual auditing visit

Fence off the streams (Black Jack) to restrict stock access, drinking bays may be used. These fences only need to be a temporary fence while stock are in the area	Check fenced areas are present. Photos	Areas of fencing damage should be repaired.
Culverts will be placed in the various positions where vehicles cross the Black Jack stream	Photo once installed	Timeline for completion required, if not completed prior to indicated timeframe then should be rectified by next audit

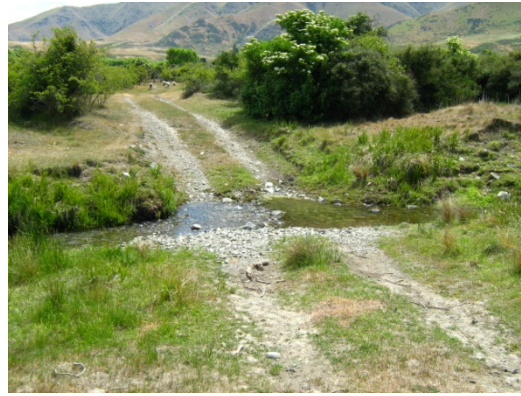
**Another area where the track crosses through the Black Jack stream that will be culverted**
