# Farm Environmental Management Plan

Godley Peaks Station

*Prepared for Lone Star Farms Ltd*

**Ryder Consulting**

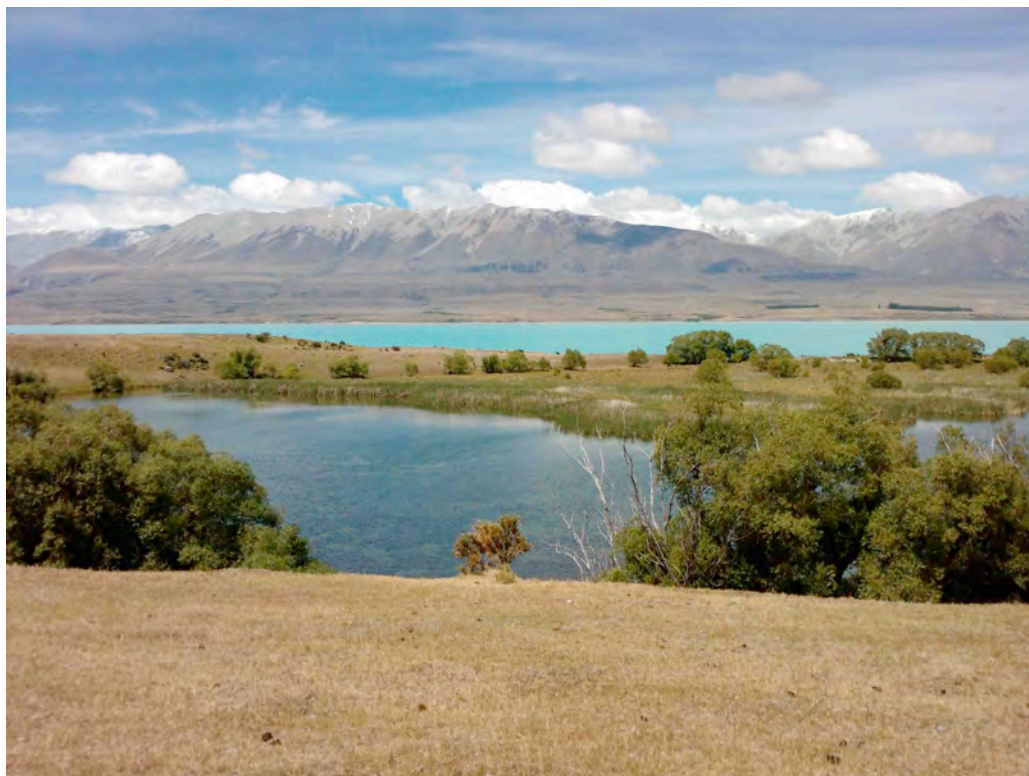
**Figure 5 Rapuwai Lagoon and Lake Tekapo in background**

Rapuwai Lagoon is found close to the shore of Lake Tekapo. It forms a significant habitat for raupo. Banded Dotteral, Australsian bittern and white winged back tern have also been identified in the wetland. Typically there are no overland inputs to the Lagoon and it is thought that the lagoon is fed by local groundwater and is also influenced by the Lake's level, Figure 5.

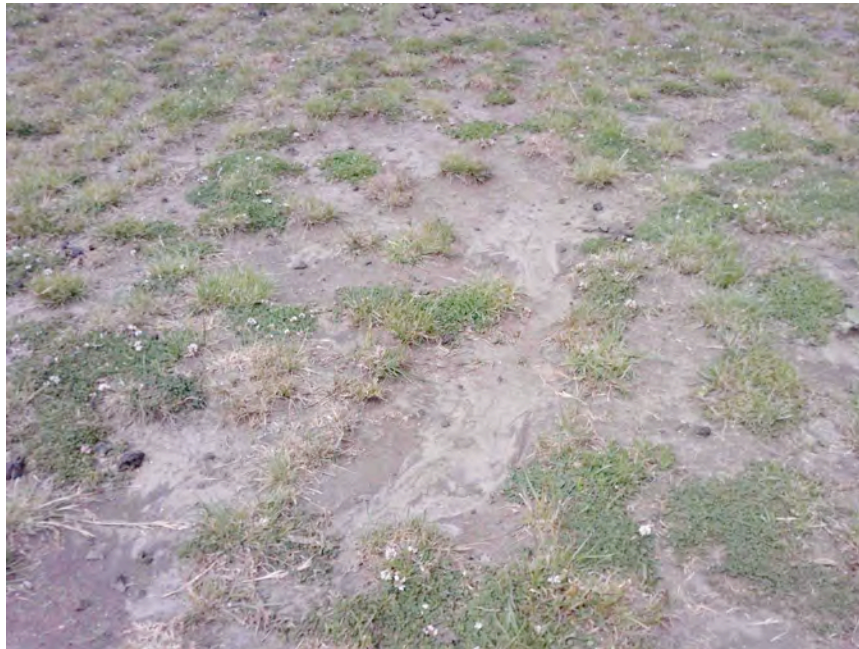
**Figure 6 Marginal surface runoff on slopes to Micks Lagoon**

Evidence of / vulnerability to water erosion	Evidence of some runoff on straight up drilled grass sloping to Micks Lagoon	-
	Evidence of / vulnerability to capping and pugging	Soils on Northern pivot location where exposed during pasture renewal have capped and under pasture have pugged, slopes toward Mick's lagoon vulnerable to pugging and capping	-

- *The installation of a buffer strip and subsoiled strip on foot of eastern slopes approaching Micks Lagoon;*
- *Ephemeral channel carrying flows to Rapuwai Lagoon to be grassed and remain under grass;*
- *Where conditions are such that there is surface water ponding flowing (ephemeral channels flowing to Rapuwai Lagoon and Lake Tekapo), stock to be restricted from the immediate area by temporary fencing;*
- *No cultivation of lower terrace North of Mistake River adjacent to the lake margin; and,*

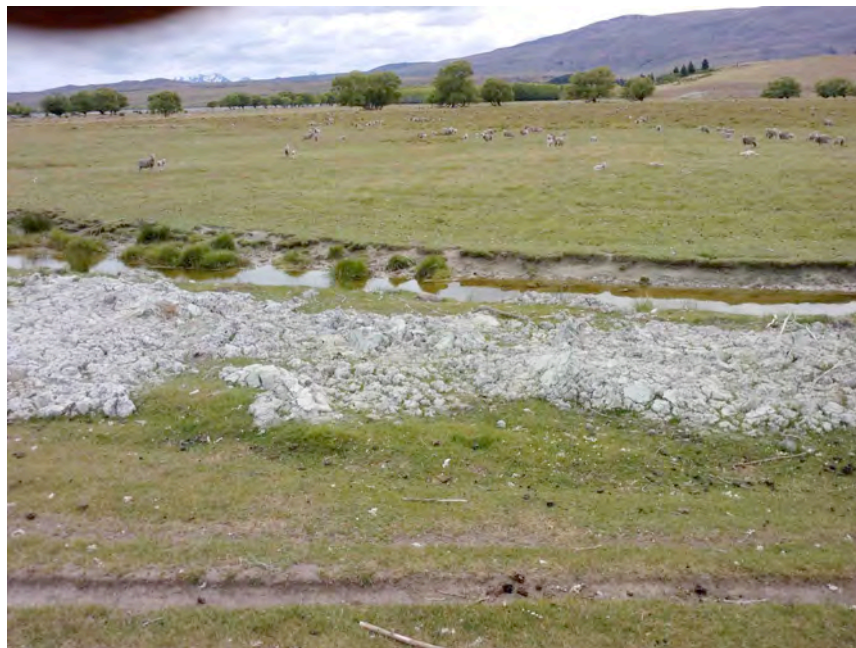
**Figure 7 Outflow from Micks Lagoon including stock encroachment**

Describe Local receiving environments		Mistake River	Homestead Pond	Micks Lagoon	Rapuwai Lagoon	Lake Tekapo	Cass River
Type		Watercourse	Pond	Lagoon	Lagoon	Shoreline of Lake Tekapo	River
Source		Highland, contained on farm	Spring fed pond augmented by 2 water races. Would be smaller without this augmentation	Irrigation water from Mistake River via water races	Spring/GWR level is thought to reflect Lake Tekapo level	NA	Highland
Destination		Lake Tekapo	-	-	No outlet	Water leave UW via canal system and Lake Benmore	Lake Tekapo
Germorphology		-	-	-	-	-	-
Condition		-	Degraded	Lagoon is good	-	Good	ND
Value		Habitat and unmodified status (IO)	Wetland of Representative and Ecological importance (WERI)	Biodiversity/ Black stilt	-	amenity/ visual	Habitat
Protection		-	-	DoC sanctuary	-	-	-
Regulation/required quality		-	-	-	NS	-	-
Current threats							
	Stock	No stock access	Stock access to lagoon although normally only sheep in this paddock. Stock on sloping field draining to lagoon	Protected from Stock	Stock have access to part of lagoon	Although stock are not restricted completely from the Lake there was no evidence of damage by stock. There is extensive (although variable) gravel foreshore	Stock are not restricted from Micks Lagoon outfall channel (Figure 7)

Check Micks lagoon, Rapuwai Lagoon and Mistake River fencing is in tact	Any failure in the integrity of the fencing must be repaired immediately or a temporary barrier placed around gap to prevent stock access.
Check in field and riparian grass strips where fodder crops are winter grazed in hydrologically connected areas	If grass strips are not in place, short term mitigations such as pathway sub soiling, temporary sediment pits or temporary straw bale barriers should be considered to protect watercourses. Strips should be planted/left the following year.
Review measures recommended by irrigation audit have been implemented	Recommendations not already implemented should be done so prior to next audit.
Review field records to verify split applications of N	Where verification is not possible, this should be rectified for the following audit. Following that - non compliance.
Review field records to verify no late autumn and winter applications of N	Where verification is not possible, this should be rectified for the following audit. Following that - non compliance.

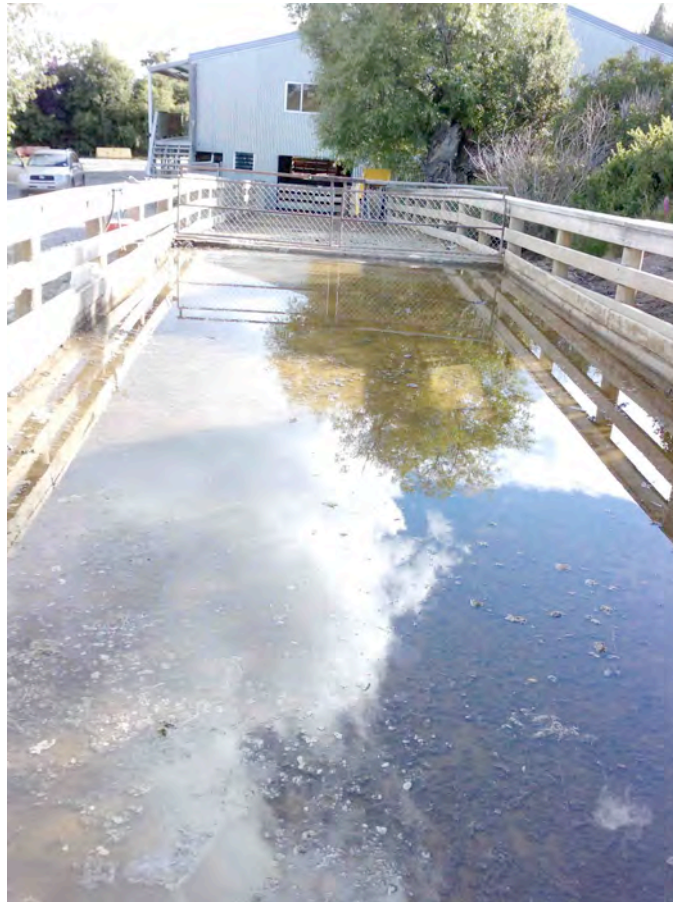
**Figure 8 Yard where sheep jetting occurs with drainage at far end**

Direct discharges from yard	Yes	-
	Application rate and depth and total load	NA	-
	How is depth determined?	NA	-
<b>Point Source - Chemicals</b>	Yard	Runoff from yard where jetting occurs escapes with roof drainage across track and flows into Homestead lagoon	-
	Store	Sealed bunker. Remainder of chemicals bought in on demand by contractor	-
	Fuel	Mobile bowzers	-
<b>Tracks</b>	Evidence of / vulnerability to tracks running off to R.E.s?	No	-

- ***Contaminated yard runoff to pass through a biobed for treatment prior to being discharged onto Killer Paddock. A biobed is essentially an organic filter system consisting of a lined structure that contains a biomix - a mixture of topsoil, compost and straw. The biomix removes the pesticides from the contaminated water, the retained pesticides are then degraded and the treated water can be reused (Fogg, 2007). Further details on biobed construction and use are given in Annexure 2;***
- ***No spray areas for chemicals to be mapped and clearly displayed in sprayer cabs; and,***
- ***Back siphoning prevention measures to be implemented on the farm when filling sprayers from an un-isolated water supply.***

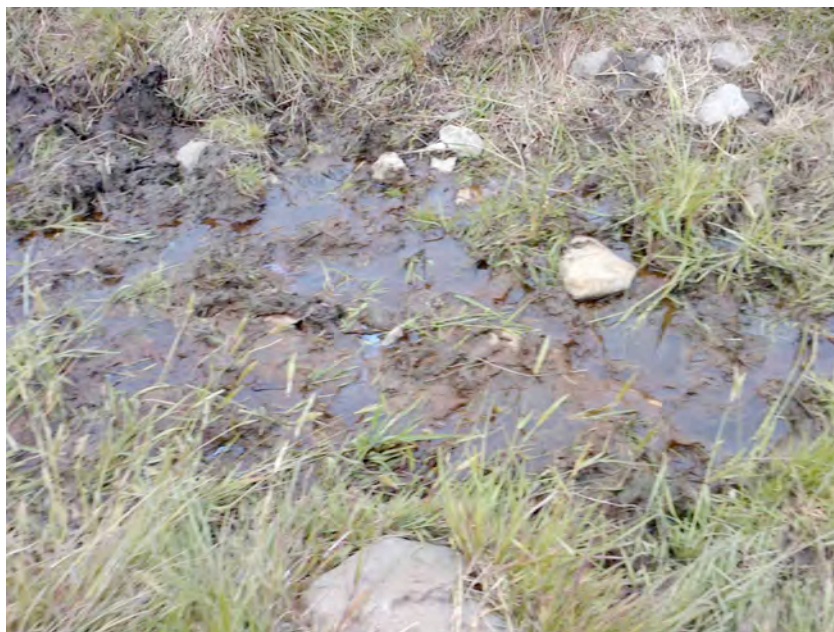
**Figure 9 Contaminate drainage from yard in Killer paddock discharging to Homestead Pond. Note Opalescent film on water.**

Runoff	In vicinity of irrigation the very shallow gradient to the river would reduce the vulnerability to runoff	Roofwater is piped via downpipe and drain under track to outlet across the paddock and meanders in a runoff channel to Lagoon. Cross drain at lowest point of yard also drains into this drain. Yard is used to treat and jet sheep and therefore runoff is contaminated with excreta and chemicals (Figure 8)	Runoff potential into Micks Lagoon - capped soils with some consolidation sloping down to lagoon (Figure 6)	The surrounding slopes may runoff, but this is a natural phenomenon	Ephemeral channel in proposed hardnose area east of eastern pivot. Runoff to lake.	-
	Effluent	NA	NA	NA	NA	NA	NA
	Fertiliser	-	NA	-	Absence of buffer	Fert applied within 20 m of the shoreline	-
	Chemicals	-	In runoff channel in Killer paddock a white/opalescent sheen was seen on the surface of the runoff water (figure 9).	-	Absence of buffer	Absence of buffer	-

The FERA highlighted water and runoff risks associated with runoff from sloping paddocks to Micks Lagoon, ephemeral surface water flow to Rapuwai Lagoon, contaminated runoff from the yard draining through Killer paddock to Homestead pond, cultivation of lower terrace North of Mistake River adjacent to the lake margin, and an ephemeral channel in proposed hardhose area adjacent to the lake margin draining to the lake. The existing network of open irrigation and stock water races are being replaced by a reticulated system, thus reducing associated risks.

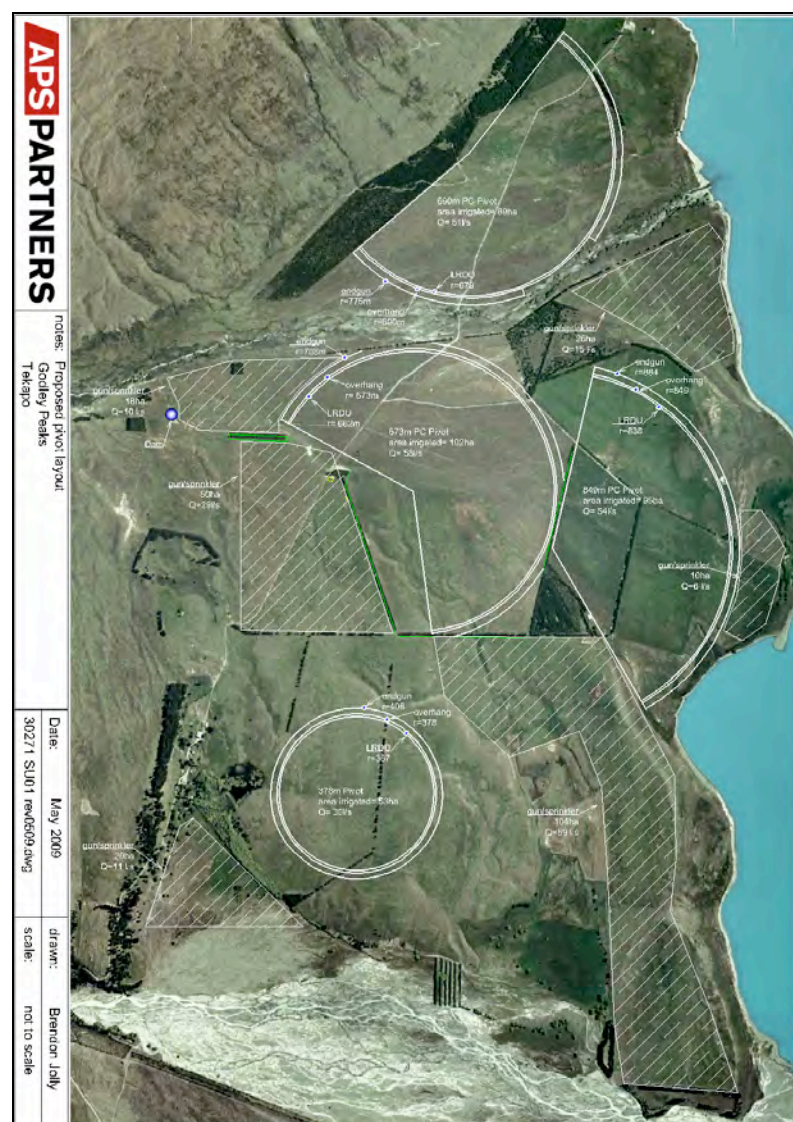
**Figure 10 Map of proposed irrigation areas on Godley Peaks Station**

The proposed farm system is an extension of the current system. The proposed irrigation, shown in Figure 10, is largely being sought as a risk management strategy in this dry environment. It would provide increased reliability of feed supply throughout the summer, and provide increased areas where winter feed crops could be grown. The base stock numbers will increase but it is not envisaged that capital numbers would be increased significantly above the levels the property has historically run (up to 14,500 SU) and the stock numbers over the winter period would not alter significantly. The additional feed provided by the irrigation over the summer and autumn would go towards increasing per head performance of capital stock, and the balance would see an increase in summer trading stock (November to April).
