ASSESSMENT OF ENVIRONMENTAL EFFECTS AS PER SCHEDULE 4 OF THE RESOURCE MANAGEMENT ACT 1991

In support of an application by Gary Robert Wilson and Raelene Cynthia Wilson for Consent to divert and discharge field drainage water to a seepage pond and to modify a watercourse.

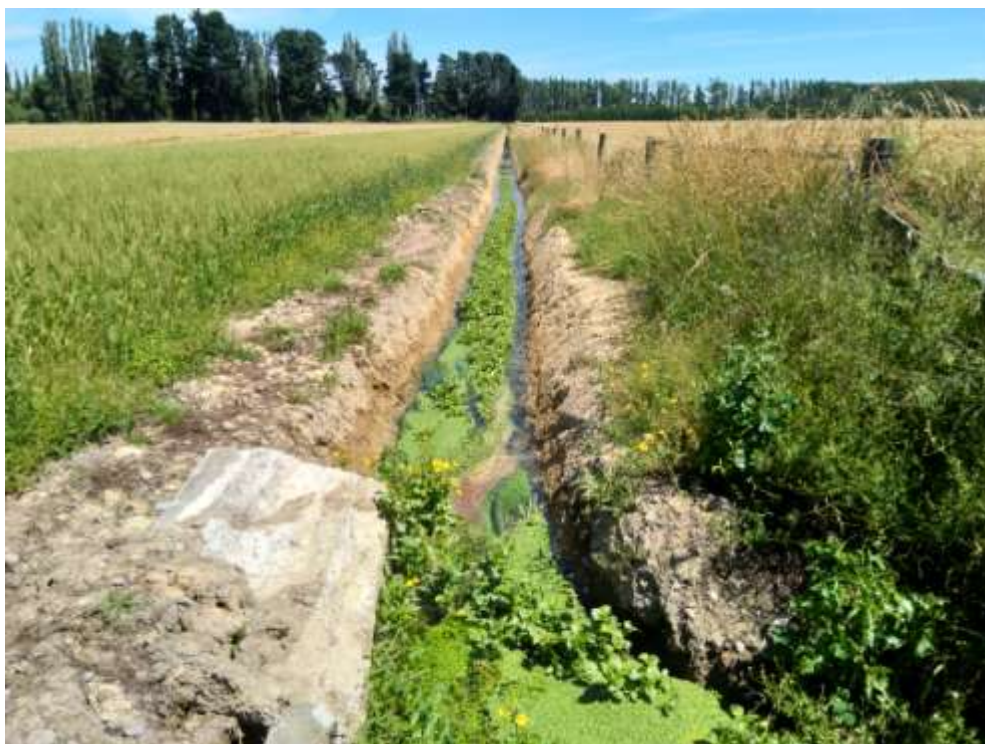
Map 1A: Recently constructed drain

- Divert water into the farm drain at 1485416-5128931 and discharge the water into a seepage pond at 1485306- 5128595 as shown on Map 1A. As described in this report, the effects are less than minor and as such a 35 year duration is required being the maximum the RMA allows.
- Modify the farm drain between 1485416-5128931 and 1485306- 5128595, of approximately 470 metres. A consent of 18 months will allow the works to be undertaken without delay but also allow for the dry conditions required for them to be safely undertaken.

93. The recently established drain is about 470 metres long, changes direction in two places and has no culverts. The cross sectional area of the new drain is significantly larger than the old drain (Table 1B) and will be further increased when the banks are battered to the recommended angles (Table 1C). As described above, the new drain and pond have been able to cope with flow resulting from high rainfall events (50 mm in one day), without any field flooding.

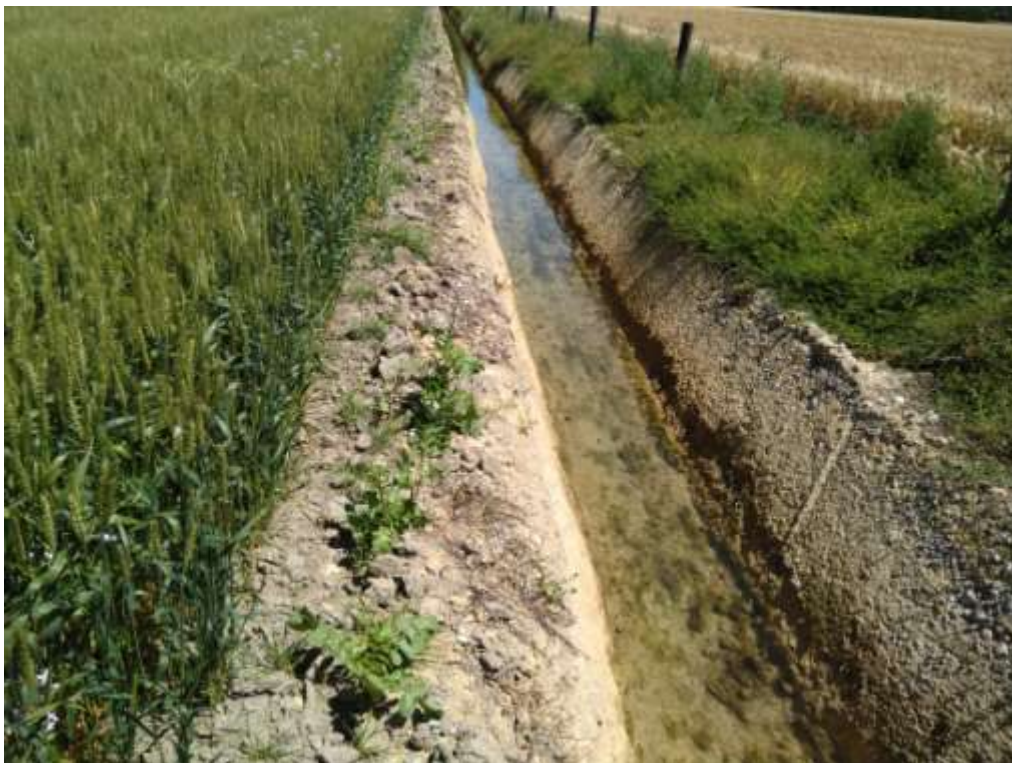
Photograph 1B: Looking south-west near point 2 on Map 1B.

- Photograph 1C: Showing the drain as it curves near point 3 with steep banks (0.37:1), the stony loose soil has been eroded and undercut.
- Photograph 1D: Looking north-west near point 4 shows the relatively steep sided banks (0.73:1), this stony loose soil has been eroded.
- Photograph 1E: Looking north-west near point 5 shows how the banks have been colonised and stabilised by vegetation.

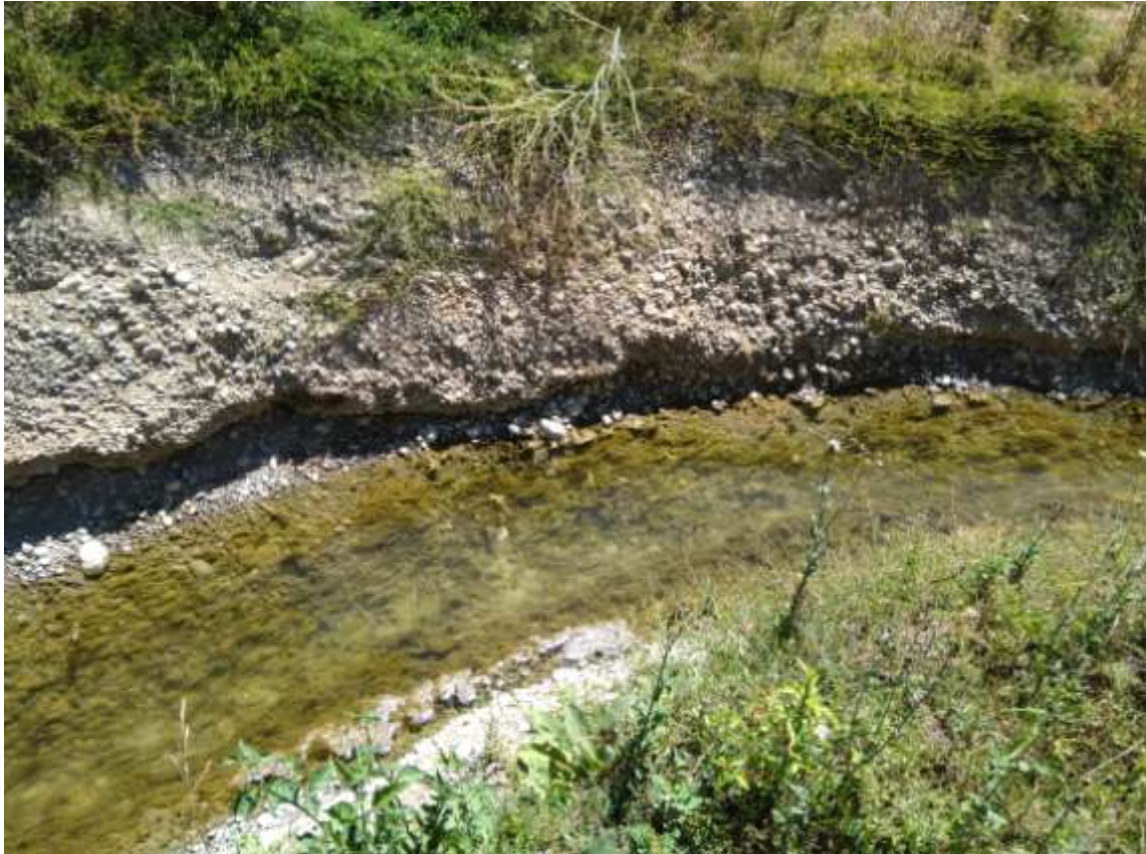
Photograph 1C: Showing the drain curve near point 3 on Map 1B.

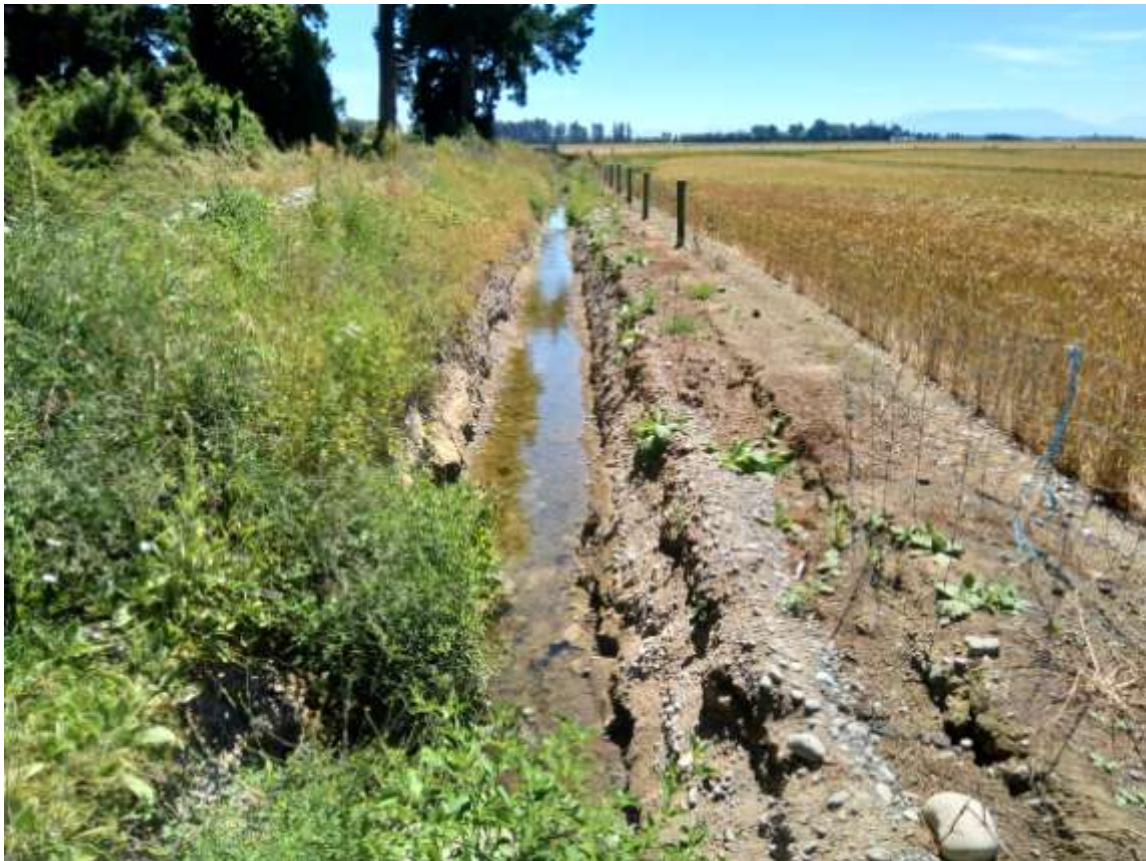
Photograph 1D: Looking north-west near point 4 on Map 1B.

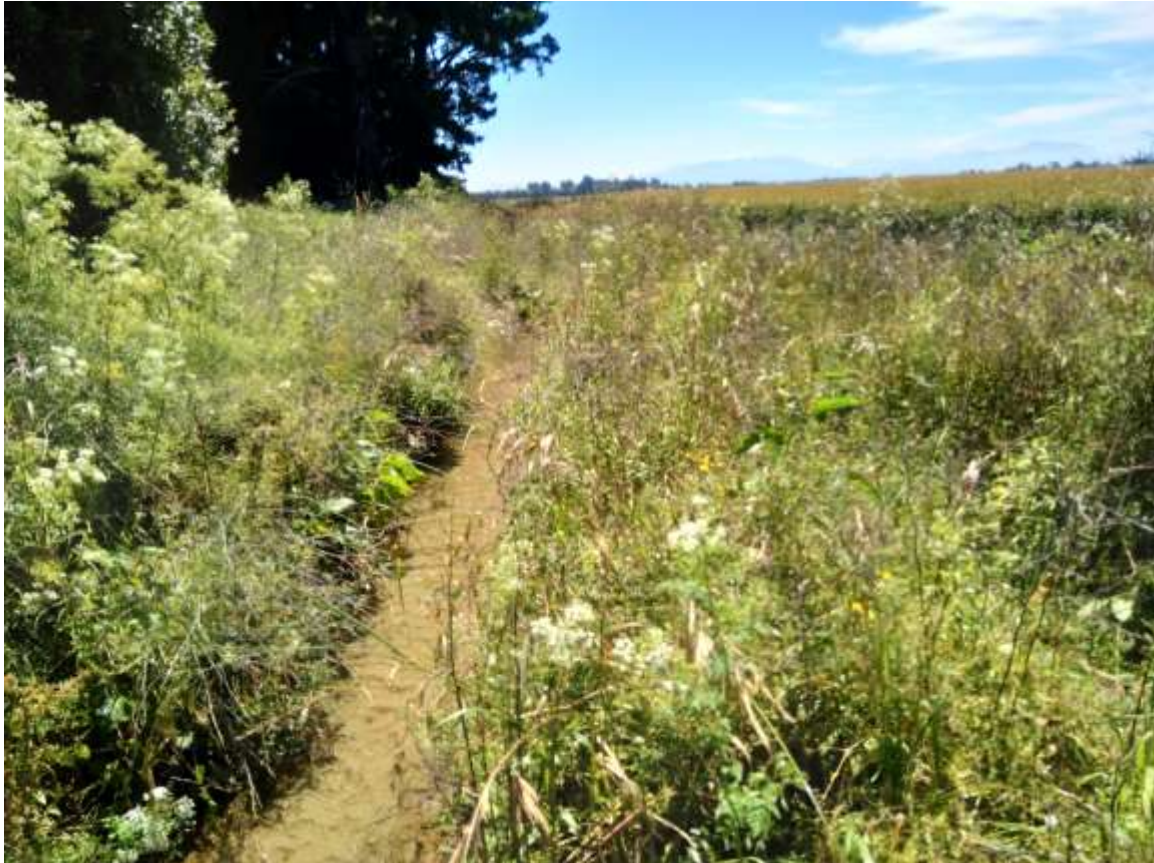
Photograph 1E: Looking north-west near point 5 on Map 1B.

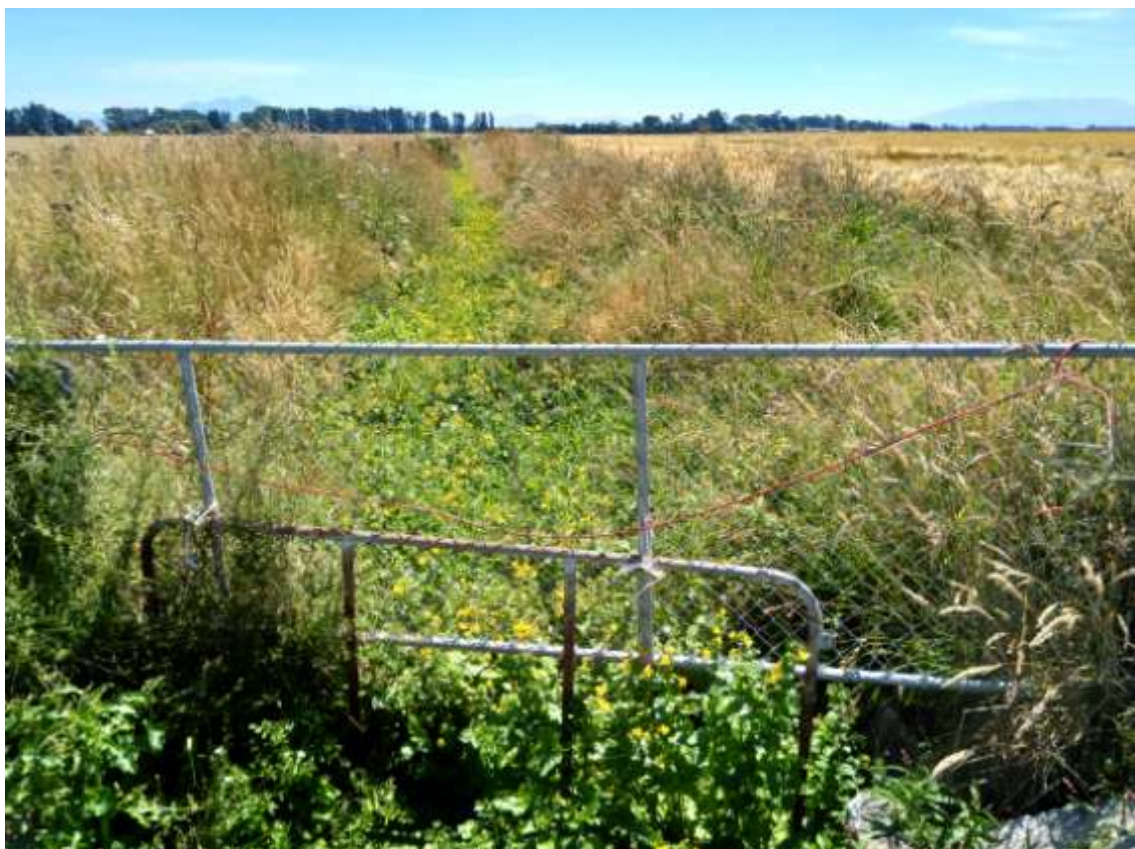
20. Photograph 2, shows the choked farm drain looking north from the boundary of the Wilson property. Prior to drainage these paddock were part of a swamp, now drained by a herringbone pattern of “tile drains” leading to the farm drain, see Map 4A.
21. Photograph 3 is the farm drain looking south, showing the culverts which can become blocked by weed mass and foliage washed downstream from the property to the north. Photographs 4 and 5 show the discharge point and the seepage pond.
22. The closest Department of Conservation Reserve is to the west of the Hinds River.
23. There are no nearby:-
 - Sites of Special Wildlife Significance.
 - Wetlands of representative importance.
 - DOC Wetland Areas.
 - DOC Wetland Points.
 - Archaeological sites.

Photograph 2: Upstream farm drain looking north from farm boundary

9. Photograph 2 shows the drain entering the Wilson property, historically vegetation has been dislodged from this drain.
10. The existing drain is crossed by culverts some 600 mm in diameter and some 400 mm in diameter, as can be seen in Photograph 3. These culverts provide constrictions in the drain of 0.5 square metres for the 400 mm culverts. Mr Wilson has observed that this drain has coped with most flows except when the narrower culverts block with vegetation swept downstream.

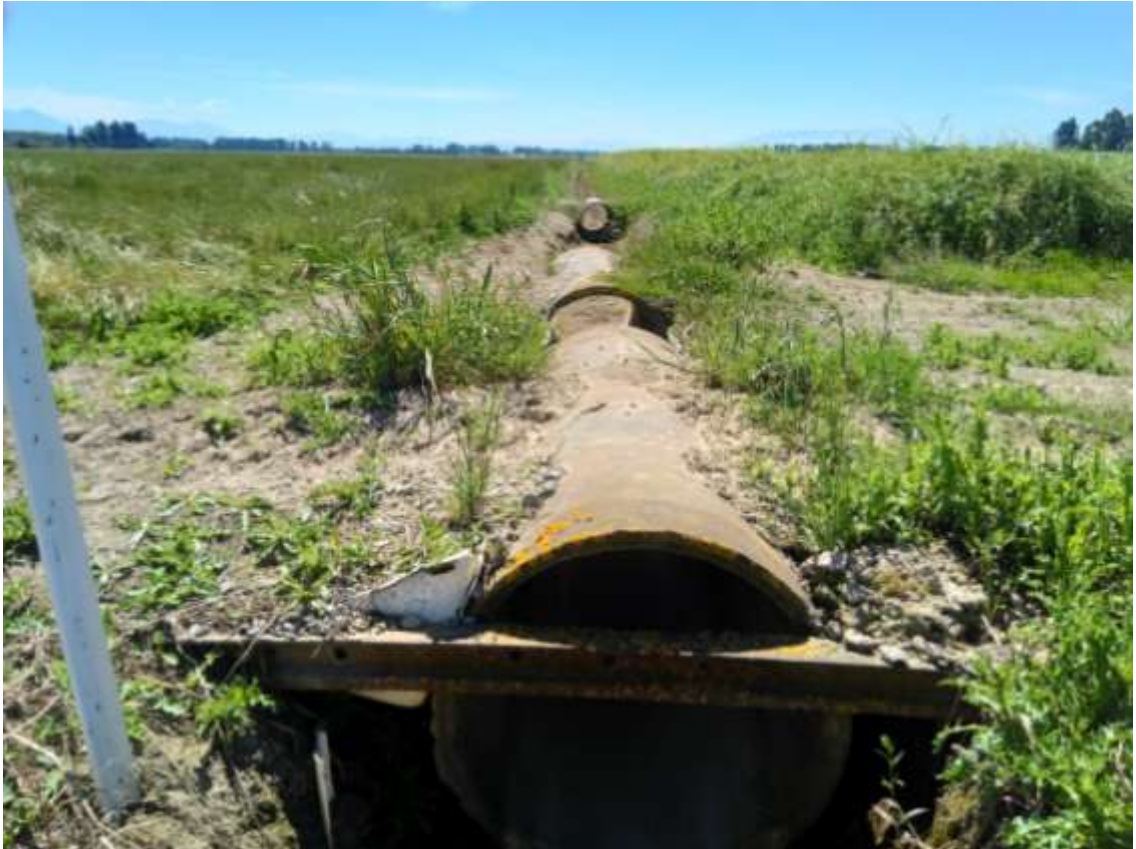
Photograph 3: Farm Drain culverts on Wilson property.

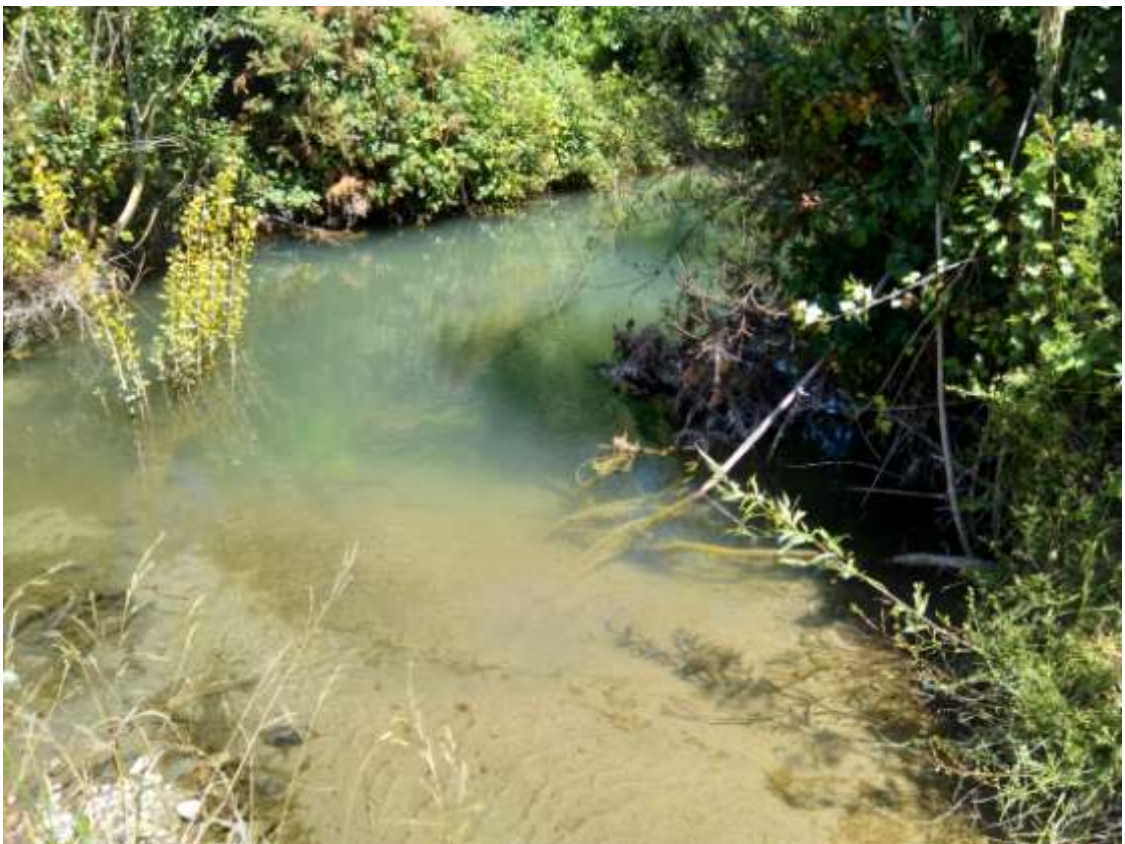
Photograph 4: Discharge into seepage pond.

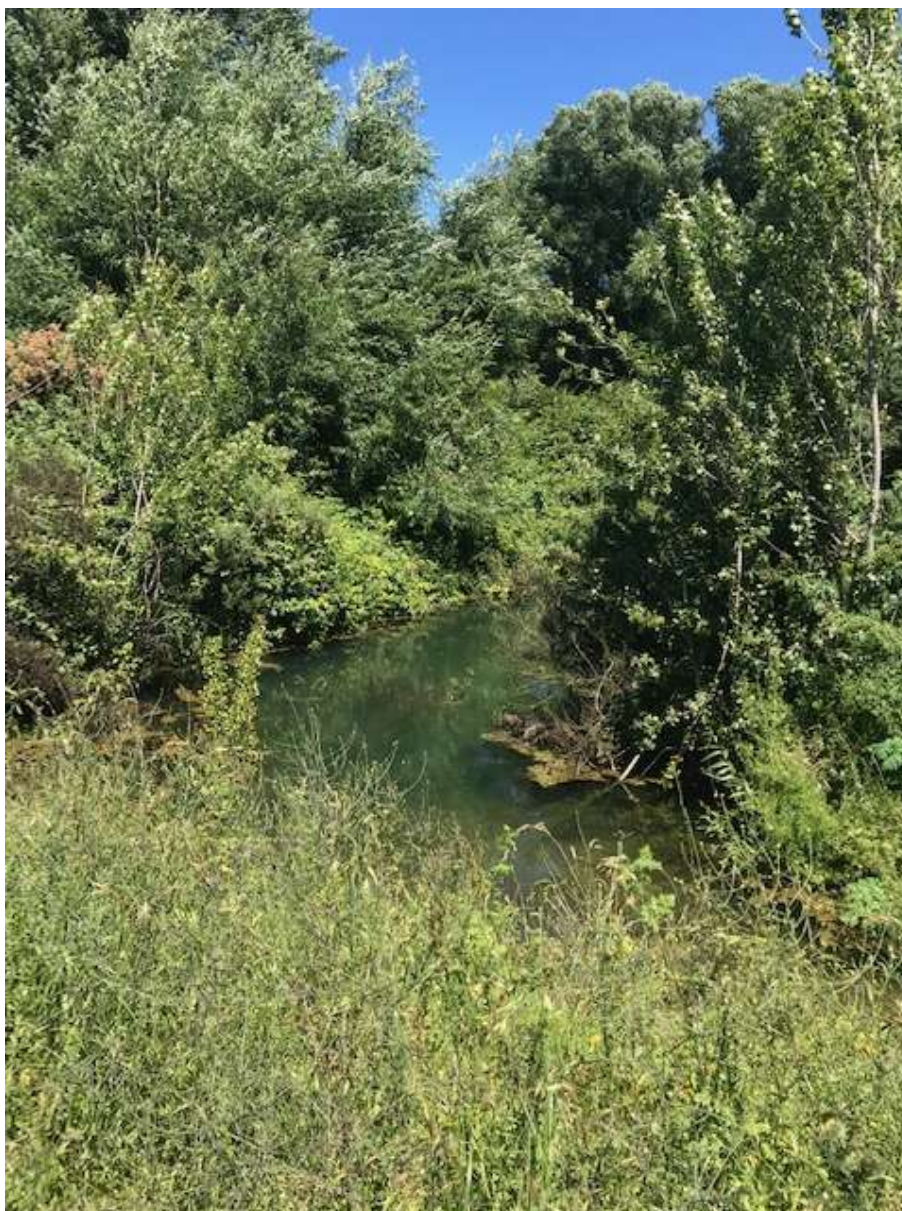
Photograph 5: Seepage Pond

15. Mr Wilson has observed that the new drain has been able to cope with all flows without any problems. He also states that the water level in the seepage pond fluctuates in line with the level of water in the Hinds River i.e. when the river is dry, the pond is dry. Even after heavy rain and subsequent increased flow in the drain, he has not observed the water level in the seepage pond rise above about 0.75 metres below surrounding ground level.

16. The seepage pond was originally dug to provide a source of irrigation water. Historically surface water drained to this area, as can be seen by the trace of a watercourse, see Map 1B. It is possible that this drainage pattern influenced the choice of location for where the seepage pond was originally dug to provide water for irrigation.

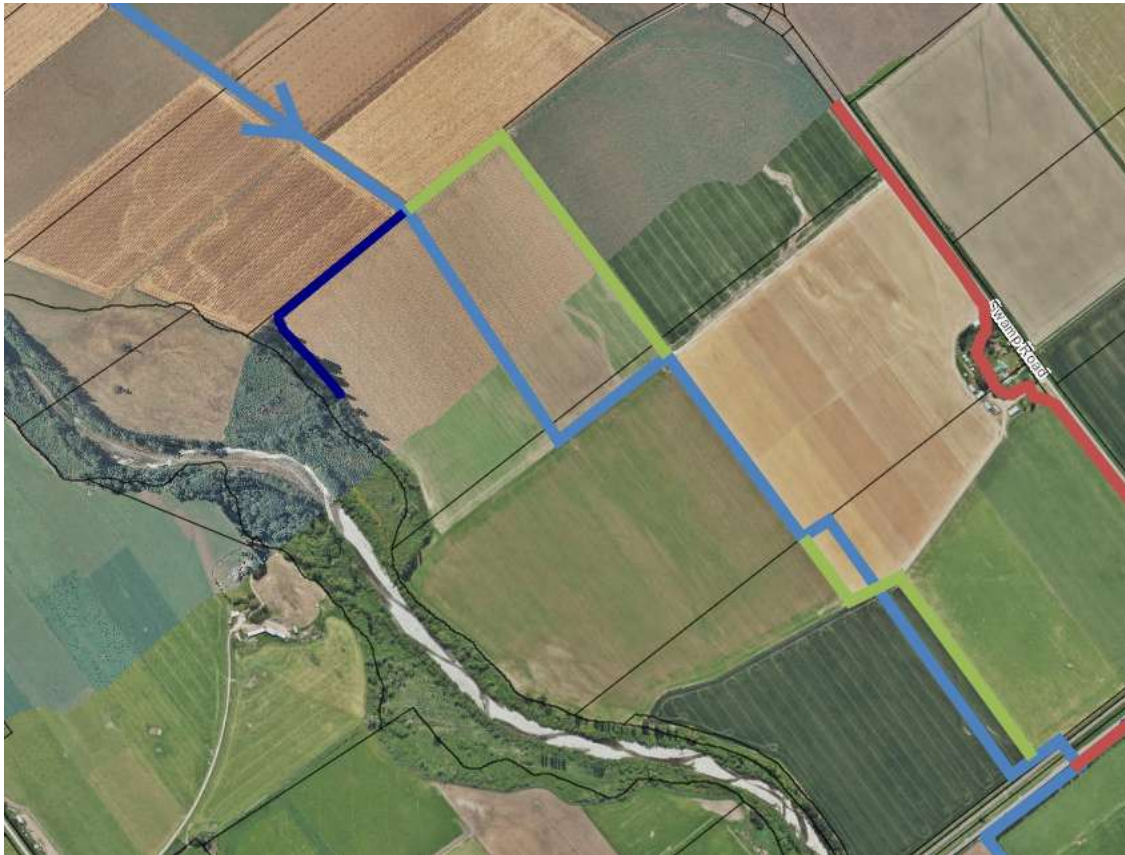
Map 3A: Light blue line is farm drain pre 2005, green line is farm drain 2005 to 2018 and dark blue line is farm drain 2018 to date.

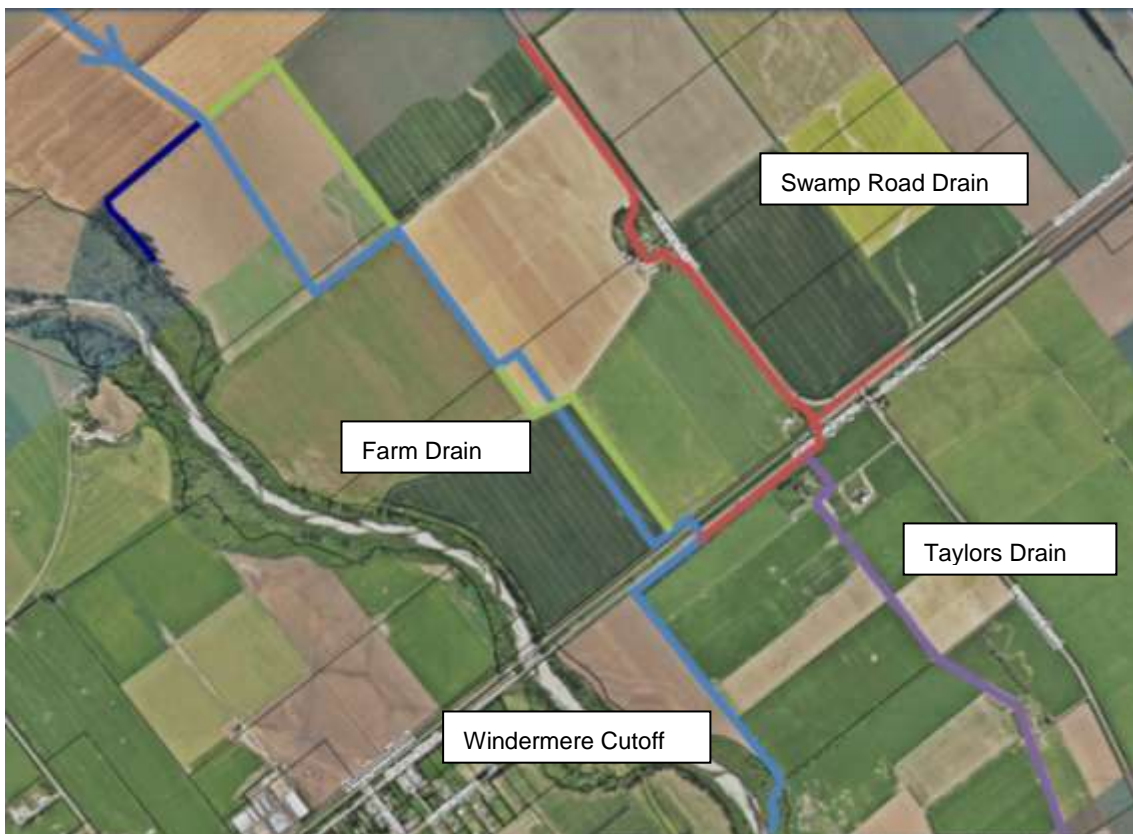
Map 3B: Local Drains.

29. Map 3B shows local drainage, the Swamp Road Drain is a straightened watercourse. It joins the drain parallel to State Highway One and then is diverted to become Taylors Drain. Excess water flows to the South West and down a flood relief channel (known as the Windermere Cutoff) to the Hinds River.
30. Map 4A shows how the fields to the north of the Wilson property have been tile drained, the green dots show where Environment Canterbury records springs. This map was drawn by the land owner Mr Lowe.

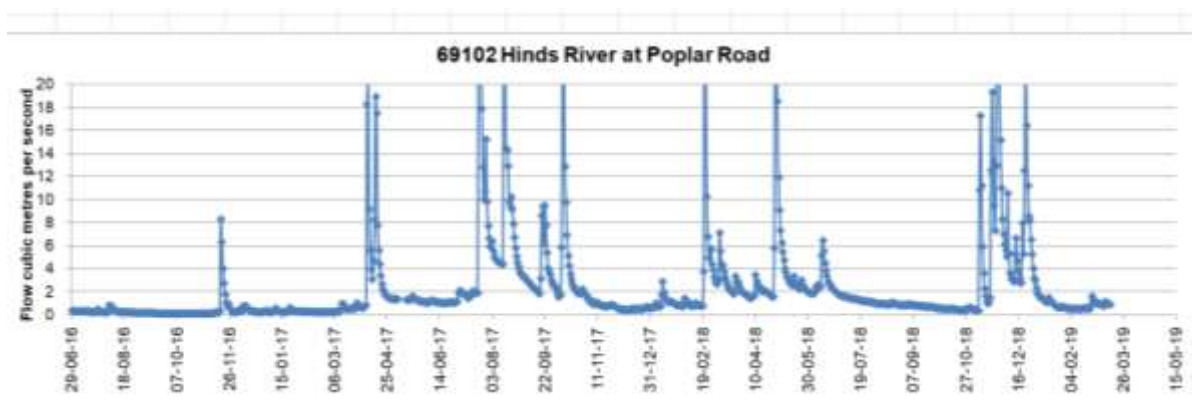
Graph 2B: Flow in the Hinds River from 29-06-2016 to 13-03-2019

33. The Hinds River has a long, continuous daily record at its flow measuring site at Poplar Road; this site is about 10 kilometres downstream from the Wilson property. Graphs 2A and 2B show how the Hinds River and by inference its associated drains have experienced very low flow in periods over the past 5 years. This is consistent with Mr Wilson's observations

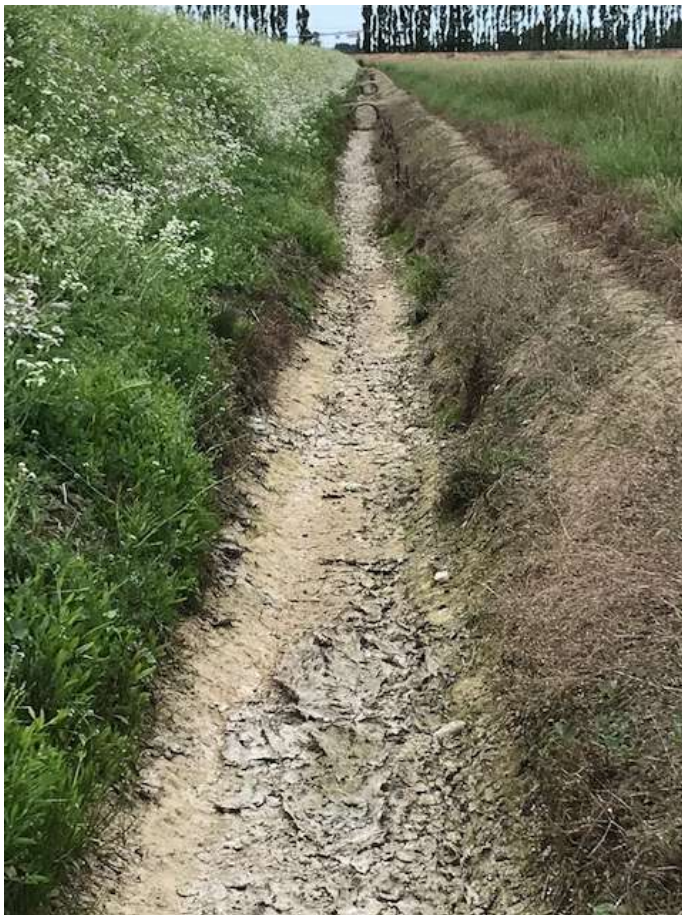
47. Photograph 6A was taken on 16 January 2019 showing a southerly view of the remaining farm drain, photograph 6B taken the same day, is a close up of the drain bed. This drain was flowing the previous week after heavy rain and in parts was damp. The drain exhibits evidence typical of a managed farm drain, dredged out every year and weed sprayed twice a year. There was some desiccated cress, but other than that all the plants were exotic weeds and grasses. Mr Hendrikz walked the entire length of this drain finding no evidence of fish or eels, even in the odd downstream puddles. As this farm drain is downstream of and had the same management regime as the filled in portion it is concluded that the habitats were very similar.

Photograph 6A: Remaining Farm Drain, taken on 16 January 2019.

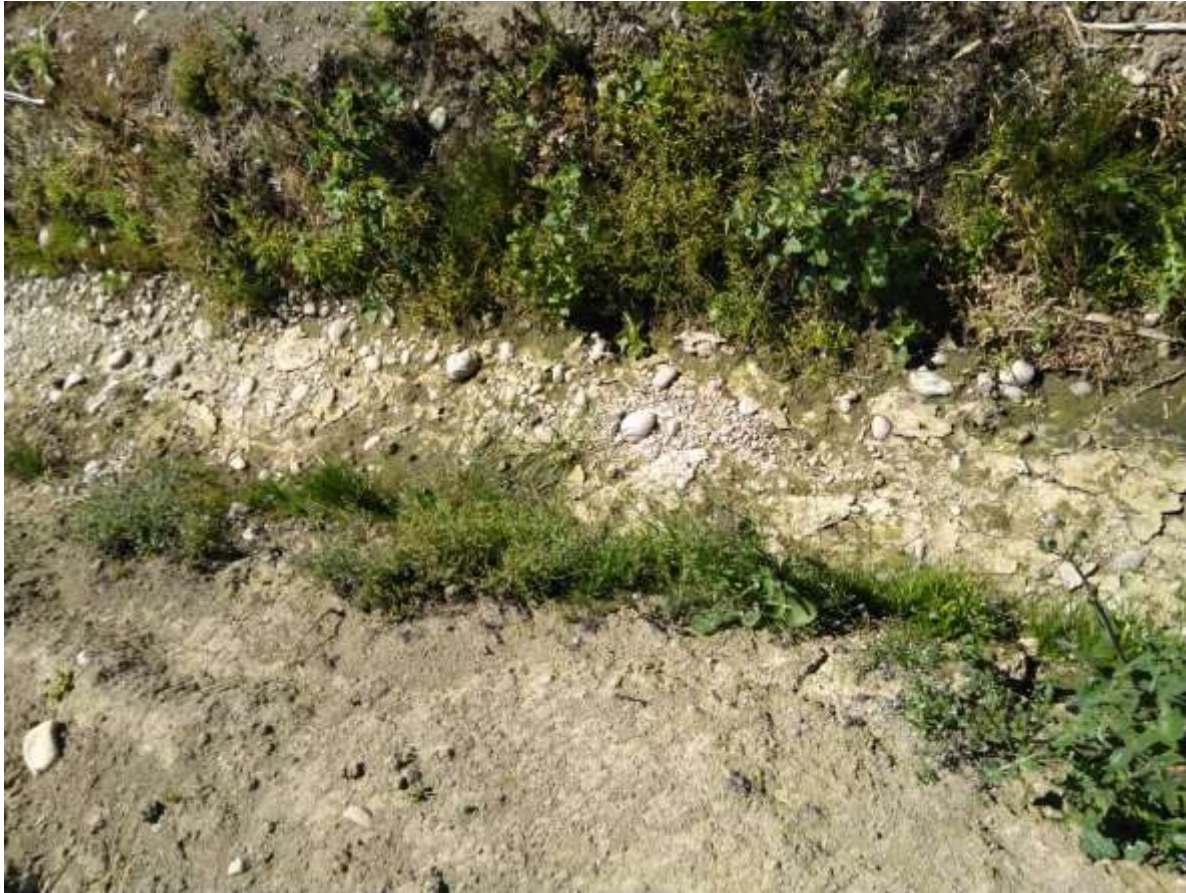
Photograph 6B: Bed of remaining Farm Drain, taken on 16 January 2019.

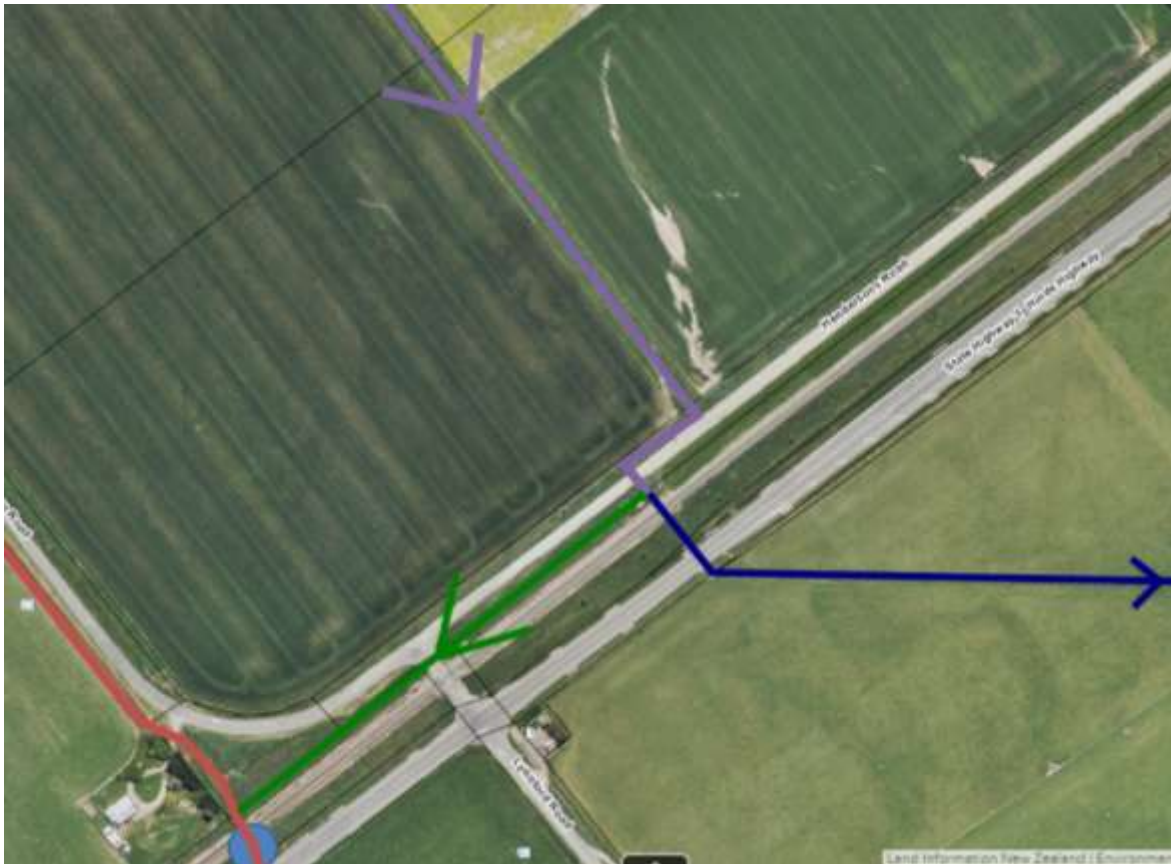
Map 5B: Rerouted drains to the east. The purple line is the field drain, the dark blue is where the water used to go, the green line is the rerouted watercourse.

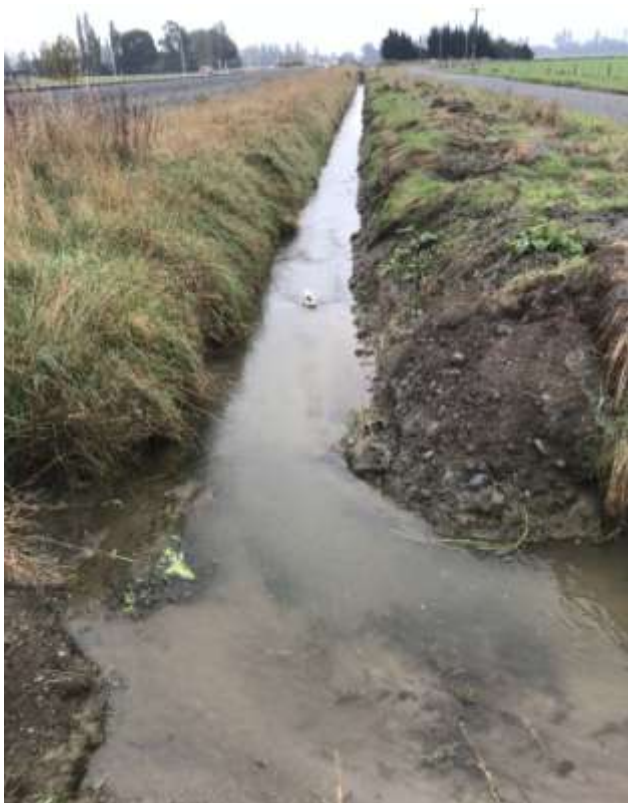
Photograph 7A : Water exiting farm drain to the east (looking south-west)

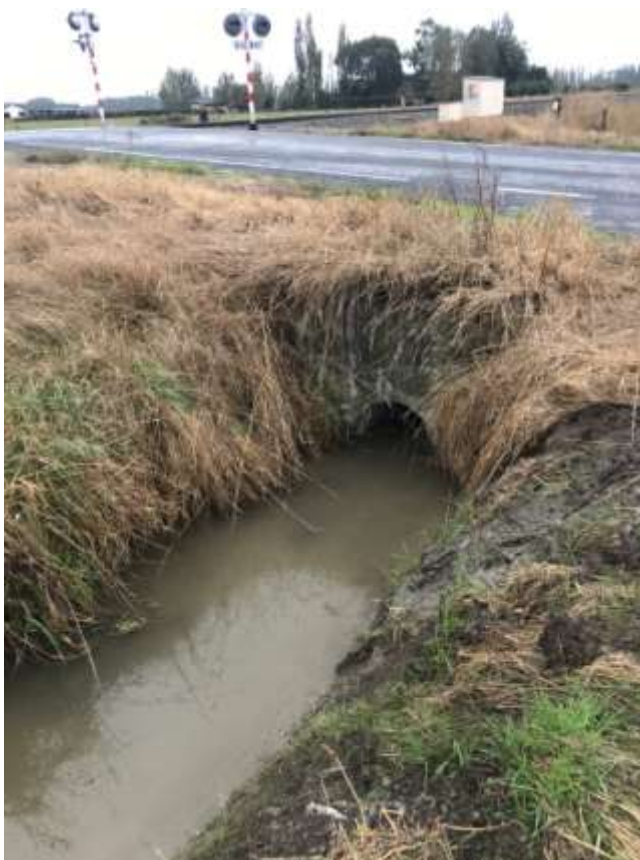
Photograph 7B: Water passing under Henderson Road, prior to joining Swamp Road/Taylors Drain
