Land, Air Water Aoteoroa (LAWA)

- Powerful tool for quickly looking at water quality
- National summary comes out annually when data are updated
- At the national level the state of water quality has not changed markedly over the past 10 years

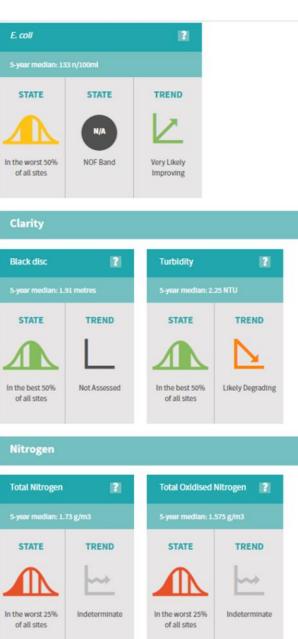
Water quality parameters for your site

- E. coli
- Clarity measures
- Three forms of nitrogen (including ammonia)
- Two forms of phosphorus
