Appendix 5

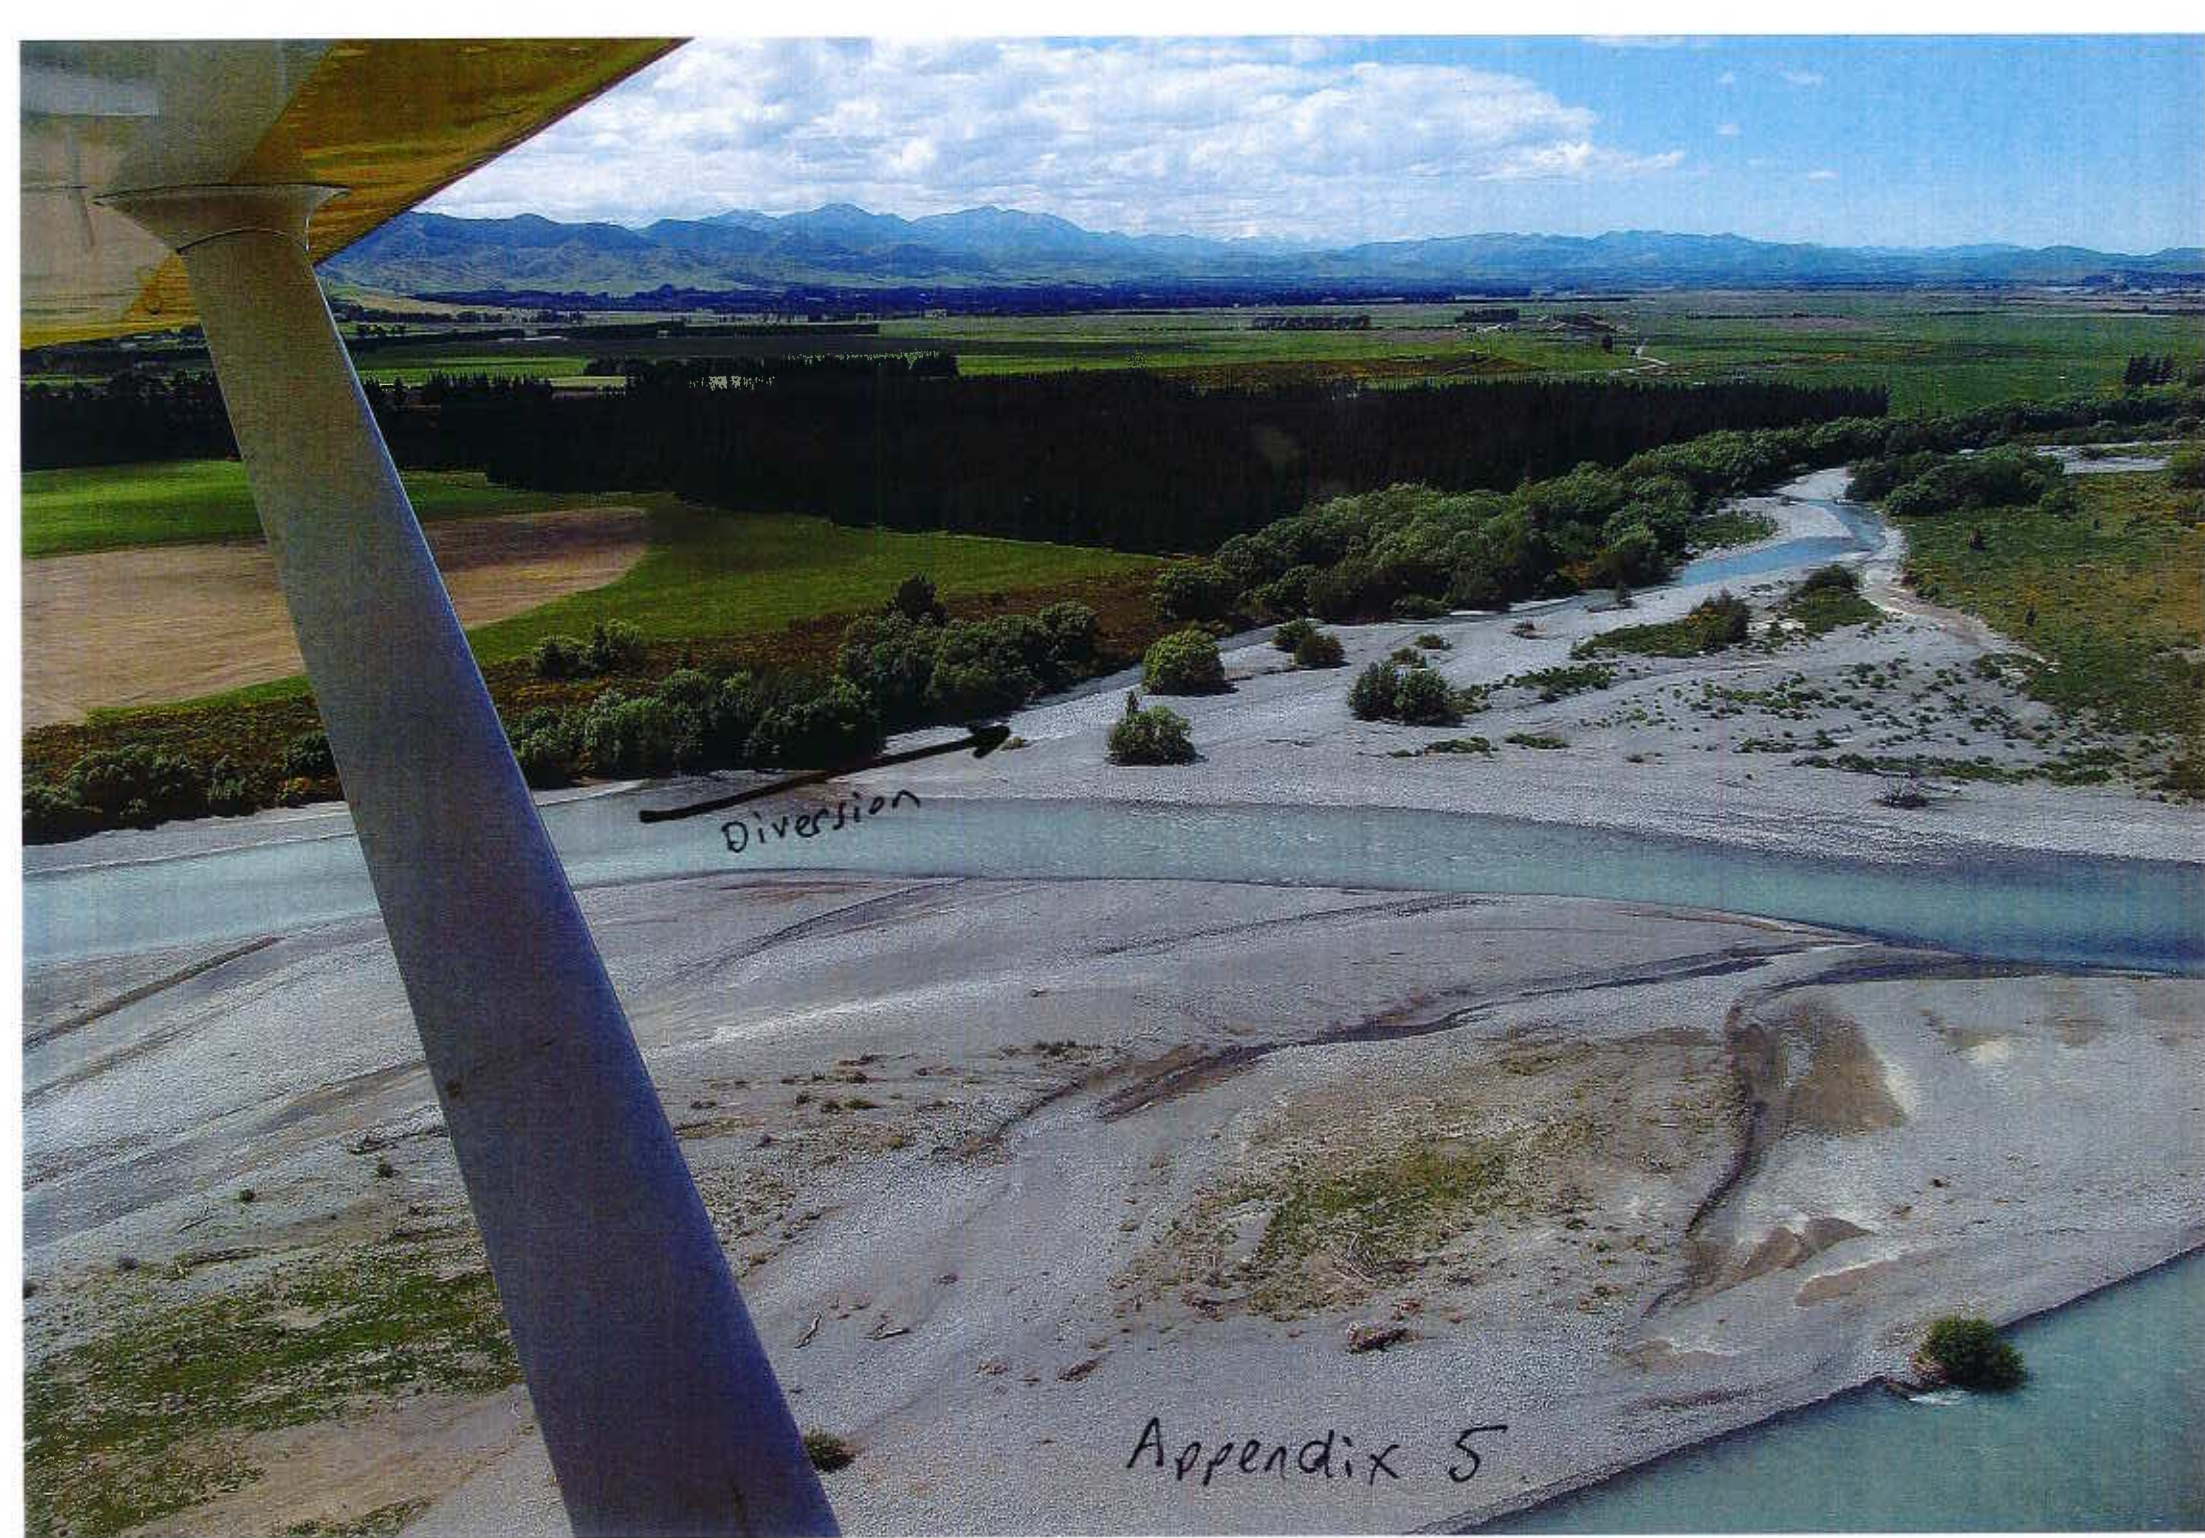
Looking upstream at principal diversion point from Waiau River. One cumec authorised to be diverted into old natural channel. Minor works necessary to maintain the open diversion. Fall is steep with rapidly flowing water which keeps the channel open. Channel is not deep, around 0.5 metres. It is a simple operation with a digger to keep the channel open to the main Waiau River channel.

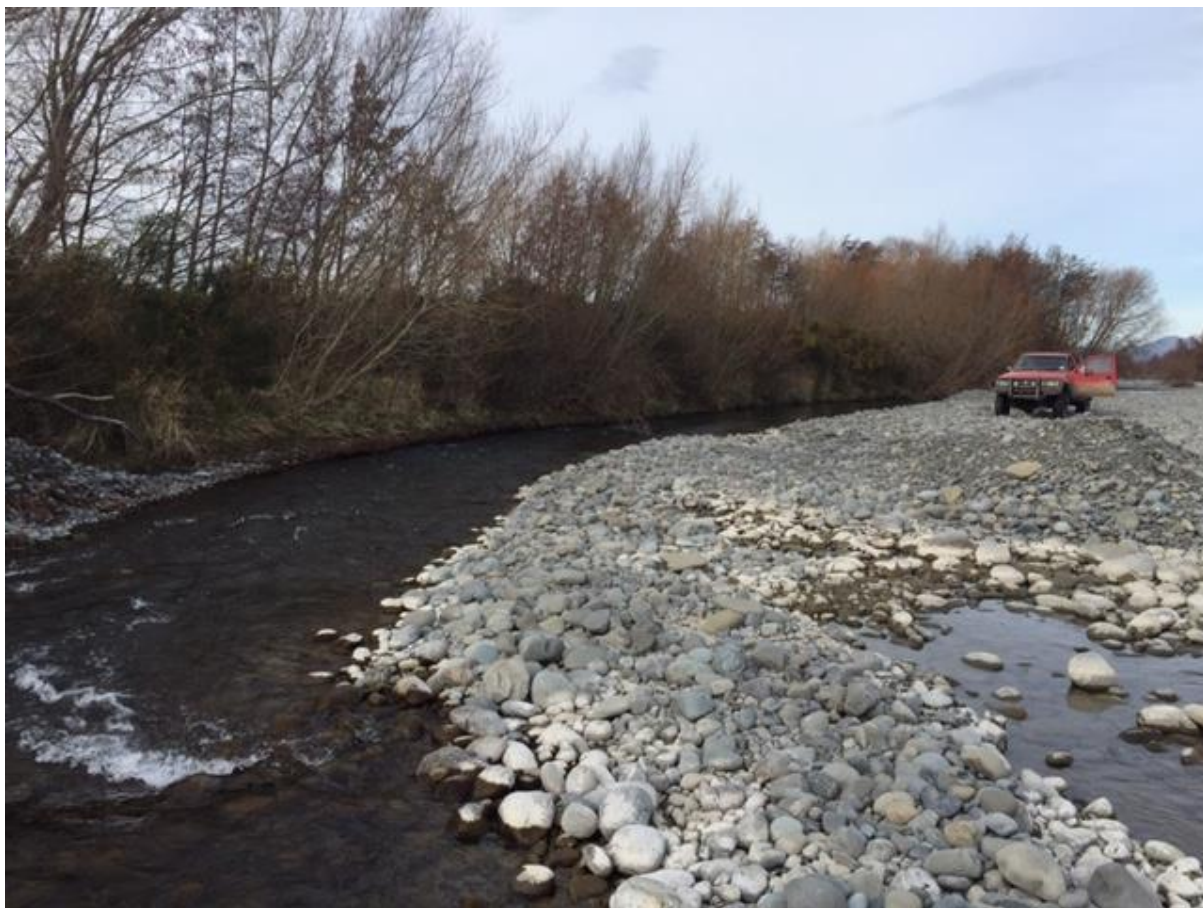
Looking downstream at diversion channel. Very stable channel. Photographs taken 18/8/20.
