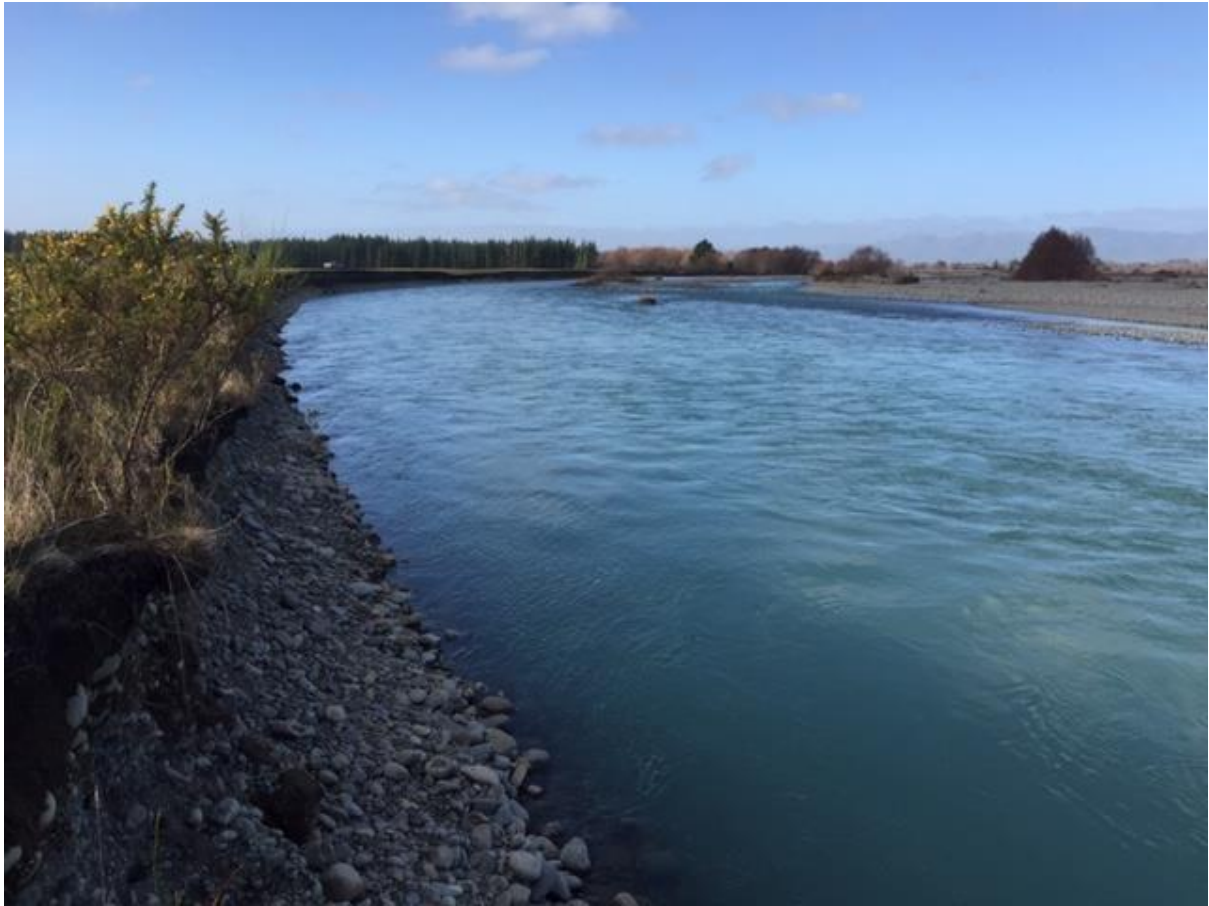
Photograph looking eastwards, downstream, at scour of true left bank at downstream location. Bank is 4 – 5 metres high along this reach of the Waiau River. Note two braids formed in the distance, and river tending to go back to south braid.

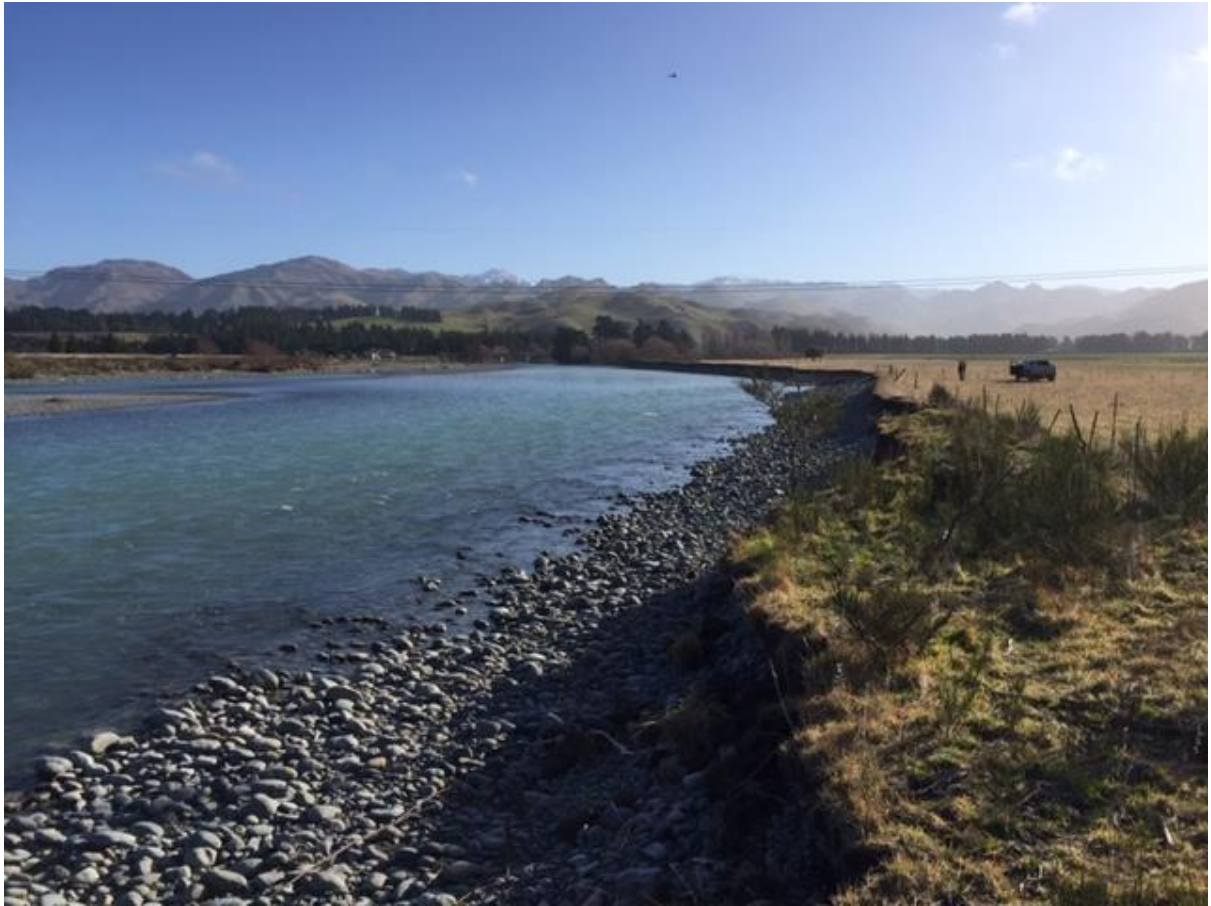
Photograph looking westwards, upstream, at scour of true left bank at upstream location. Note power lines across Waiau River at this site. AIC Scheme on left bank and Twin Bridges in the distance.

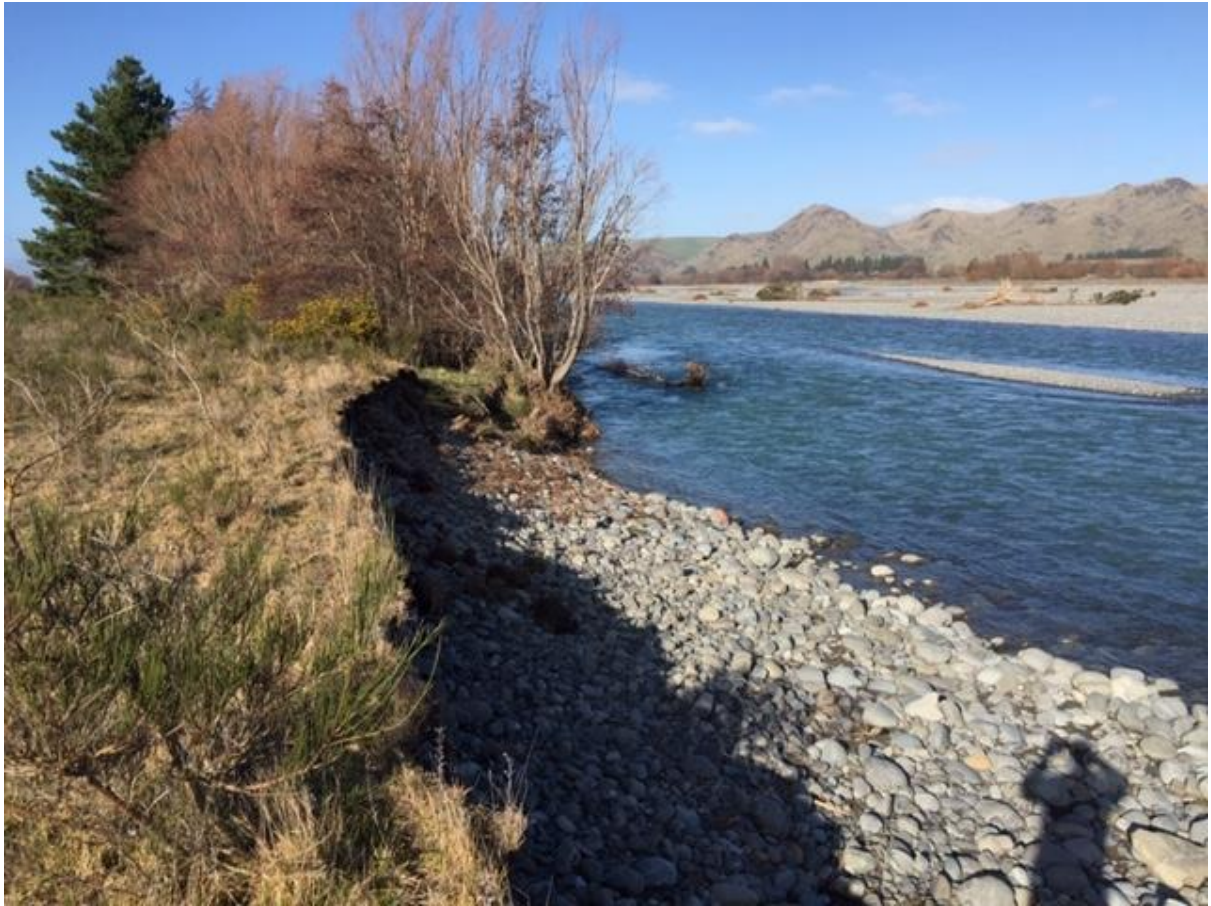
Photograph looking eastwards, downstream, at scouring willows at most downstream location of the upstream reach.
