Waiau Braidplain Delineation

Upon your request, we have assessed the NIWA report on the use of LiDAR (Light Imaging and Ranging) technology for the delineation of braidplain width (Hoyle & Bind 2018). To demonstrate the methodology, NIWA uses an example of a foothills-source braided river (i.e., the Ashley River), and an alpine-source river (i.e., The Waiau River).

The consent application (CRC231732 and CRC231733) pertains to the installation of two lengths of anchored tree protection (ATP) on the true left (north) bank of the Waiau River, downstream of Leslie Hills Road. The purpose of this ATP is to prevent further erosion of the true left bank into the neighbouring farmland. The farmland in this instance is used for grazing stock.

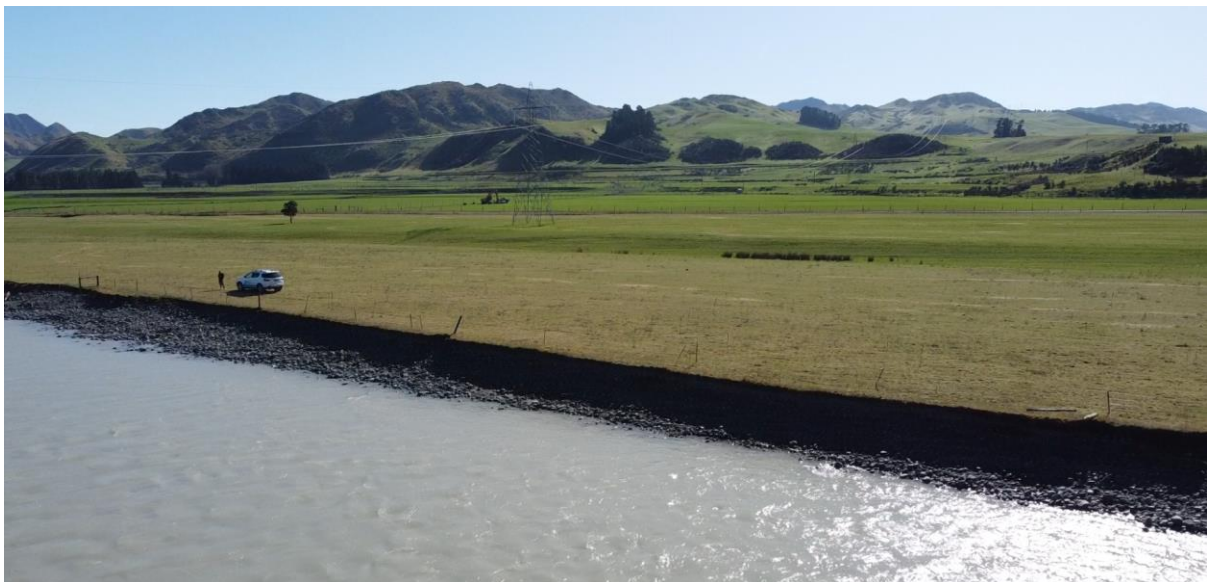
Figure 2. Drone footage of the flat flood-plain behind the location of the proposed localised ATP and the eroding bank in the foreground. A low terrace and pylons can be seen within the proposed ATP area.

have been no recent flood flow conditions in which the waterway exceeded the historical maximum extent on the true left bank. While the land appeared flat, there was a low terrace present on the upstream ATP reach (Fig. 2), which is detectable on the aerial imagery, but the DEM indicates that the high water does not connect to the channel directly upstream of the proposed ATP placement, but floods back to the high terrace on the north side of Leslie Hills Road.

It is worthy to note that infrastructure (high-voltage lines, pylon, Leslie Hill) is situated in the area behind the proposed upstream ATP (Fig. 2). So, not only would the ATP provide locale defence against water for pasture, it would also protect critical power supply infrastructure and road incursion.

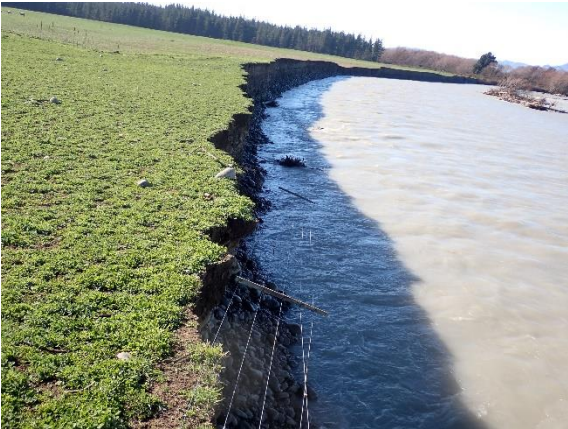
Figure i. Downstream-most proposed ATP reach. Note the visible erosion, but no indication of water egress over the bank toe.

The physical geomorphology of the ATP locations, as observed during a site visit on 23/08/2022, is consistent with the braidplain definitions and historical maximum extent mentioned above. The water level during this survey was deemed higher than normal baseflow conditions, but was not considered a flood flow. While signs of bank erosion were present, especially in the downstream ATP reach, no signs of previous water egress over the bank toe were observed at either location (App. II, Figs. i - iv). There

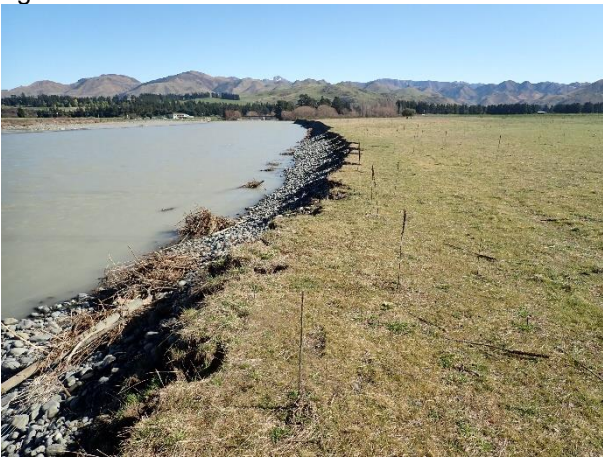
Figure iii. Upstream-most proposed ATP reach. Less erosion than downstream, but still present. No signs of water egress over the bank toe.

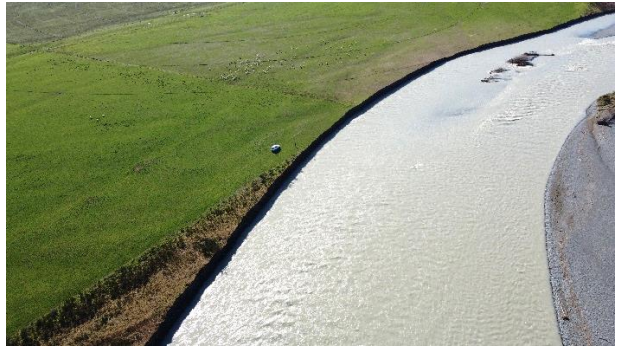
Figure ii. Drone footage of downstream ATP reach.

In the location of the downstream DEM (App. II, Fig. ii), old channels are discernible across a flat plain, which is consistent with the DEM in that these backfill with water at levels in excess of 4.0 m above the low flow level (App. I, Fig. viii-ix), and may accommodate braids connected to the main flow at levels of 4.5 m and above. However, inspection of DEM models indicate that old braids do not connect to the main flow within the ATP areas until the greater river width is flooded back to old terraces, and water levels this high are likely to cause infrastructure damage.

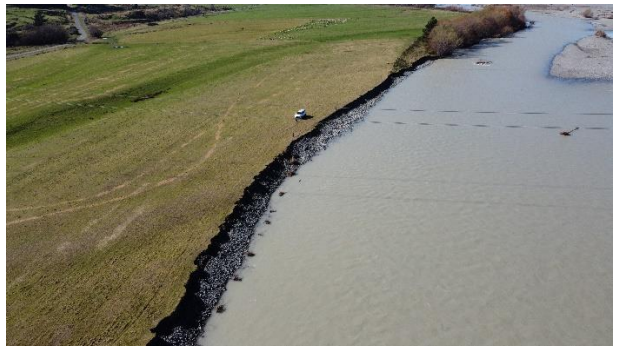
Figure iv. Drone footage of upstream ATP reach.
