Treated Timber Waste Minimisation Project

Timber Identification Tool Development

August 2013

Report No. R13/71

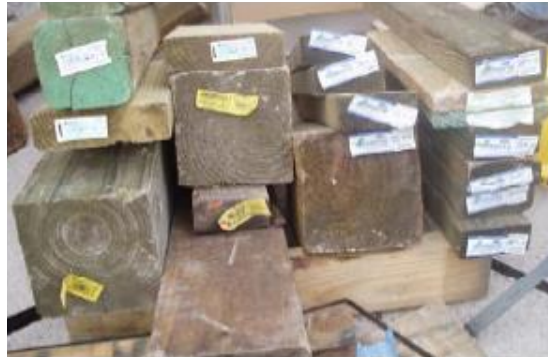
Figure 2. Visual identifiers on treated timbers: end tags [Solo-Gabriele et al., 2006]

Tags, listing type and level of preservative, are normally attached to the end of treated timber lengths (Figure 1). If present, these can be used as identifiers. However, it is likely that most of them would be lost during or after construction

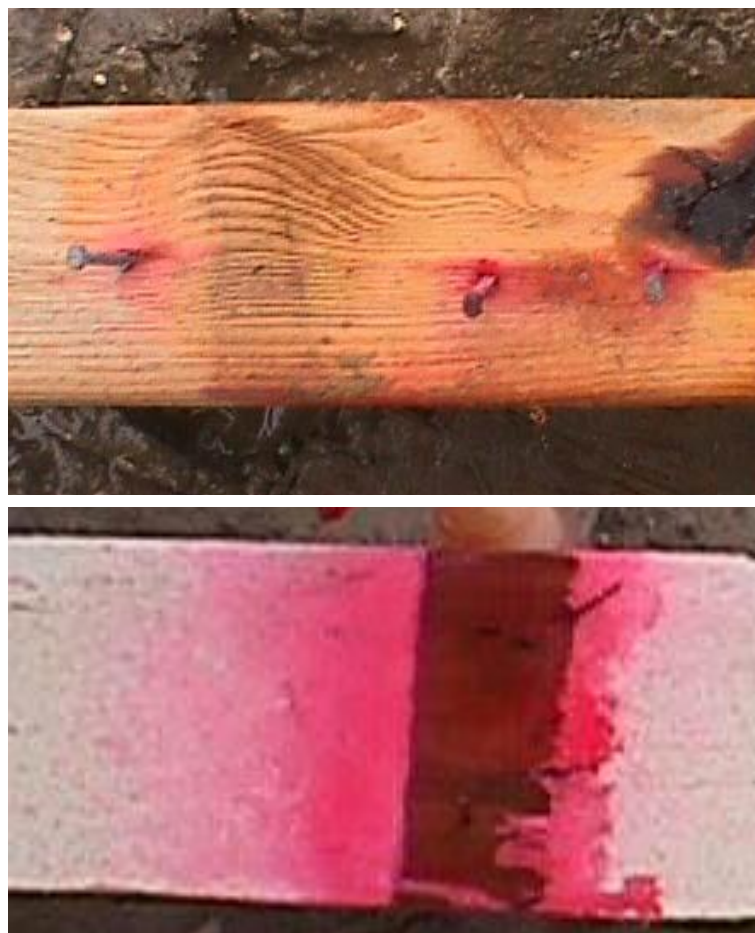
Figure 11. Interferences from nails and paint [Solo-Gabriele and Townsend, 2005]

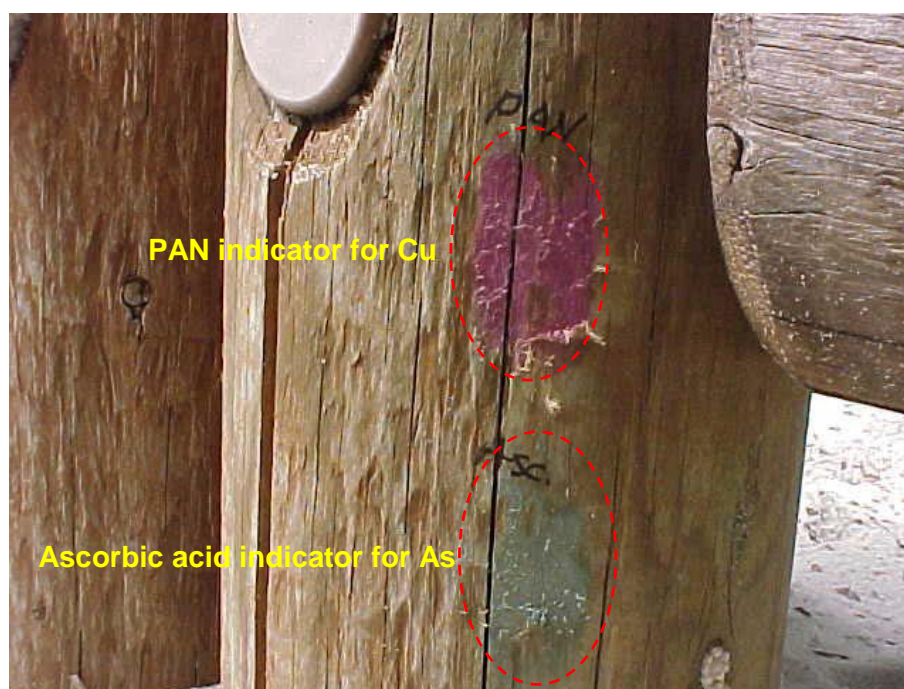
Figure 15. Performance of ascorbic acid based chemical stain indicator with CCA treated timber [Solo-Gabriele and Townsend, 2005]

- observe the colour. If the sample turns an intense blue, then the timber is positive for arsenic (Figure 1514).

The major disadvantages of the ascorbic acid colour indicator is that it requires 1 hour for colour development and, on occasions, untreated timber samples show a faint blue colour which may be confused with the more intense blue colour associated with CCA-treated wood.

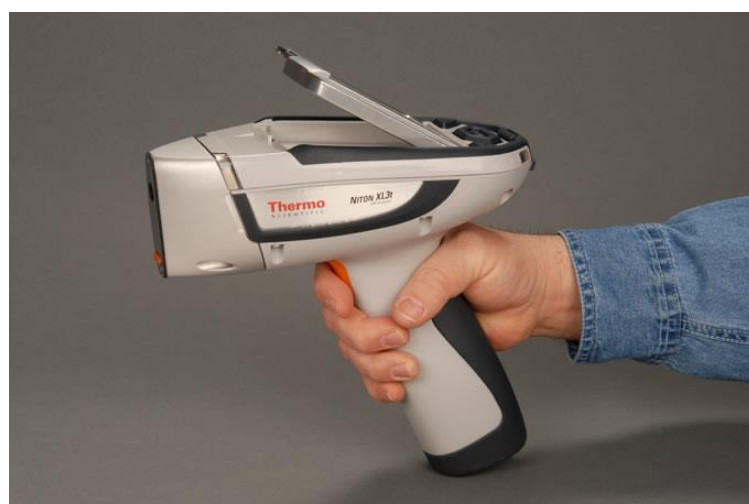
Figure 23. Thermo Scientific Niton XL3t handheld x-ray fluorescence (XRF) analyser
[<http://www.niton.com/en/niton-analyzers-products/xl3/xl3t>]

A Thermo Scientific Niton XL3t handheld X-ray fluorescence analyser was used in this comparative trial. The specifications and an image of this instrument are shown in Table 75 and Figure 2322, respectively.

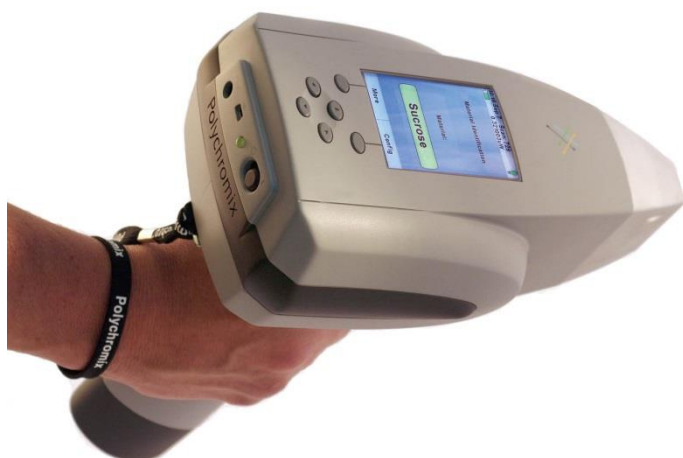
Figure 24. Phazir Handheld NIR Material Analyser
[<http://www.engineerdir.com/product/catalog/12415/>]

A Phazir handheld NIR material analyser was used in the WRAP comparative trial. The specification and an image of this instrument are shown in Table 86 and Figure 2423, respectively.

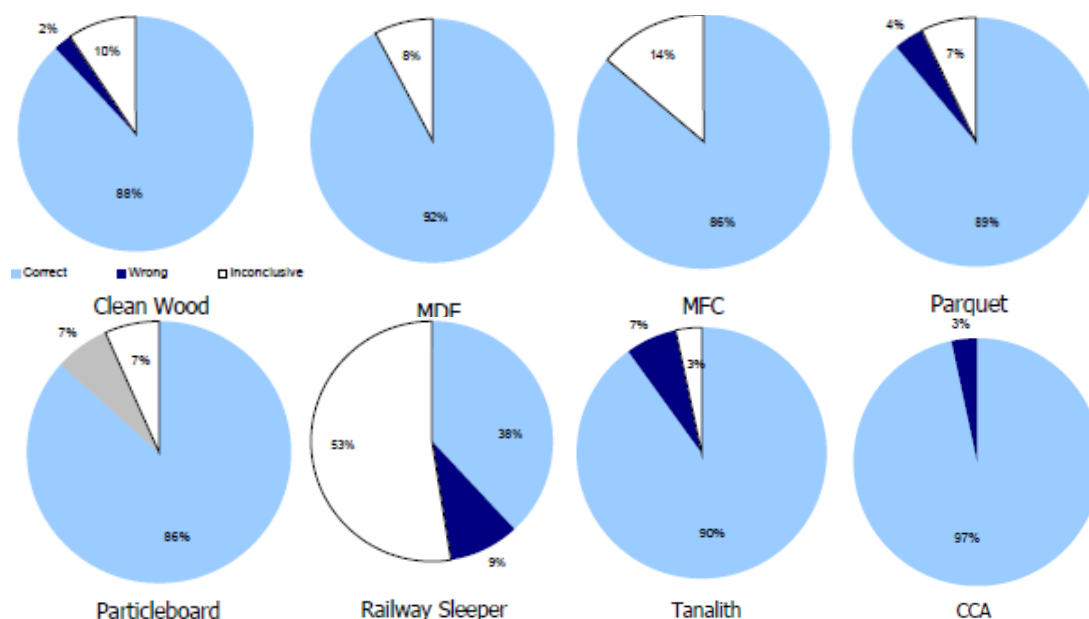
Figure 25. Sorting accuracy of NIR under dynamic conditions
[Pöyry Forest Industry Consulting Ltd, 2009]

Identification was based on qualitative measurement since actual threshold levels could not be set with NIR analysis. An accuracy of around 90% was achieved with most timbers (Figure 2524).

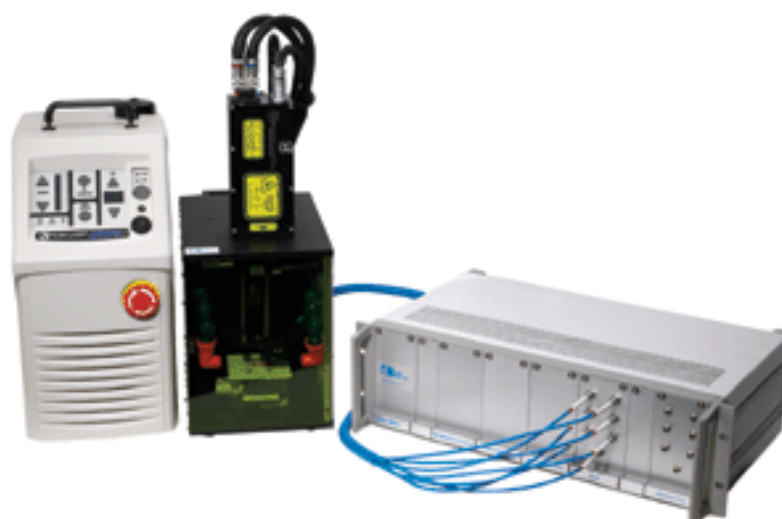
Figure 26. LIBS2000+ LIBS system
[<http://www.speciation.net/Database/Instruments/Ocean-Optics/LIBS-2000-;i2306>]

In the WRAP test, a high-intensity, 10 nanosecond-wide laser pulse beam was focused onto the timber sample placed inside a sample chamber. Various elemental emission lines were automatically labelled by comparing those emission lines with pre-defined intensity levels for element detection. The specification in Table 97 and the image in Figure 2625 give an indication of commercially available LIBS systems.

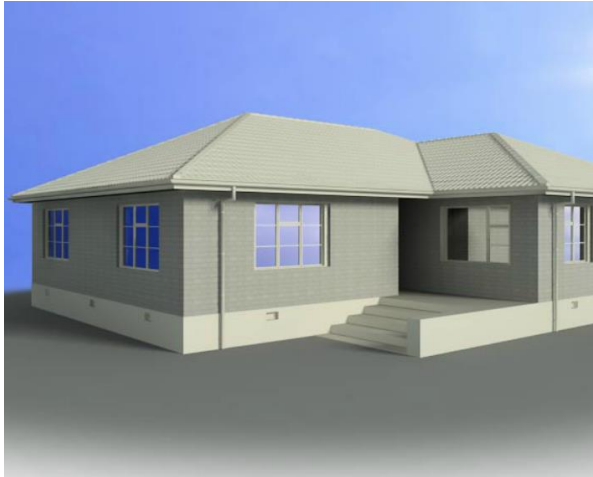
1960s Brick and Tile

- Later additions or alterations may use treated timber
- Decks and fences are likely to use treated timber

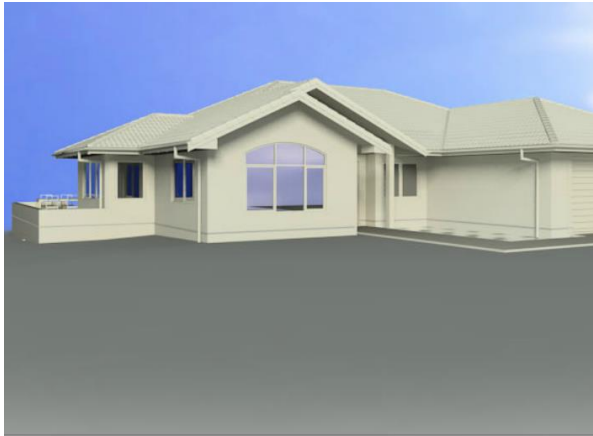
1990 on

- Likely most timber is treated
- Decks and fences are likely to use treated timber
