**Rangitata Diversion  
Race Management  
Limited**

**Klondyke Water Storage Facility  
Fish Screen Verification  
Management Plan**

**Revised May 2018**

### **Ryder Environmental Limited**

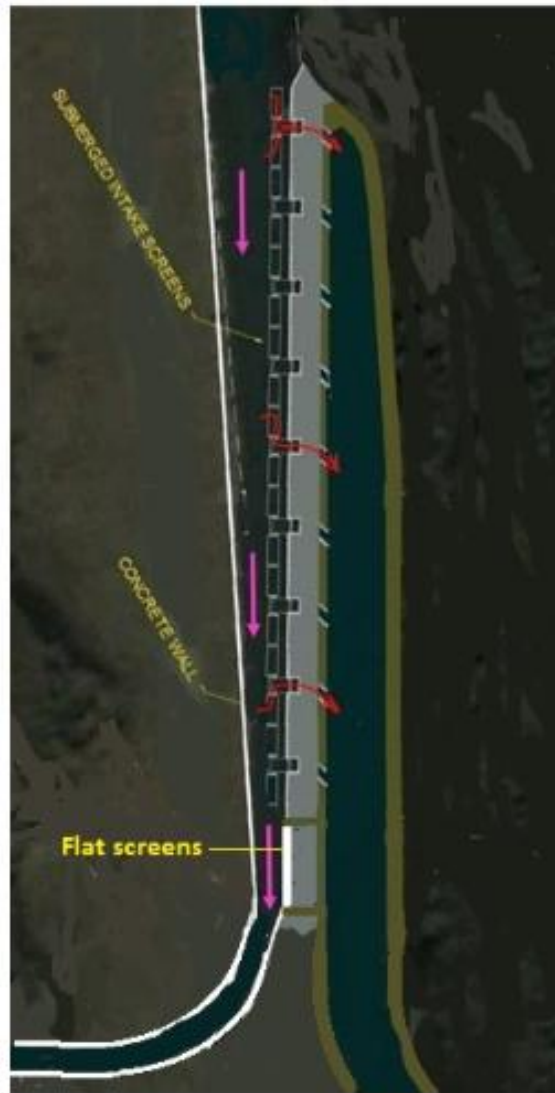
**Figure 1.** Schematic layout of revised RDR fish screen and bypass channel (redrawn from Riley 2017).

The concept for the revised RDR fish screen is shown in Figure 1. It consists of a concrete structure for the fish screens to be positioned at an acute angle to the flow in the canal. Water flowing along the channel will progressively enter through a series of cylindrical (rotary) screens, positioned along a concrete wall, and pass into the downstream race (the RDR). A proportion (between 3 and 5 cumecs) of the flow will continue along the entire length of the screen system and downstream towards a fish bypass entrance and back to the Rangitata River.
