### **Compliance Monitoring Report**

**Consent number:** CRC184072  
**Location:** 81 Conservators Road, Christchurch  
**Description:** To discharge contaminants to air

**Overall Inspection Compliance: Non Compliance Action Required**

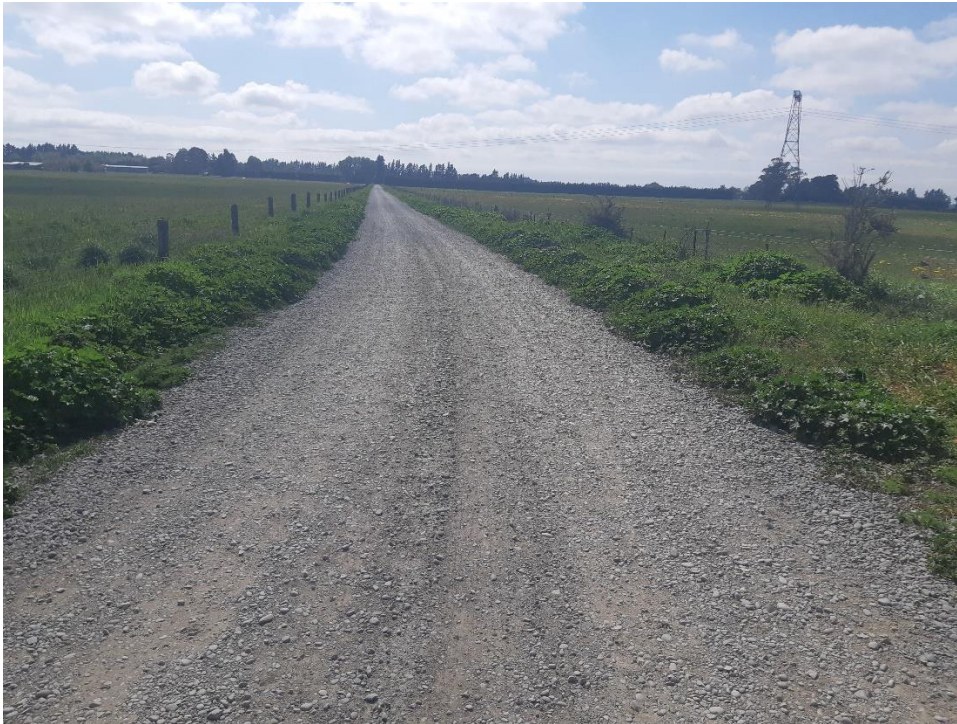
*Figure 1 Staff access road*

The first of which was the type of aggregate used on internal roads. The community is concerned that the chip used on the staff access road is not clean and generates dust. While the aggregate used on site is not "clean" (ie: does not go through a washing process) there is minimal loose material which would generate dust, which is the purpose of this condition. When we drove on the track with Ben Dormer, no dust kicked up from the vehicle. We were driving approx 30km. When we later took our own vehicle, still no dust kicked up behind us.

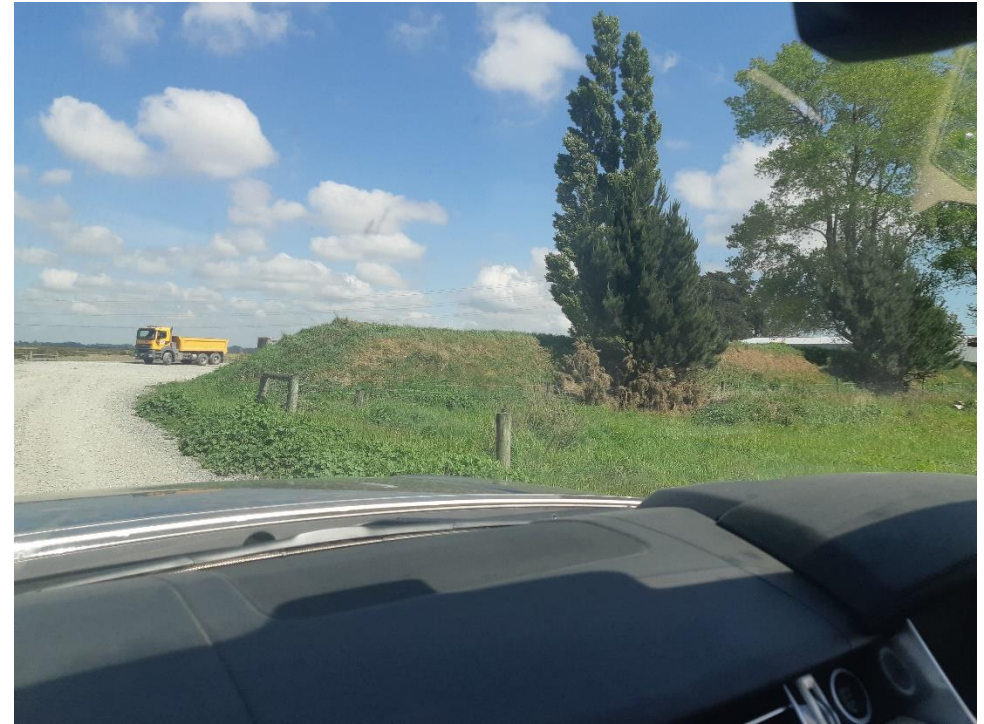
*Figure 2 Example of the bunds around the property which are grassed / planted*

- a. The bunds have been built as required
  - b. Bunds are mostly planted and grassed. There are some areas where soil has been exposed due to cattle being present in the area and walking up and down the bunds. The purpose of the cattle was to keep the area maintained; however an unexpected result is that cattle can expose soil. On a call dated 05/11/2020 at 2:10pm, Ben Dormer has explained that the cattle have already been removed (04/11/2020) and Ben Dormer has seeded the exposed areas already. Rain is expected for the upcoming week and as such the seeds should germinate in the very near future. I have graded this consent as complies as all actions to remedy the situation have been undertaken.

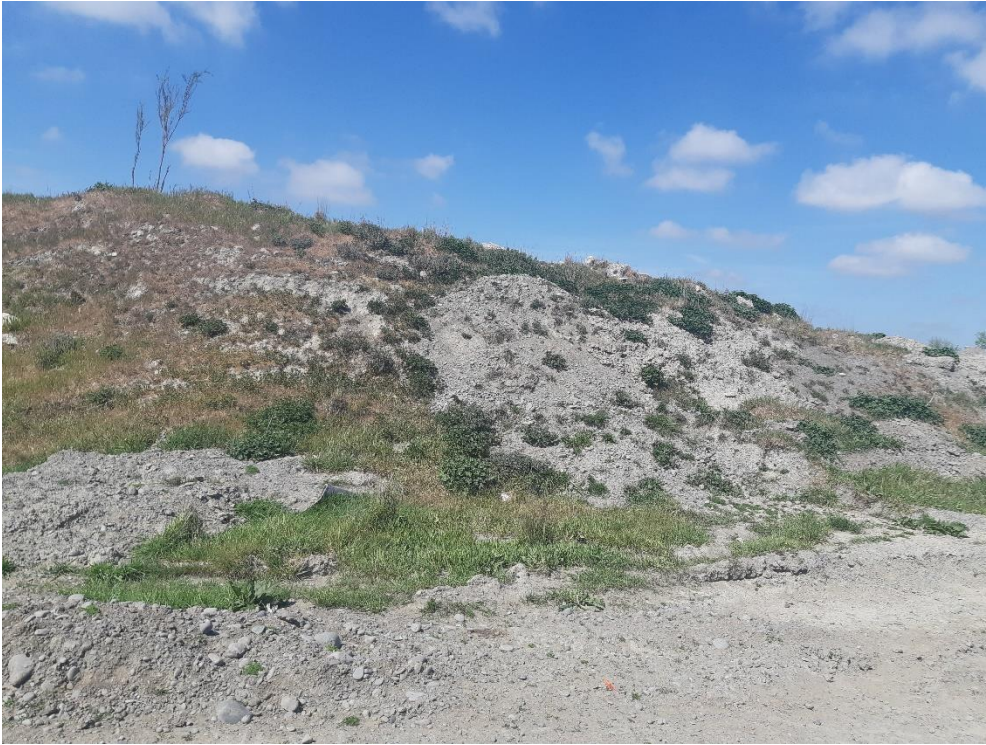
*Figure 3 in alignment with 6d, an area which has been regrassed.*

- c. Watering is not required currently as all vegetation has been established
  - d. Grass / vegetation is mostly well maintained. Please refer to (b)

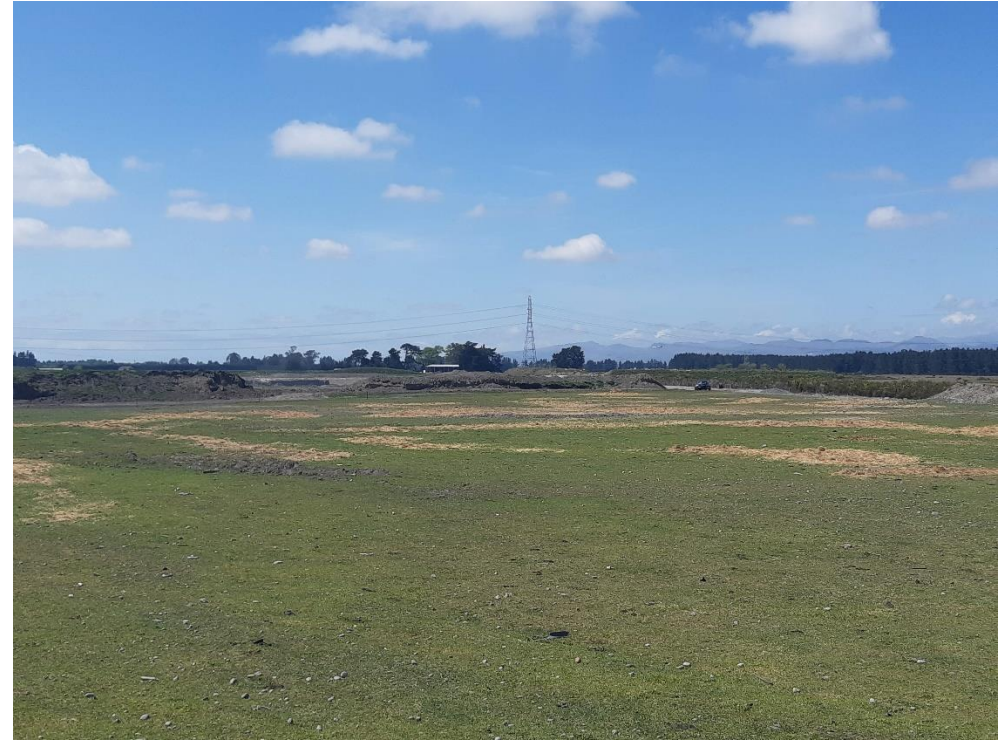
*Figure 4 Remediated Area A which has been filled and seeded.*

- a. Region A has been completed and works are being undertaken in Region B
  - b. Preparation only occurs when the currently active area is near completion. On site there is a line been dug (less than 1m deep) to demarcate the next stage.
  - c. At time of writing there is only 6.5ha of land opened with the activities described in condition11(c)
-

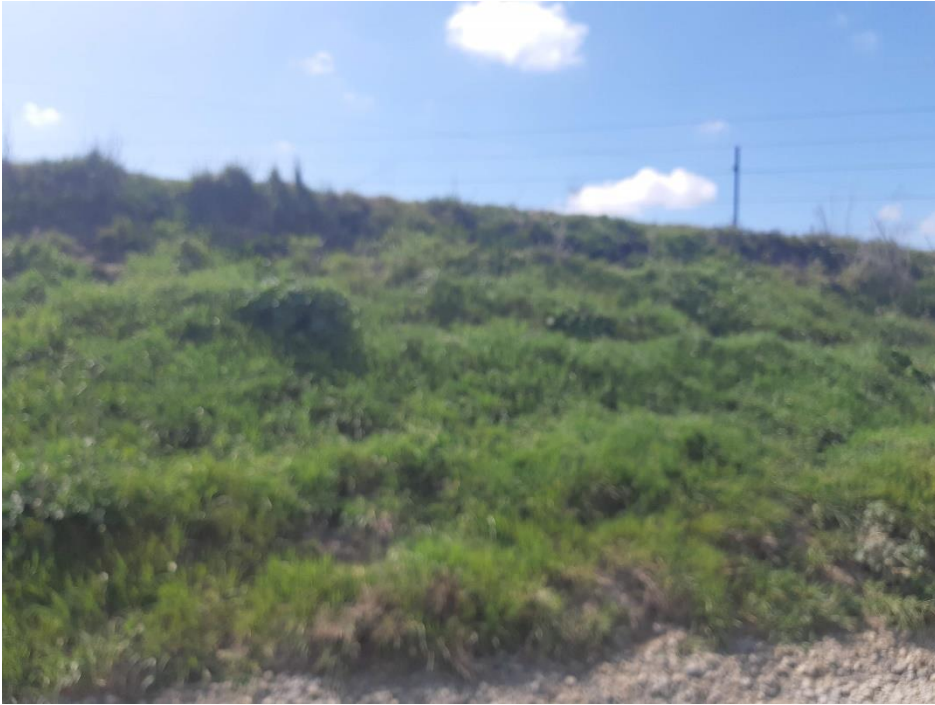
*Figure 5 Grassed bunds around property*

The second concern was that the bunds have not been grassed or vegetated. All of the bunds on the property have been grassed. There are some areas which appear to be bare soil, but this is due to cattle being present on site and the repetitive movement of those cattle over certain areas. Ben Dormer has since removed the stock (04/11/2020) and has grass seeded the bare areas. Grass should soon strike as rain is predicted for Christchurch in the next few days.

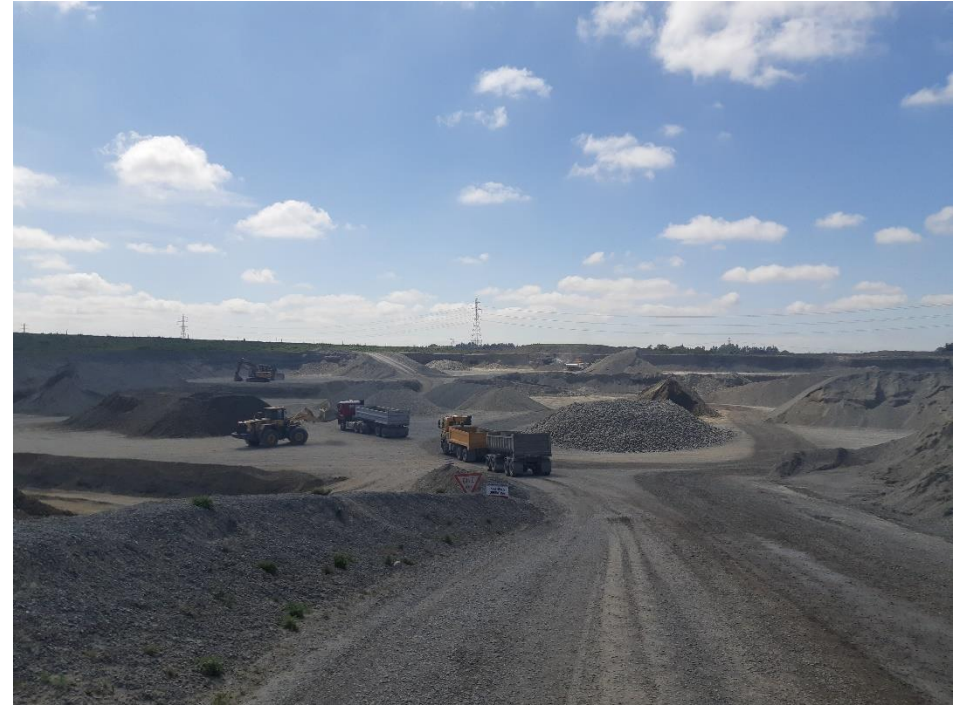
*Figure 6 Pit floor. Stockpiles are not within 3m of NGL. Very minimal dust generated from loading of aggregate into trucks.*

- a. It was estimated that the stockpiles were less than 5000 cubic meters
- b. The stockpiles are 3m below the natural ground level
- c. Overburden piles have not all been grassed, but that is because they are being progressively spread in areas that have been completed, as cleanfil fills the site
- d. The water cart discussed in previous conditions also wets down the surfaces of stockpiles

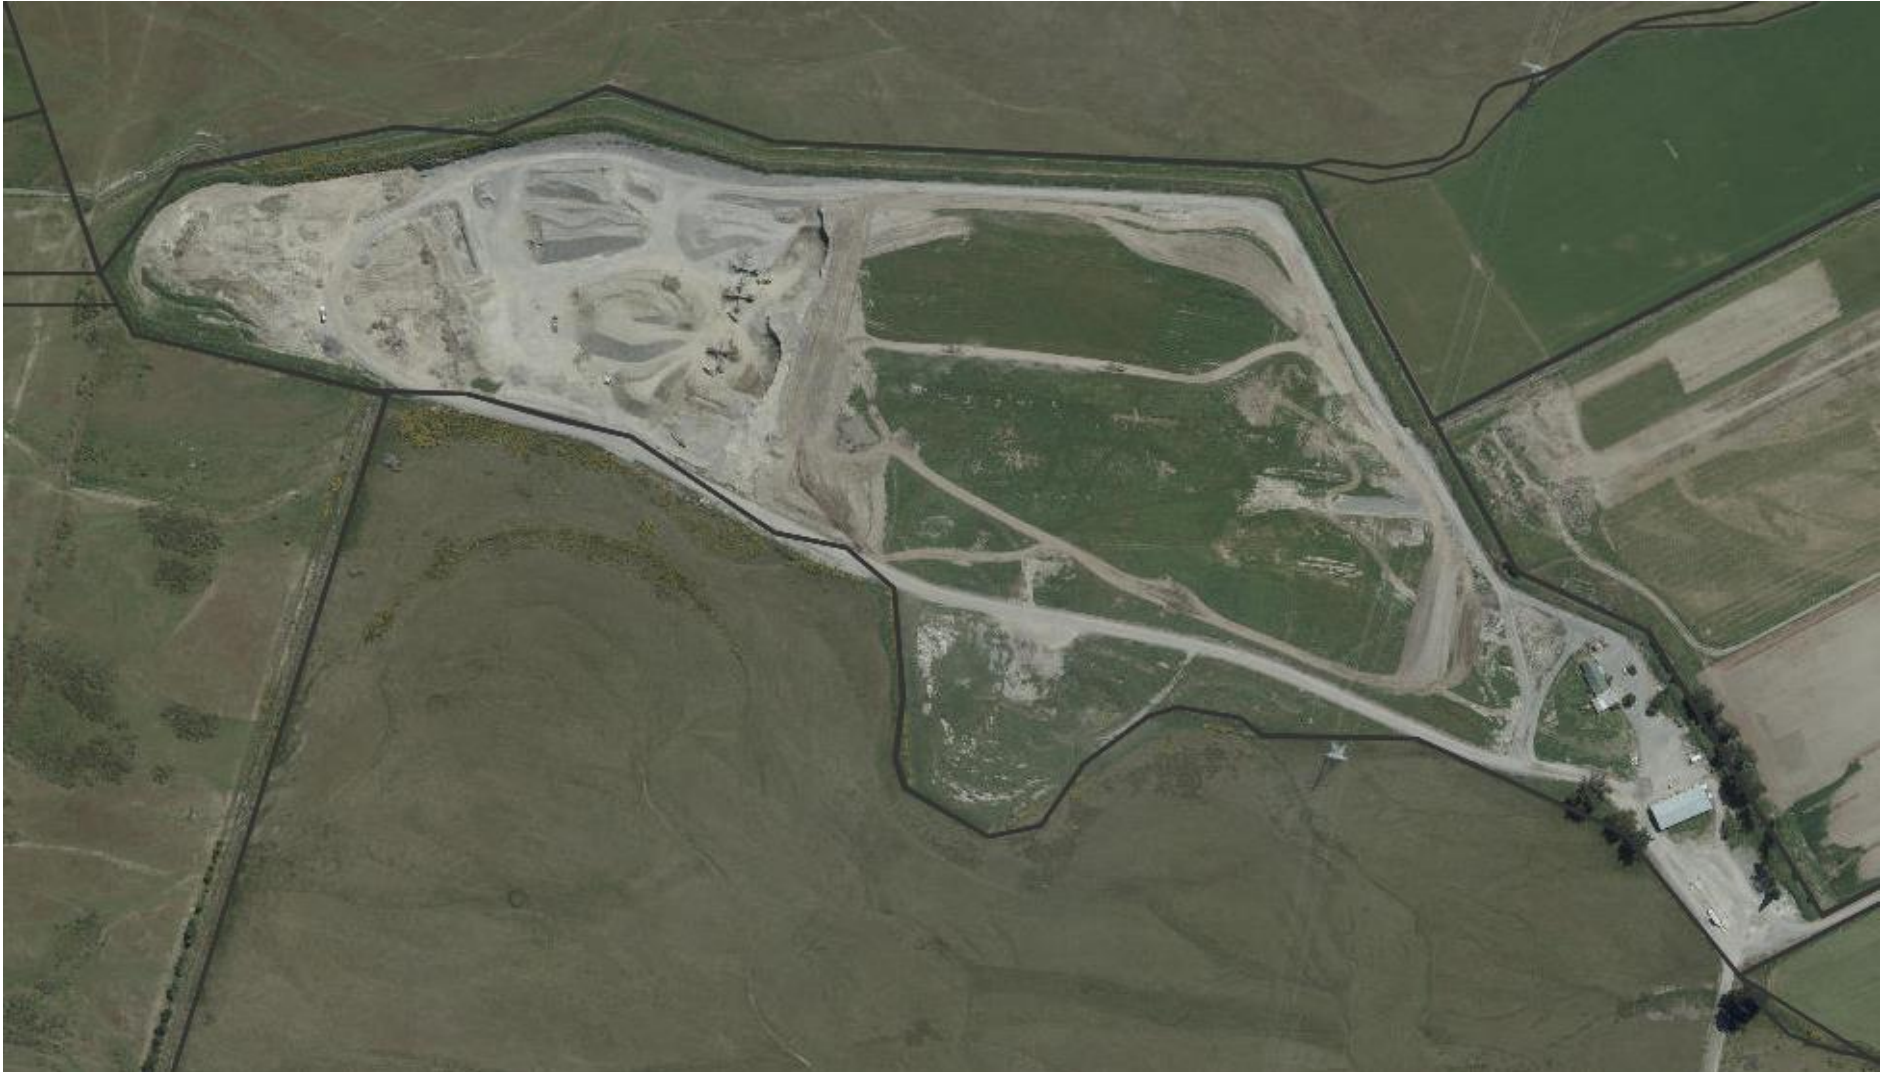
*Figure 8 Bunding required by this consent is in place. There is one break to the west of the property to allow stock access between the stock water race and area A grazing.*

- e. Not relevant on this site visit
  - f. Bunds are in the correct location
-
