In the matter of an application for Resource Consents by Road Metals Company

Limited to extend quarry operations onto adjoining land and

operate an aggregate processing activity.

STATEMENT OF EVIDENCE OF ANDREW ALAN METHERELL FOR ROAD METALS COMPANY LIMITED

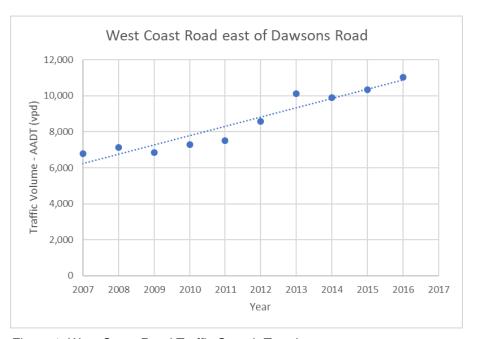
Figure 1: West Coast Road Traffic Growth Trend

11 West Coast Road past the access currently operates with a 100km/hour speed limit. The most recent traffic counts carried out by NZTA show that West Coast Road east of Dawsons Road carries approximately 11,000 vehicles per day (as at 2016). This has increased from about 7,000 vehicles per day ten years ago.

This traffic volume is well within the capacity of the road. At peak times there will be some additional peak period delays for vehicles accessing West Coast from side roads and accesses.
