Farm Environmental Management Plan: Grampians Station (A N Hope)

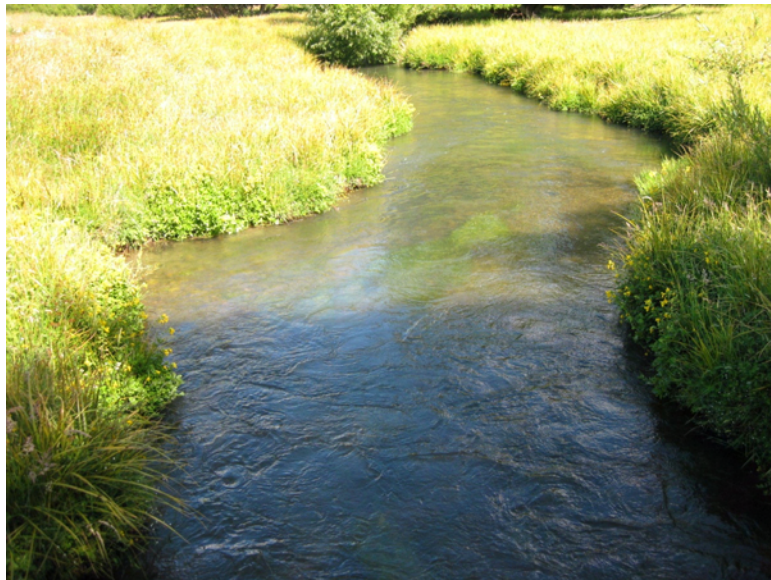
Grays River

- 4.3.11 Contractors are brought in and used if anything is being sprayed off.
- 4.3.12 There is evidence of bankside erosion along the Grays River. The majority of this is not stock induced, but is the result of high water level flows during the winter and early spring.

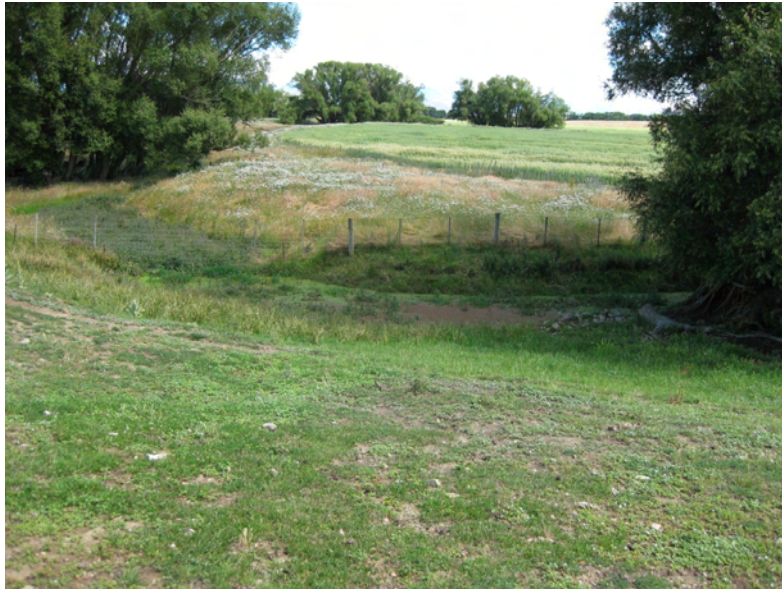
Wetland that recieves discharge

- 4.3.13 The small wetland that receives the excess runoff water from the diverted source is not very large, and it is planned, if need be to do more planting around this area. The wetland does not get stocked and will be fenced. This runoff is then allowed to return to the Grays River.

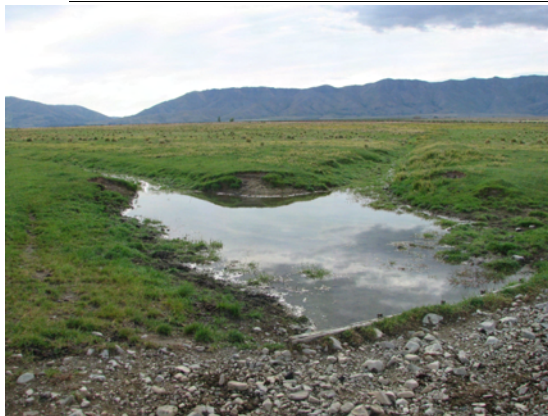
- 4.3.14 There are other small streams that are culverted, but not fenced. Where stock have access to these streams there is a small amount of stock induced erosion (as seen in photo; Grampians- evidence of culverted track, but stock have easy access to the stream).

Evidence of a culvert through a stream but notice stock induced erosion

FEMP stage	Measure	Monitoring	Auditing
	adequate		
3	Fence off the Grays River as much as possible to restrict stock access to the river	Photos and annual survey of the erosion and compaction	Annual auditing visit until the fencing is complete
3	Maintain a 20 metre layback from waterways when applying land based fertilisers	Field Records	Annual auditing report
3	Maintain a 5-11 metre irrigation buffer from any water ways (Grays River)	Photos	Annual auditing visits
3	Plant a riparian margin within the wetland as detailed in the map below	Water quality monitoring continued quarterly, and photos in the audit report	Annual audit report and visit
3	Monitor and manage stock access, stock type and stock number from all permanently flowing waterways within non irrigated intensively farmed areas	Photos and location plan of waterways	Photos

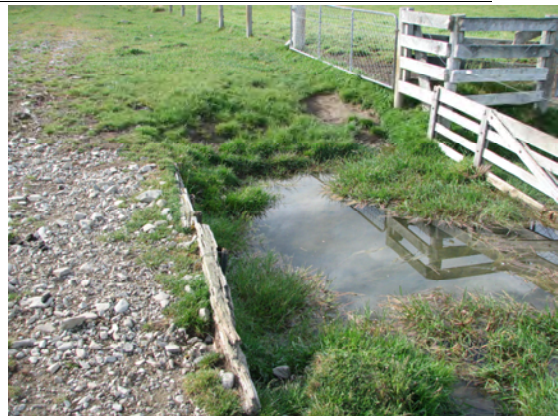
Another culvert where stock have access to water and have caused some erosion
