## EARTHQUAKES

### EXPOSING CANTERBURY'S SHAKY FUTURE

August 2008

ECan Publication: E08/116

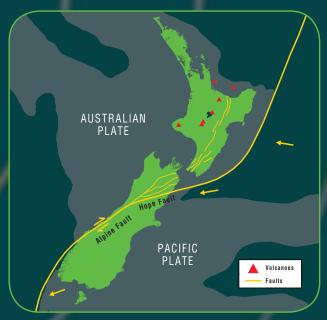
Above: New Zealand's plate boundary location.

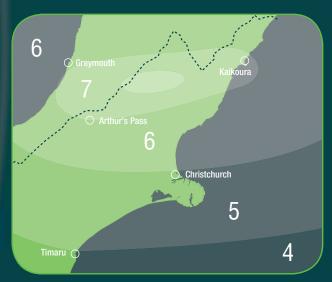
Above: The general pattern of Modified Mercalli shaking intensity during the magnitude 7.0-7.3, 1888 North Canterbury earthquake on the Hope Fault. Shaking intensity generally decreases away from the source of an earthquake, but can be influenced by local topography, geology and soil.

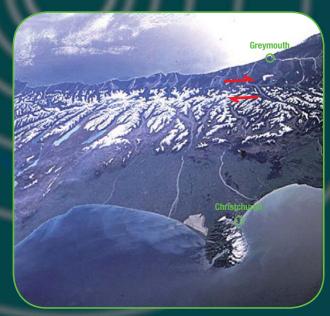
Above: The central South Island, with the west coast at the top of the picture and the east coast and Banks Peninsula in the bottom. The Alpine Fault marks the sharp western edge of the Southern Alps through the image.

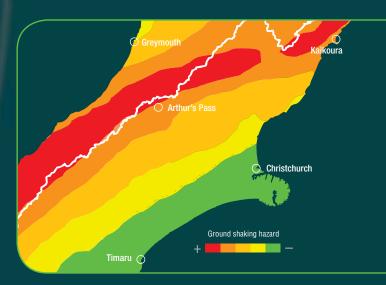
Above: This map shows the relative ground shaking hazard across the central South Island (the white line is the Canterbury region boundary). The redder the area, the more likely it is to experience strong ground shaking. This is based on the location of known active faults as well as historical earthquakes.

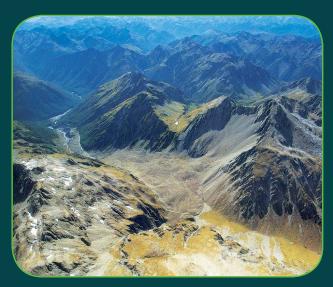
Above: Fifty-five million cubic metres of rock fell from Falling Mountain on the Main Divide during the 1929 Arthur's Pass earthquake and travelled 4.5km down the Otehake River.
